# *Skagit County Creosote Inventory and Removal Project: Phase II*

**Skagit County Marine Resources Committee**

**Final Report -- June 2007**

PROJECT TITLE: Treated Wood Inventory and Removal

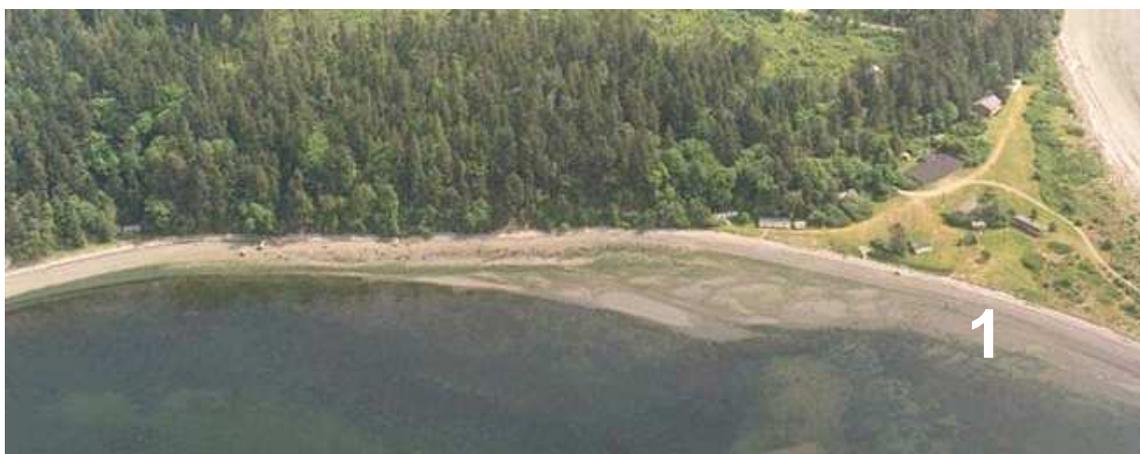
Southwest side of Samish Island at Camp Kirby  
Shoreline Aerial Photo #SKA0277  
Surveyed by Paul Dinnel and Rich Hoover, May 2007

1. Creosote fixed piling 240" x 12" dia.

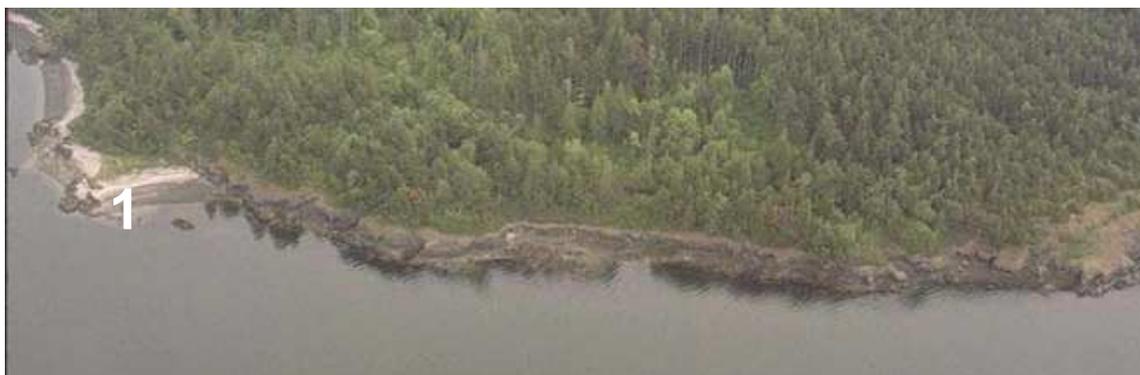
Southwest side of Vendovi Island  
Shoreline Aerial Photo #SKA0093  
Surveyed by Paul Dinnel, Lin Folsom, Erica Pickett, Vicki McNeil, October 2006

1. 1 creosote log, 3' x 18" dia.

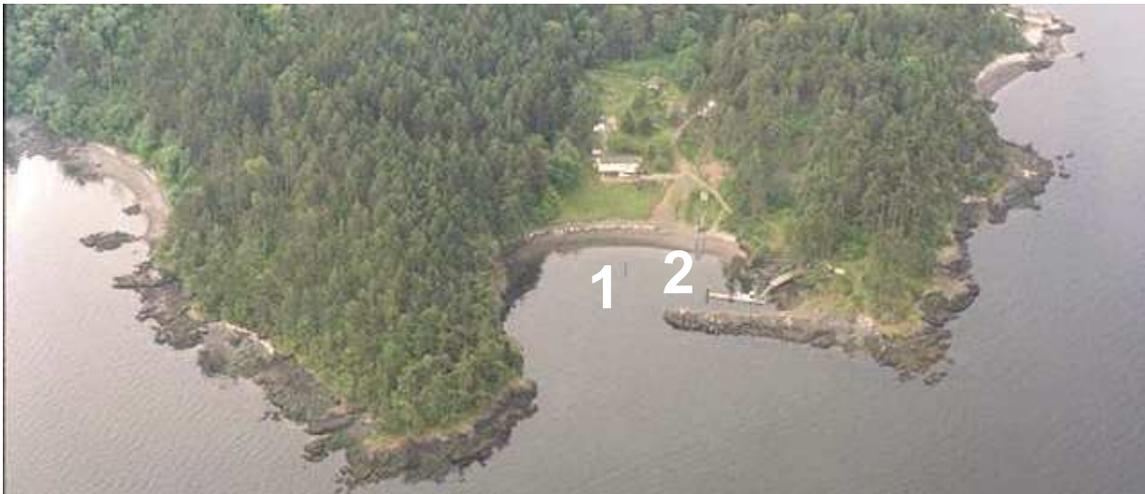
1. Creosote fixed piling 20' x 12" dia.

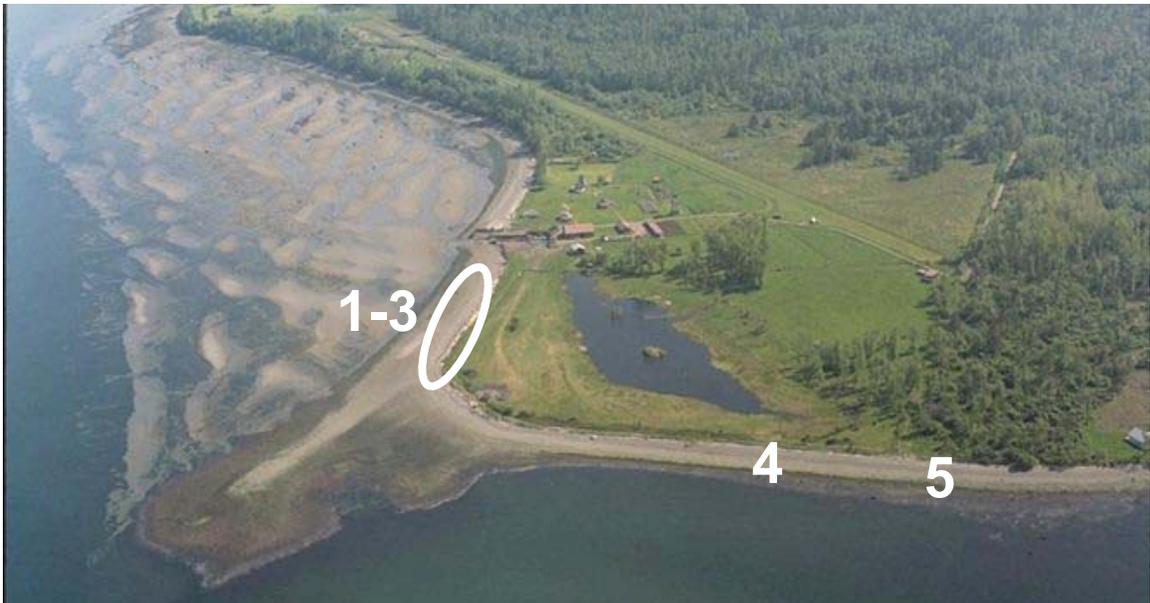
1. Small timber, no size given
2. Creosote log, no size given
3. Creosote stub, 6'' x 14'' dia.
4. Creosote log 10'' x 8'' dia.
5. Creosote log, partially buried, length unknown, 15'' dia.

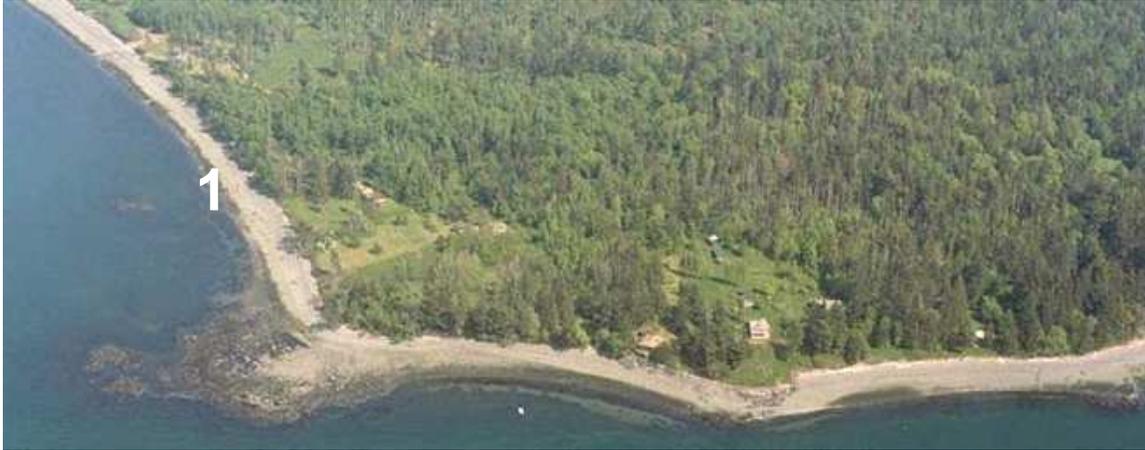
Southwest corner Sinclair Island  
Shoreline Aerial Photo #SKA0006  
Surveyed by Ferdi Bussinger, August-October 2006

1. Creosote log 30+' x 12" dia.

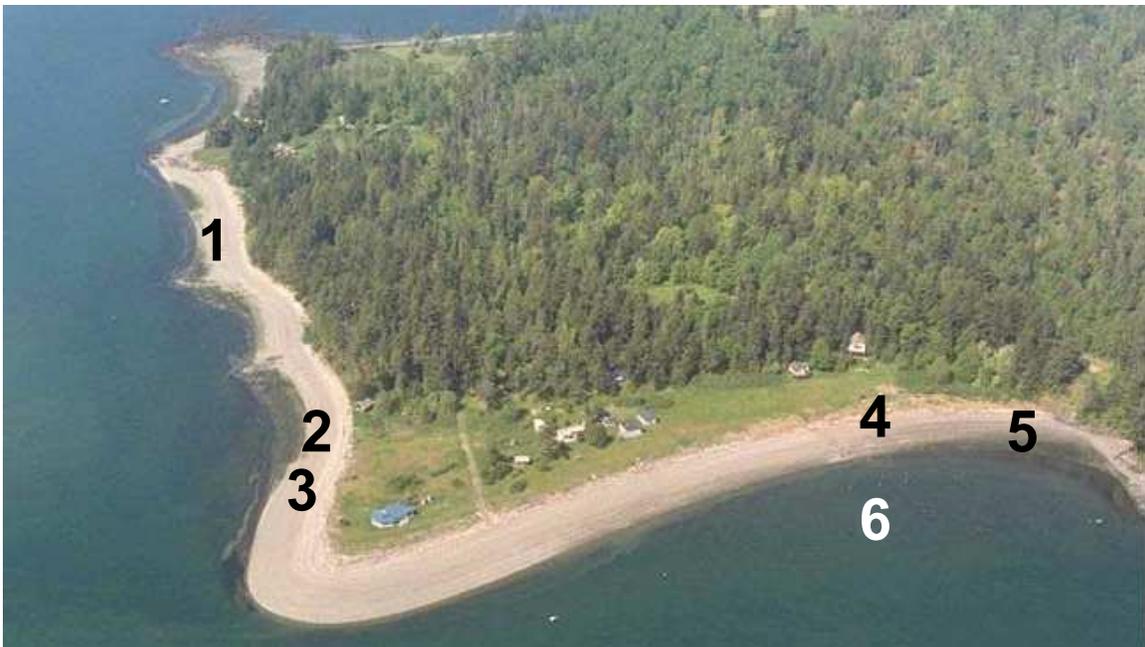
Southwest side of Sinclair Island  
Shoreline Aerial Photo #SKA0008  
Surveyed by Ferdi Bussinger, August-October 2006

1. Timber (creosote?), 15' x 12" x 12"
2. Small timber pieces (creosote) bolted together
3. Creosote log, 10' x 12" dia.
4. 3 creosote logs, 6-10' x 8-12" dia.

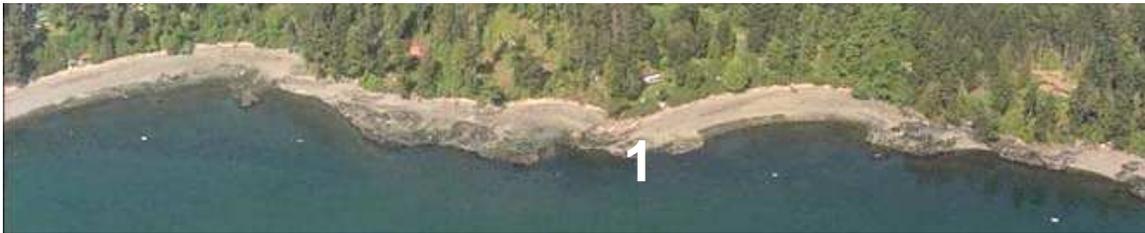
South side of Sinclair Island  
Shoreline Aerial Photo #SKA0010  
Surveyed by Ferdi Bussinger, August-October 2006

2. 40' plank (creosote?)

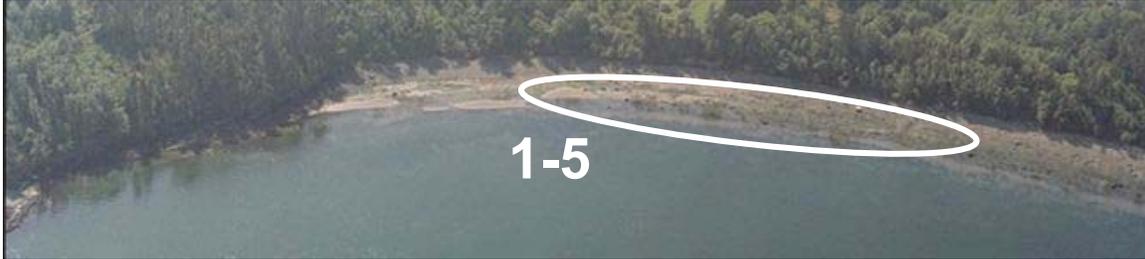
East side of Sinclair Island  
Shoreline Aerial Photo #SKA0020  
Surveyed by Ferdi Bussinger, August-October 2006

1. Creosote log, 10' x 10" dia.
2. 2' piece of treated timber
3. 3' piece of creosote timber
4. Creosote stub, 4' x 8" dia.
5. Creosote stub, 2' x 12" dia.

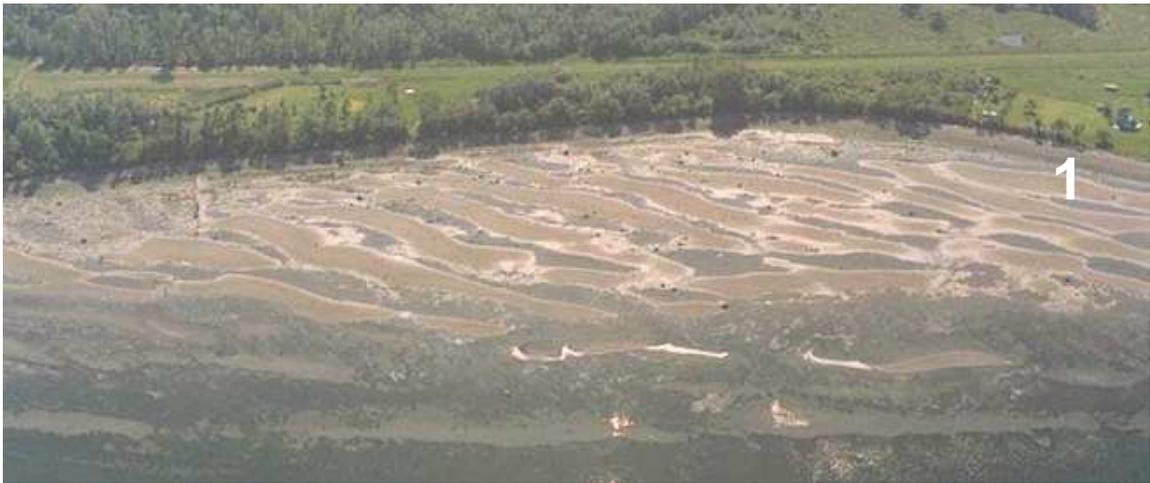
North side of Sinclair Island  
Shoreline Aerial Photo #SKA0023  
Surveyed by Ferdi Bussinger, August-October 2006

1. Creosote log, 12' x 8" dia.

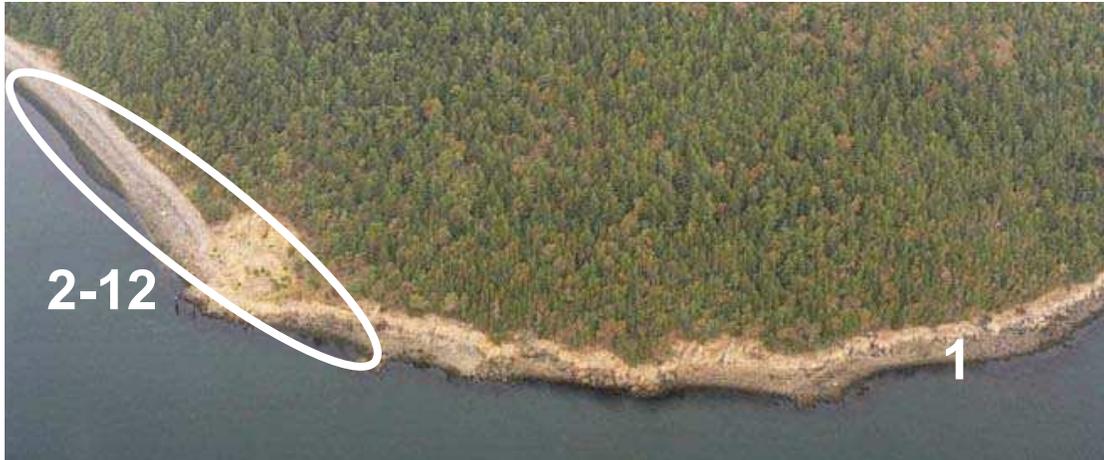
Southwest Cypress Island  
Shoreline Aerial Photo #SKA0158  
Surveyed by Sean Hewitt, October 2006

1. Creosote timber 120" x 8" x 8"
2. 6 Creosote fixed pilings, each 360" x 10"
3. 5 Creosote fixed pilings, each 240" x 12" dia.
4. 3 Creosote fixed pilings, each 175" x 12" dia.
5. Creosote log 96" x 14" dia.
6. Creosote log 72" x 14" dia.
7. Creosote timber 192" x 6" x 6"
8. Creosote timber 48" x 12" x 12"
9. Treated timber 144" x 6" x 4"
10. Creosote timber 36" x 10" x 3"
11. Creosote log 72" x 14" dia.
12. Creosote timber 60" x 6" x 4"

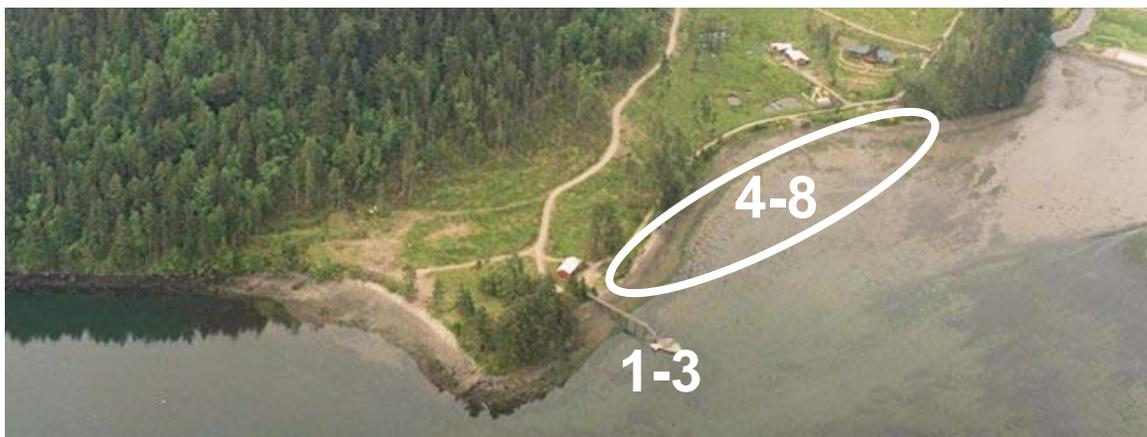
Secret Harbor, Cypress Island  
Shoreline Aerial Photo #SKA0162  
Surveyed by Sean Hewitt, October 2006

1. Creosote log 24" x 12" dia.
2. 10 Creosote pilings for dock & float, each 168" x 12" x 10" dia.
3. 11 Creosote timbers for dock, each 96" x 10" x 11"
4. Creosote log 72" x 10" dia.
5. 2 Creosote fixed pilings, derelict, each 240" x 9" dia.
6. Creosote fixed piling stub derelict 6" x 6" dia.
7. 3 Creosote fixed pilings, derelict, each 36" x 9" dia.
8. 3 Creosote logs, each 36" x 12" dia.

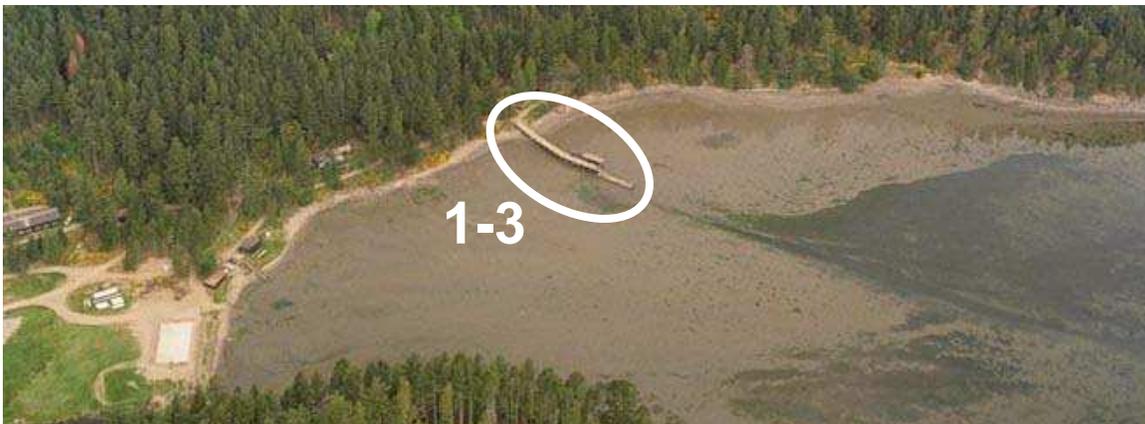
Secret Harbor, Cypress Island  
 Shoreline Aerial Photo #SKA0165  
 Surveyed by Sean Hewitt, October 2006

1. 2 Creosote fixed pilings, each 144" x 12" dia.
2. 2 Creosote fixed pilings, each 120" x 12" dia.
3. 40+ fixed pilings, concrete enclosed (creosote??). No sizes given

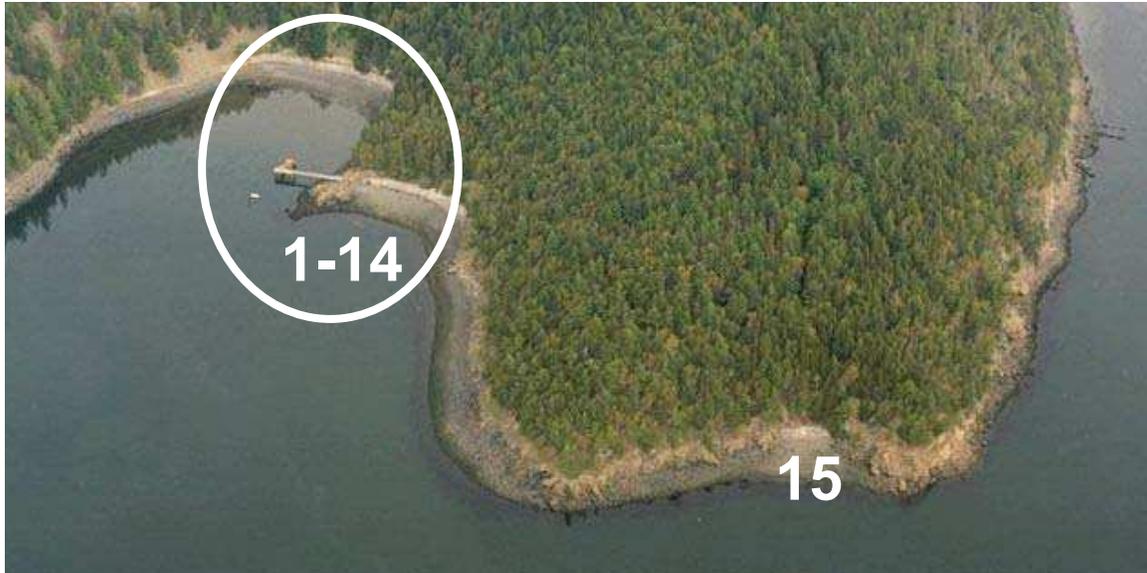
North end of Deepwater Bay, Cypress Island  
Shoreline Aerial Photo #SKA0171  
Surveyed by Sean Hewitt, October 2006

1. Creosote fixed piling, derelict, 36" x 9" dia.
2. Creosote fixed piling, derelict 36" x 12" dia.
3. Creosote log 396" x 13" dia.
4. Creosote timber 40" x 10" x 10"
5. Creosote timber 30" x 10" x 2"
6. Creosote timber 36" x 6" x 2"
7. Creosote timber 96" x 8" x 8"
8. Creosote timber 156" x 12" x 12"
9. Creosote log 96" x 13" dia.
10. Creosote log 480" x 9" dia.
11. Creosote log 48" x 10" dia.
12. Creosote fixed piling 360" x 10" dia.
13. 8 Creosote fixed pilings, each 144" x 10" dia.
14. 6 Creosote fixed pilings, each 24" x 10" dia.
15. Creosote log 18" x 12" dia.

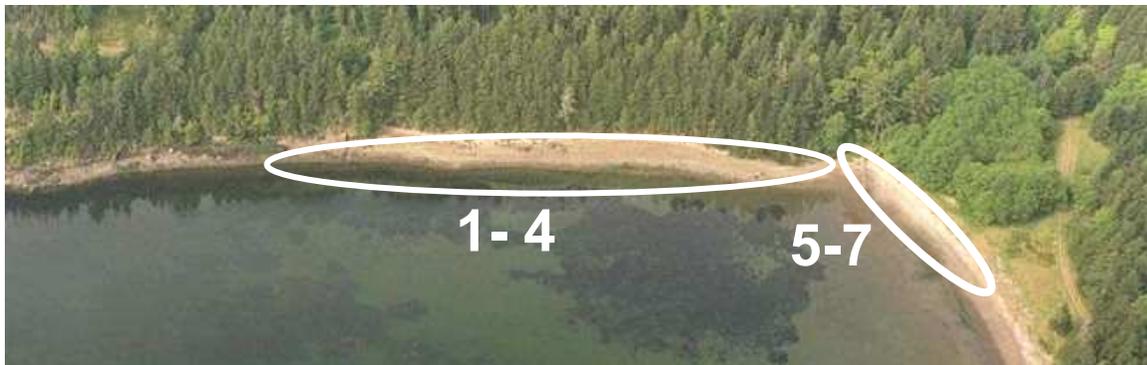
Eagle Harbor, west side, Cypress Island  
Shoreline Aerial Photo #SKA0183  
Surveyed by Sean Hewitt, October 2006

1. Creosote log 42" x 16" dia.
2. Creosote log 26" x 12" dia.
3. Creosote timber 18" x 8" x 3"
4. Creosote log 24" x 12" dia.
5. Creosote log 40" x 16" dia.
6. Creosote timber 18" x 12" x 6"
7. Creosote timber 30" x 12" x 6"

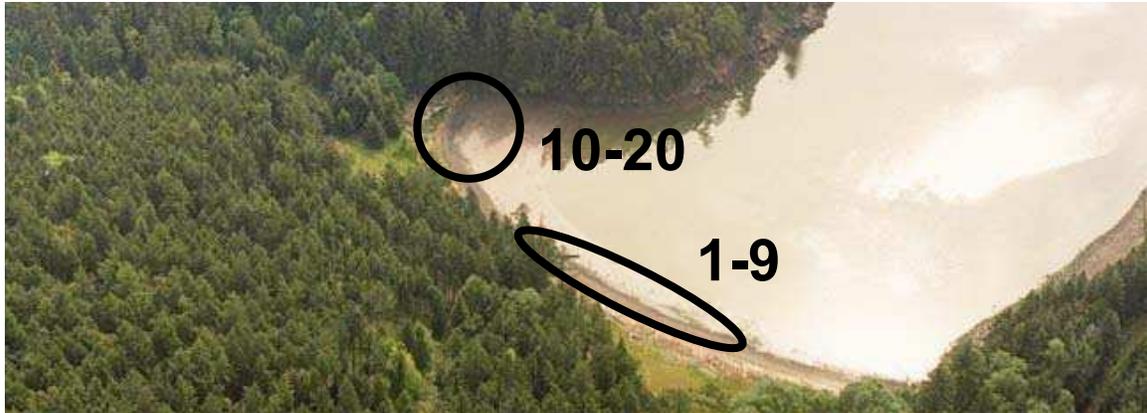
Eagle Harbor, north end, Cypress Island  
Shoreline Aerial Photo #SKA0185  
Surveyed by Sean Hewitt, October 2006

1. 3 Creosote (?) timber pieces, total 24" x 6" x 6"
2. Creosote timber 60" x 6" x 4"
3. Treated timber 72" x 4" x 2"
4. Creosote log 24" x 14" dia.
5. Creosote timber 60" x 6" x 3"
6. Creosote log 40" x 12" dia.
7. Creosote log 48" x 16" dia.
8. Creosote timber 48" x 6" x 6"
9. Creosote beam 24" x 12" x 12"
10. Creosote timber 72" x 2" x 8"
11. Creosote timber 132" x 3" x 12"
12. Creosote log 48" x 12" dia.
13. Creosote log 14" x 14" dia.
14. Creosote log 24" x 12" dia.
15. Creosote log 192" x 15" dia.
16. Creosote timber 120" x 4" x 5"
17. Creosote log 72" x 8" dia.
18. Creosote log 30" x 14" dia.
19. Creosote log 108" x 10" dia.
20. Creosote log 120" x 14" dia.

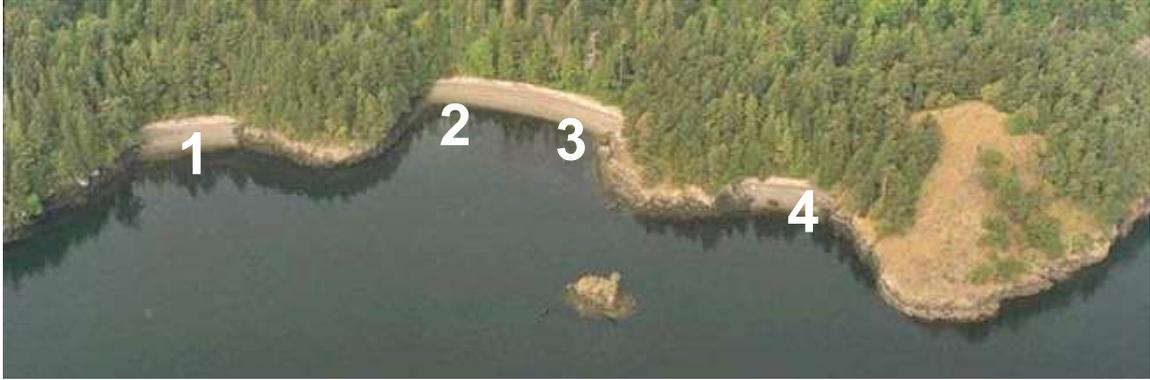
North of Eagle Harbor, Cypress Island  
Shoreline Aerial Photo #SKA0189  
Surveyed by Sean Hewitt, October 2006

1. Creosote log 64" x 10" dia.
2. Creosote log 72" x 18"
3. Creosote log 480" x 10" dia.
4. Creosote timber 84" x 12" x 12"

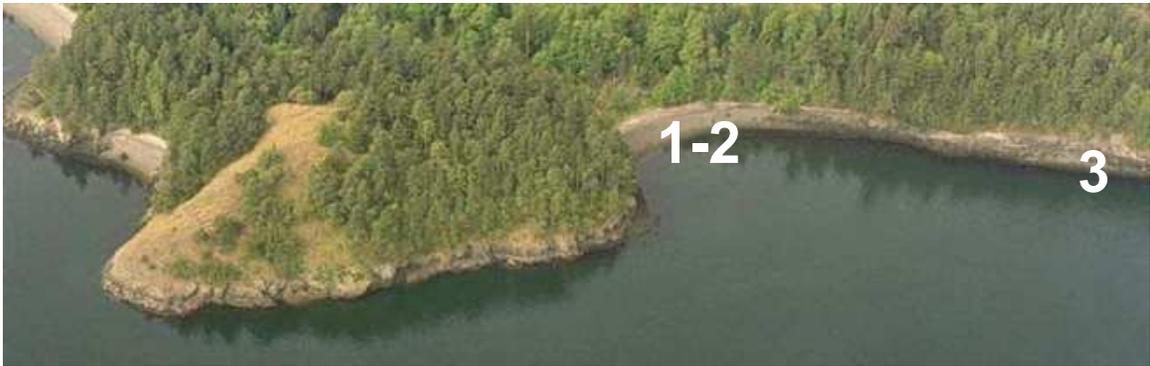
North of Eagle Harbor, Cypress Island  
Shoreline Aerial Photo #SKA0190  
Surveyed by Sean Hewitt, October 2006

1. Creosote log 24" x 18" dia.
2. Creosote log 12" x 12" dia.
3. Creosote timber 60" x 12" x 2"

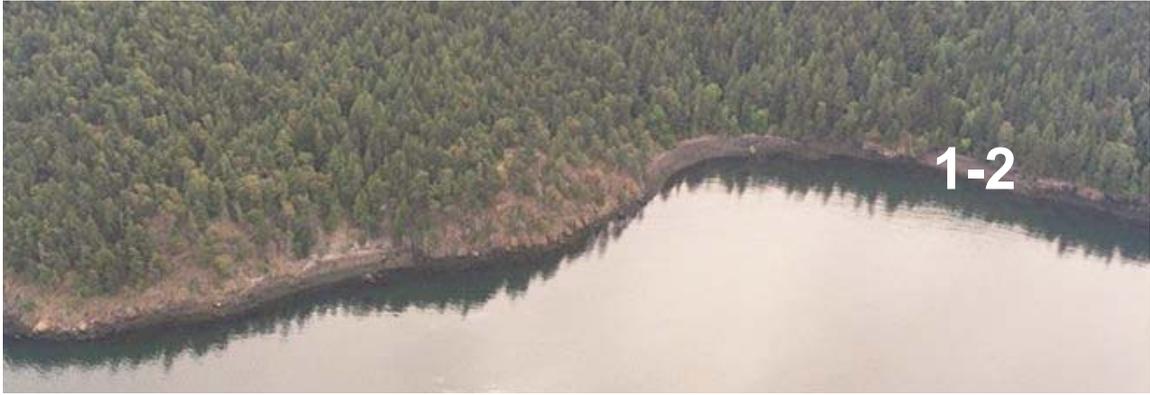
North of Tide Point, Cypress Island  
Shoreline Aerial Photo #SKA0130  
Surveyed by Sean Hewitt, October 2006

1. Creosote timber 24" x 8" x 6"
2. Creosote log 72" x 11" dia.

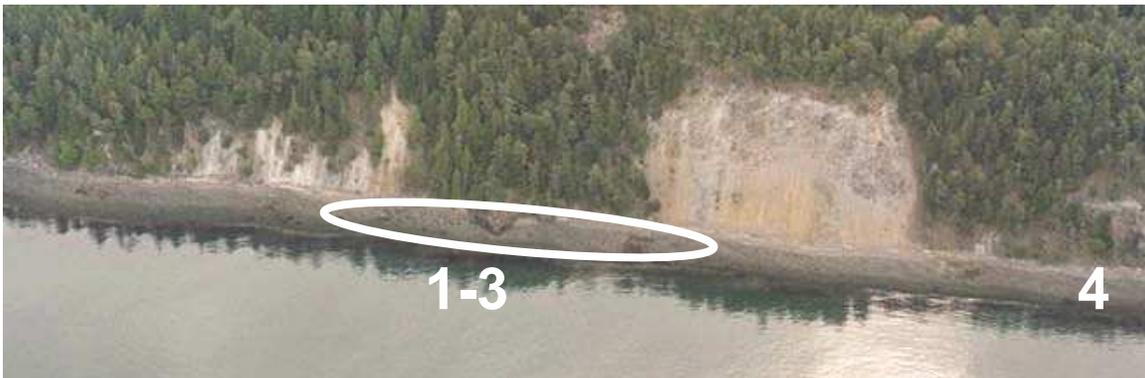
South of Strawberry Bay, Cypress Island  
Shoreline Aerial Photo #SKA0146  
Surveyed by Sean Hewitt, October 2006

1. Creosote timber 40" x 8" x 4"
2. Creosote timber 60" x 16" x 8"
3. Creosote timber 216" x 12" x 12"
4. Creosote timber 24" x 16" x 16"

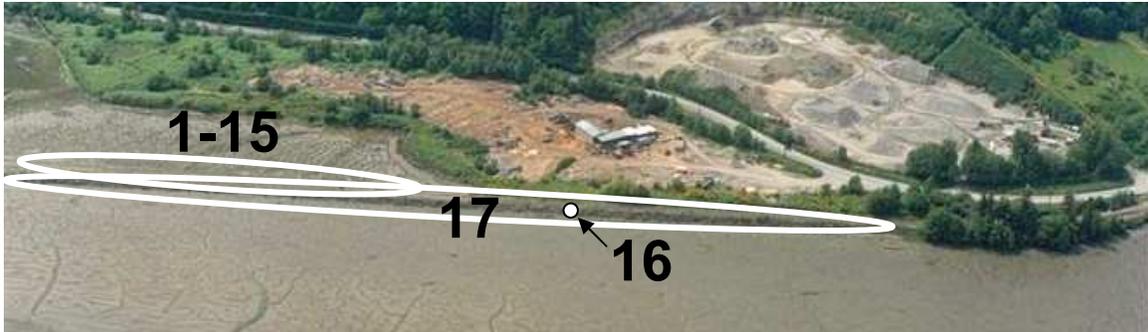
1. Creosote fixed post 48" x 2" dia.
2. Creosote railroad tie piece 36" x 2" x 4"
3. Creosote railroad tie piece 36" x 2" x 6"
4. Creosote fixed post 48" x 12" dia.
5. Creosote railroad tie piece 48" x 8" x 10"
6. Creosote fixed post 48" x 12" dia.
7. Creosote railroad tie piece 36" x 8" x 10"
8. Creosote railroad tie piece 24" x 8" x 10"
9. Creosote railroad tie piece 48" x 8" x 10"
10. Creosote railroad tie piece 36" x 4" x 6"
11. Creosote railroad tie piece 36" x 4" x 6"
12. Creosote fixed post 60" x 12" dia.
13. Creosote fixed post 48" x 12" dia.
14. Creosote log 48" x 12" dia.
15. Creosote fixed post 36" x 12" dia.
16. Creosote log 12" x 12" dia.
17. About 40 pieces of cast off railroad tie pieces along track (average ~ 36" x 4" x 8")

Noted also ~ 25 additional pieces of cast off railroad tie pieces in area 1-15, each averaging ~ 36" x 4" x 6" in size.

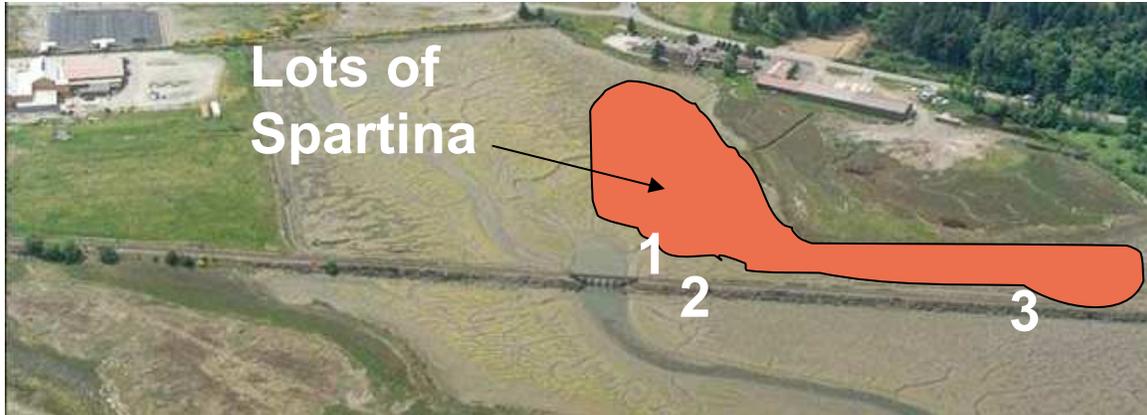
1. Creosote fixed utility pole 360" x 10" dia.
2. Creosote railroad tie piece 96" x 4" x 8"
3. Creosote railroad tie (new) 96" x 8" x 12"

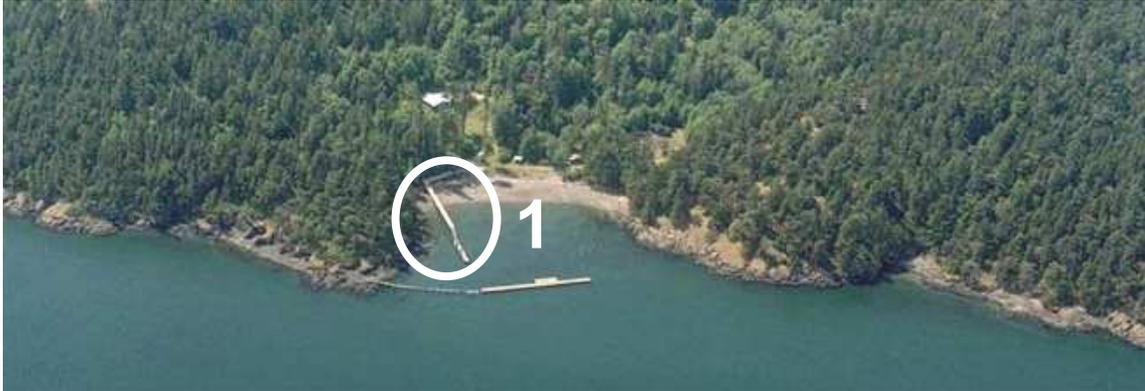
1. 37 Fixed piles in use for dock. Each pile averages about 240" x 12" dia. In addition, about 20 creosote timbers averaging 120" x 12" x 2".

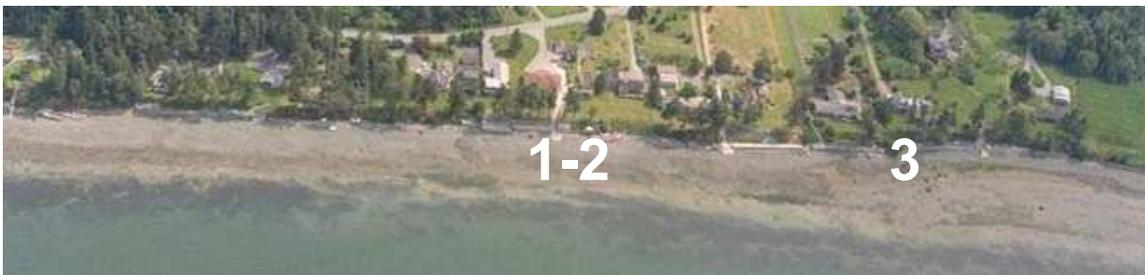
1. Creosote timber bulkhead, ~100 feet long and 4 feet high, 6" x 12" timbers
2. 15 creosoted fixed pilings, in use, each 72" x 12" dia.
3. Creosote log 120" x 12" dia.

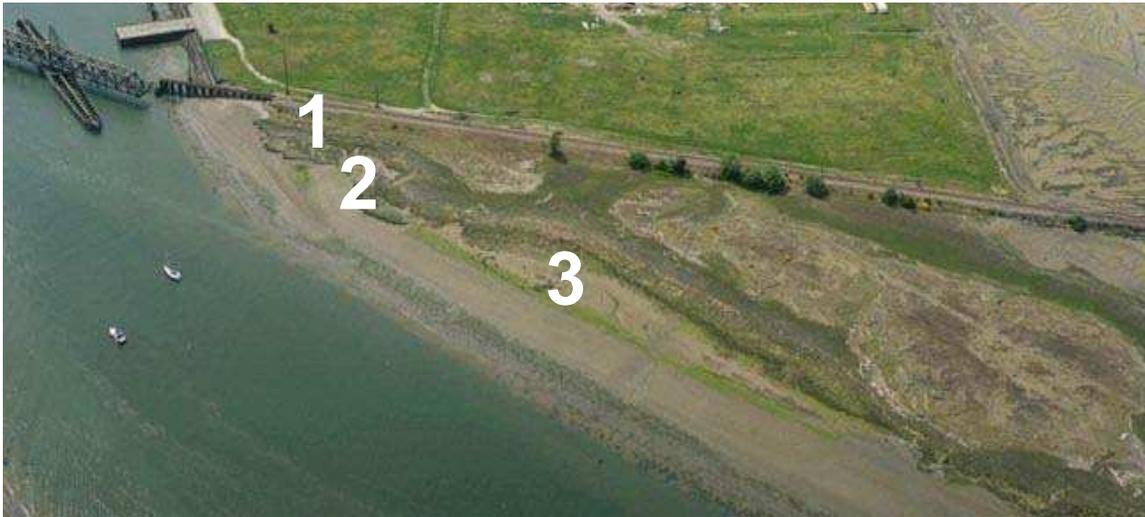
1. Massive 120" x 18" x 48" creosote railroad timber alongside tracks. This was not removed in 2004. This is not a new item.
2. Creosote log, 24" x 6" dia.
3. Treated timber, 6" x 8" x 4"

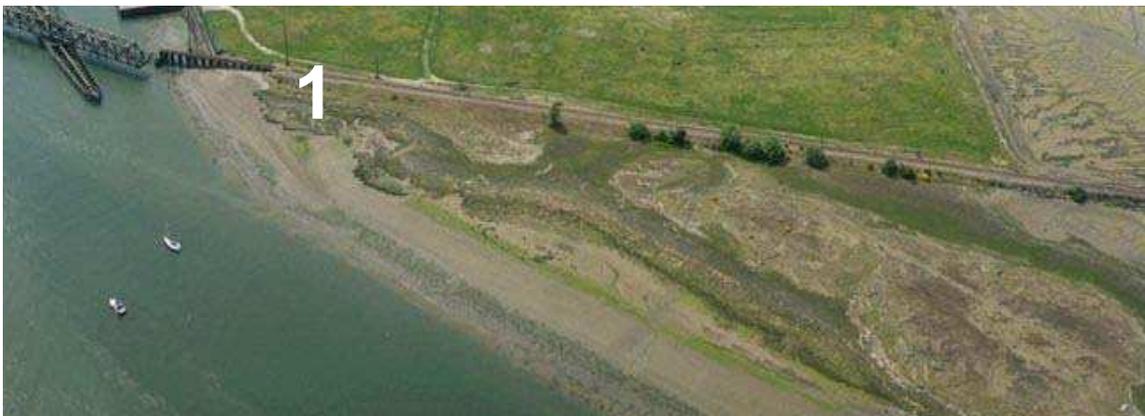
1. Massive 120" x 18" x 48" creosote railroad timber alongside tracks. This was not removed in 2004, but was removed in 2006. This is not a new item.

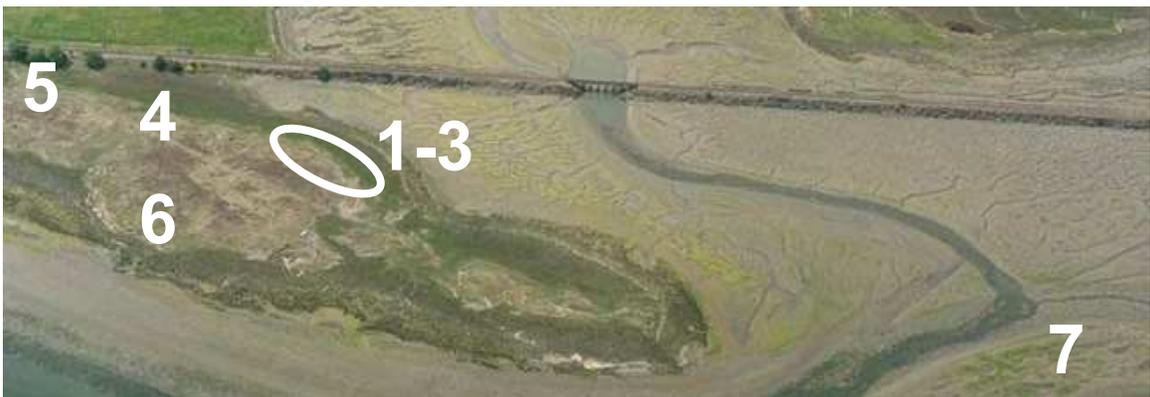
1. Creosote log, 70" x 12" dia.
2. Creosote log, 48" x 12" dia.
3. Creosote log, 96" x 12" dia.
4. Creosote log, 144" x 12" dia.
5. Creosote log, 24" x 14" dia.
6. Creosote log, 24" x 12" dia.
7. Creosote log, 480" x 12" dia.

**Only item #5 was not a new item – it was present in 2004 and not removed in 2004. Items 6 and 7 were removed in 2006, but the others were left in place due to being inaccessible by tug & barge at the time. In summary, 6 new treated wood items were found in this location in 2006, compared to 72 pieces observed in 2004.**

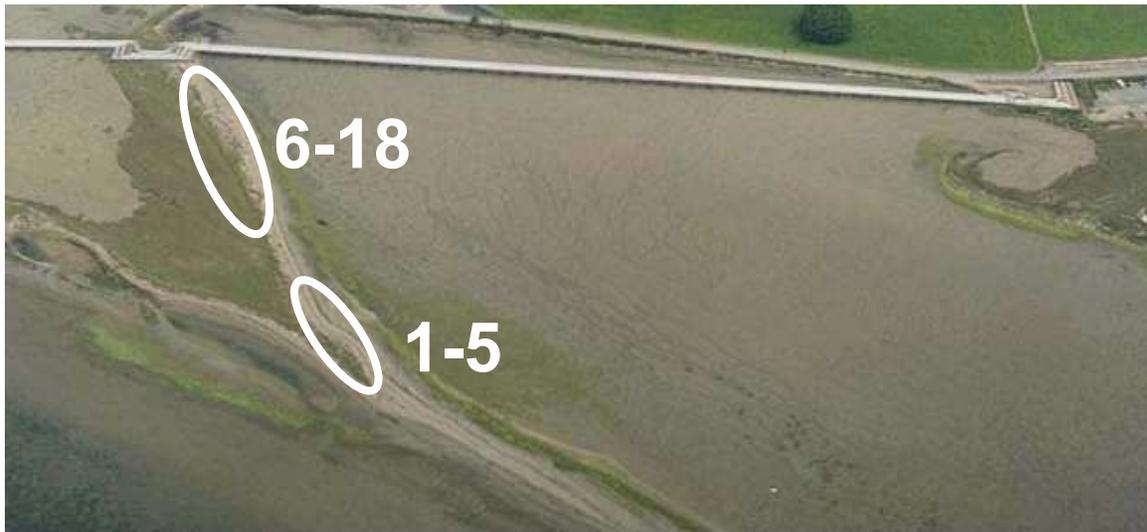
1. Treated timber, 12" x 4" x 4"
2. Treated timber, 192" x 16" x 18"
3. Treated timber 84" x 16" x 8"
4. Treated timber, 12" x 12" x 10"
5. Treated timber, 6" x 8" x 4"
6. Treated timber, 108" x 10" x 6"
7. Treated timber, 48" x 4" x 2"
8. Treated timber, 12" x 10" x 6"
9. Treated timber, 192" x 12" x 4"
10. Creosote log piece, 4" x 10" dia.
11. Float with creosote timbers, two 216" x 8" x 8" timbers and seven 216" x 10" x 2" timbers
12. Creosote log, 60" x 14" dia.
13. Treated timber, 48" x 12" x 4"
14. Creosote log, 120" x 14" dia.
15. Treated timber, 12" x 10" x 12"
16. Creosote log, 60" x 20" dia.
17. Treated timber, 36" x 4" x 2"
18. Treated timber, 12" x 4" x 2"

**Twenty-five new pieces of treated wood were found on Crandall Spit in January 2007. All were removed in January 2007. This compares with just 8 pieces reported in 2004; however, this may have been an underestimate, as more pieces than that were later removed in 2004 (exact number removed not recorded).**

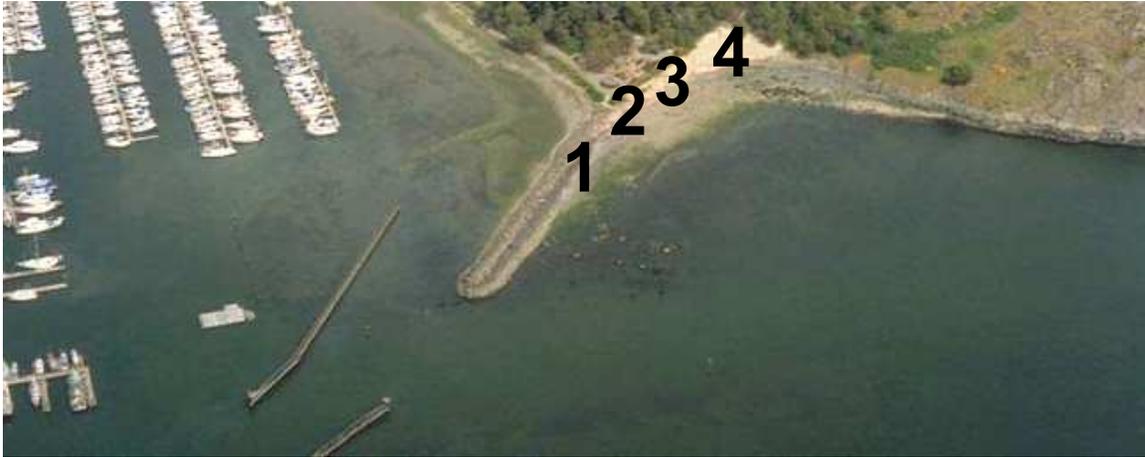
1. Treated timber, 96" x 8" x 4"
2. Treated timber, 36" x 6" x 2"
3. Treated timber, 18" x 12" x 4"
4. Creosote log, 24" x 12" dia.

**Only 2 new pieces of treated wood were found on the Cap Sante pocket beach during the first resurvey in November 2005 and 4 pieces were found on the second resurvey in May 2007. This compares with 15 pieces reported in 2004, all of which were removed in 2004.**
