North Fidalgo Island Geomorphic Assessment & Drift Cell Restoration Prioritization

Prepared for:
Skagit County Marine Resources Committee

Prepared by:
Coastal Geologic Services, Inc.
Andrea MacLennan, MS and
Jim Johannessen, LEG, MS

April 24, 2008

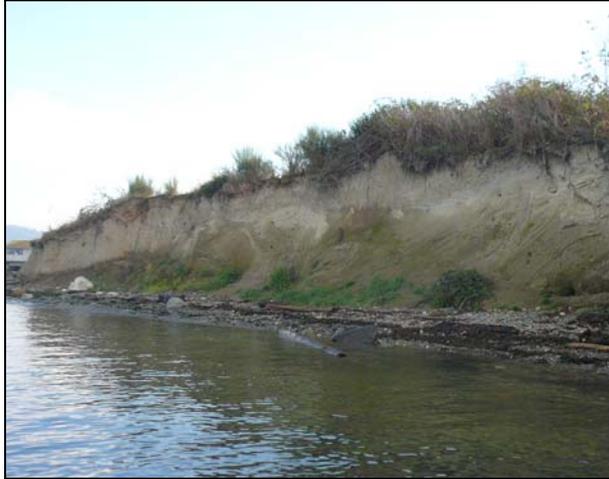
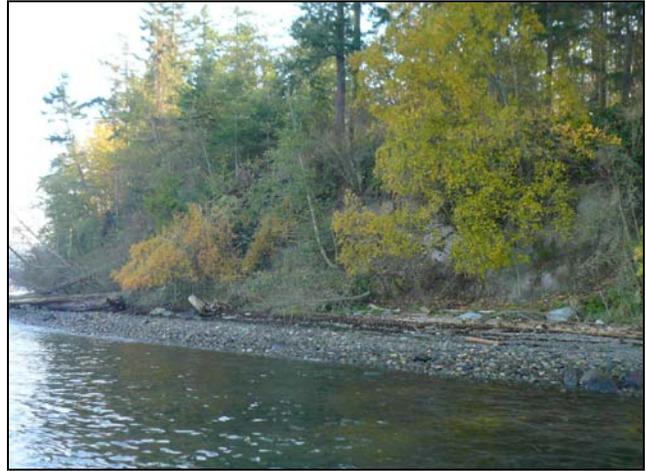
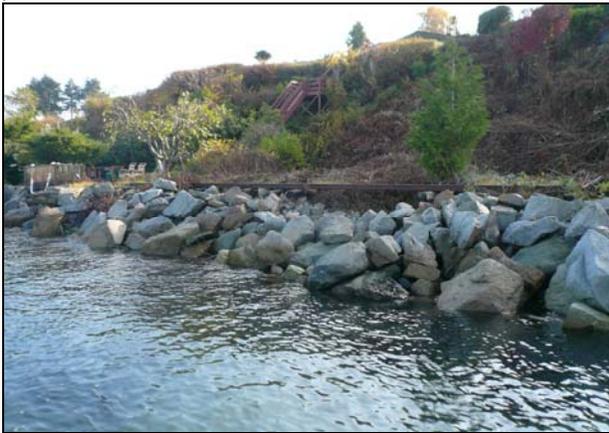
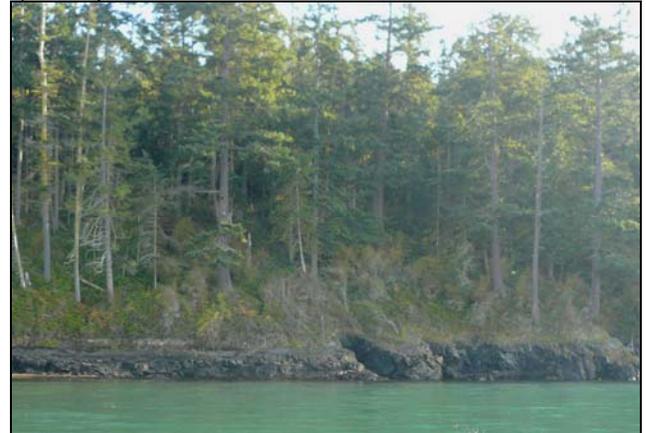
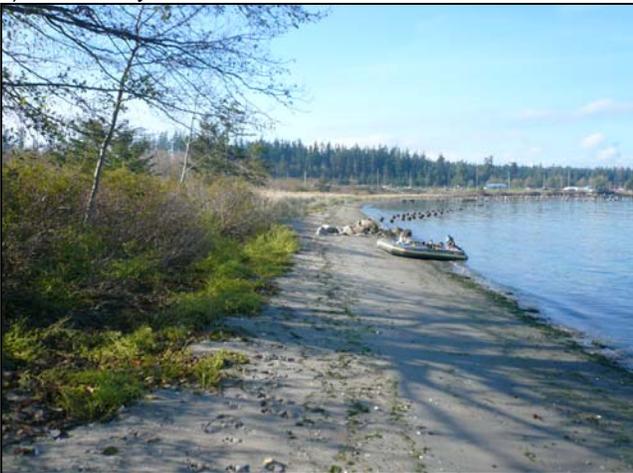
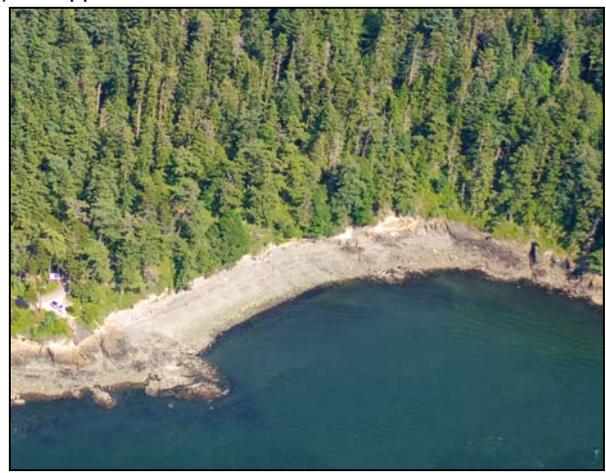
a) Feeder bluff

b) Transport zone

c) Modified by historic rail revetment

d) No Appreciable Drift

e) Accretion shoreform

f) Pocket beach

Figure 2. Photos of representative geomorphic shoretypes for the North Fidalgo study area. Photos a-e are CGS field photos, photo f Department of Ecology 2006 shoreline oblique.

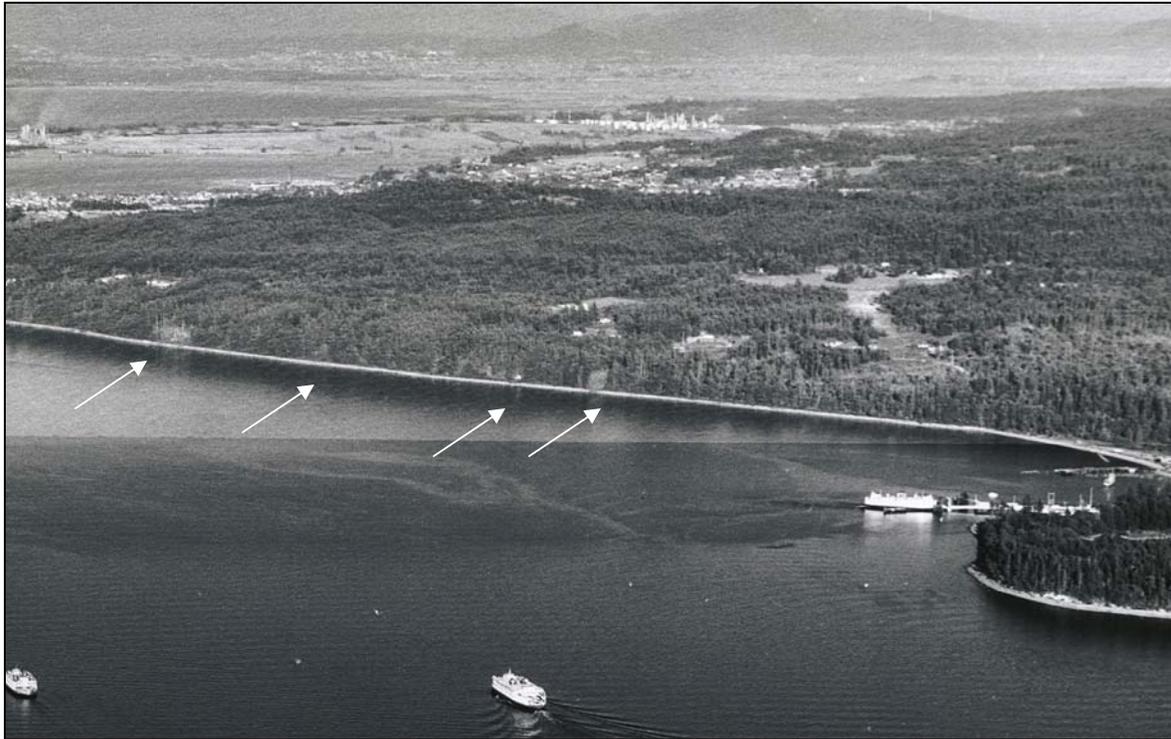
Figure 7. Historic feeder bluffs in cell SK-D-1-5 during 1960s. Feeder bluffs were modified at the time of the photo, however landslides appear to be visible (see arrows). Image courtesy of the Anacortes History Museum. Photo No. 5636.

The large accretion shoreform at Ship Harbor also receives sediment supplied from bluffs to the east. Drift cell SK-D-1-5 was recently mapped by CGS as a historic drift cell that existed prior to the installation of the Great Northern rail causeway, which impounded sediment throughout the cell. All of the historic sediment sources found within this cell are not currently functioning, thus currently drift is mapped as “no appreciable drift”. It should also be noted that the historic sediment sources found within this drift cell were some of the highest-ranking historic or current sediment sources in the entire North Fidalgo Island study area.

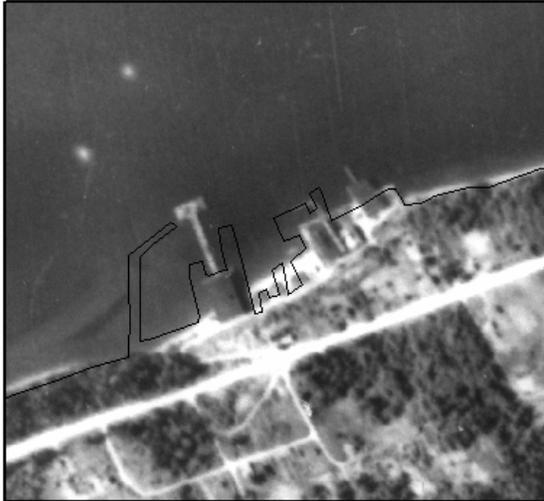
Figure 8. Lovric's boat yard in 1943. Shorezone shoreline displayed in black for reference to current configuration of shoreline (WDNR 2001).

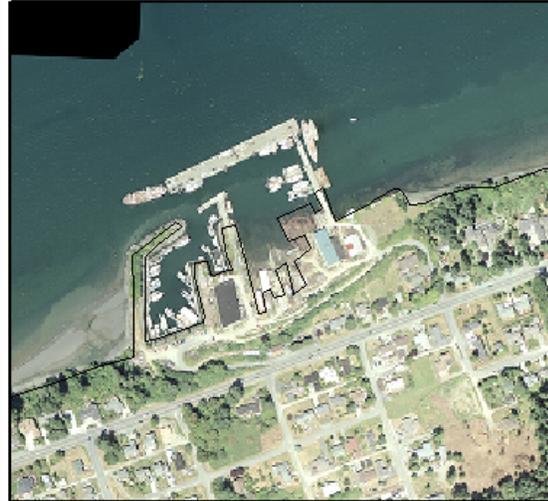
Figure 9. Lovric's boat yard in 2006. Note sediment accumulation west of westerly jetty/breakwater.

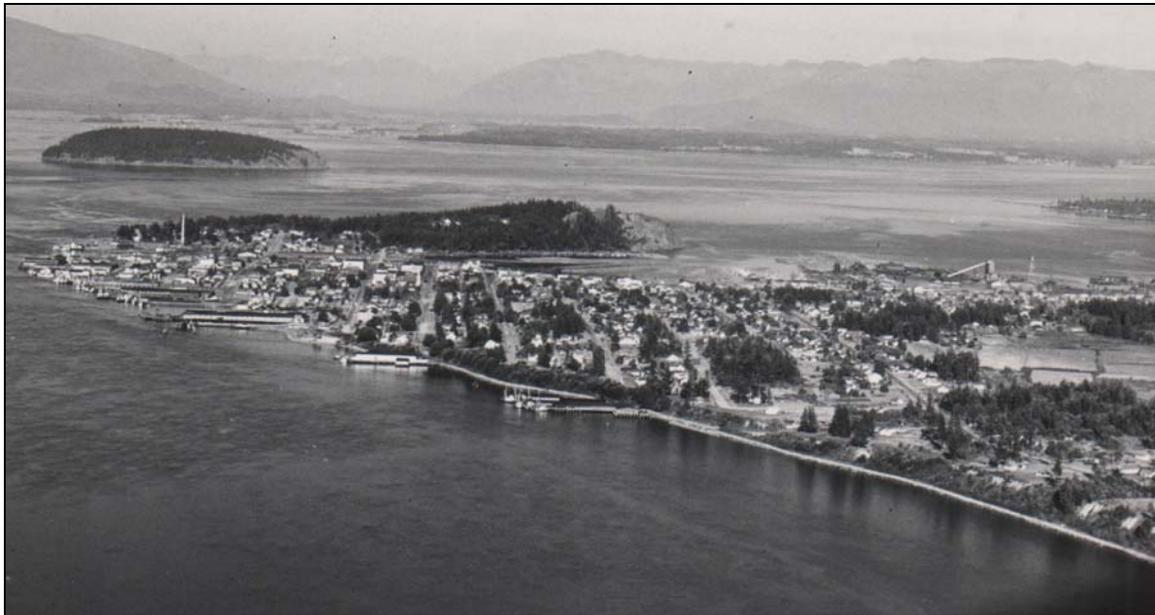
Figure 10. Historic City of Anacortes shore encompassing drift cells western portion of cells SK-D-1-5, SK-D-1-4. Exact year of photograph unknown (approximately ~1950). Anacortes History Museum. Photo D.X. 079.001.

The adjacent drift cell to the east, cell SK-D-1-4, has also incurred a substantial decrease (97%) in sediment sources (feeder bluffs and feeder bluff exceptional units) as a result of prolific shore modifications along North Fidalgo Island. These sediment inputs were predominantly located near the origin of the drift cell in central north Fidalgo Island, west of the Guemes Island Ferry landing. Unfortunately a major net shore-drift impediment also exists at Lovric's boat yard (Figures 8 and 9). The highest scoring historic sediment sources in the cell were located west of this heavily modified shore. The boat yard is comprised of several old boat hulls that have been filled, and currently function as a jetty and breakwater. Extensive intertidal fill has also occurred surrounding a building that was historically an overwater structure, which is evident in photos and the contrasting position of the current and historic shorelines. The sediment accumulation west of the breakwater confirms that littoral drift is impaired as a result of the structure. Further down-drift, to the east, there are additional sediment sources that are worthy of restoration, which are displayed in Figure 6. Sediment derived from these sediment sources supplied the broad beaches that were once prolific along northeastern Fidalgo Island and the historic embayed salt marsh west of Cap Sante Park (Figure 10).

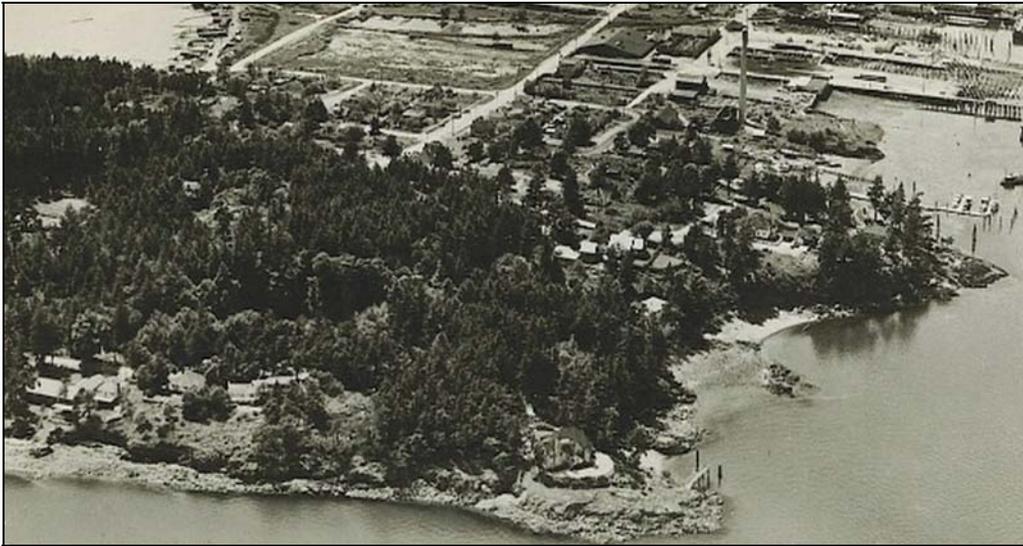
Figure 11. Historic view of Cap Sante shore. Year of photograph unknown. Photo courtesy of Anacortes History Museum. Photo No WF 0288.

SK-D-1-3/SK-D-1-4 is not technically a drift cell, as it is entirely comprised of bedrock shores, with the exception of two very small pocket beaches (representing just 2% of the cell). The bedrock is mapped as metagraywacke (marine metasedimentary rocks) of the Lummi Formation (WDNR – Division of Geology and Earth Sciences 2001). No sediment sources were mapped within this portion of the study area (Figure 11).

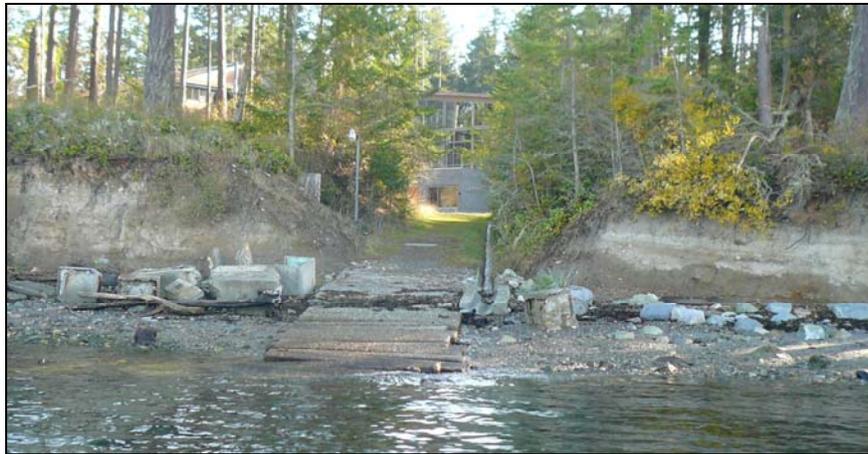
Figure 13. Shore modification unit ID 5, SK-D-2, protecting Shannon Point boat launch.

The two of the three top ranking restorable sediment sources in drift cell SK-D-2 appear feasible and would not likely preclude existing land uses. The top ranking opportunity in the drift cell had the most evidence of active bluff erosion, but measures only 31.5 ft in length. The bulkhead was comprised of concrete and rock and appeared to be constructed to protect the boat ramp at Shannon Point (Figure 13). This armoring likely provides little function as erosion control, as the adjacent bluffs appeared to be actively eroding at the time of the field visit.

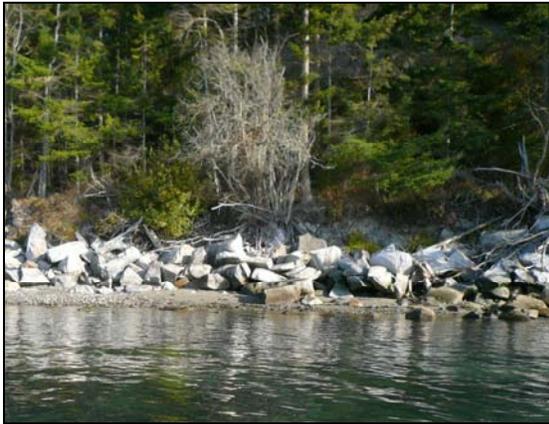
Figure 14. Armored (historic) feeder bluff along Shannon Point shore.

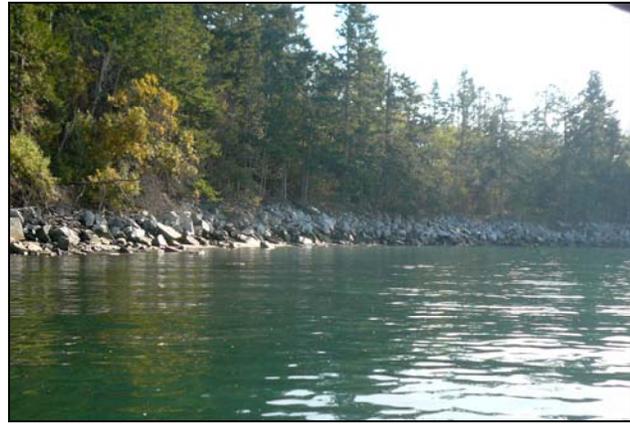
Figure 15. Armored (historic) feeder bluff along Shannon Point shore.

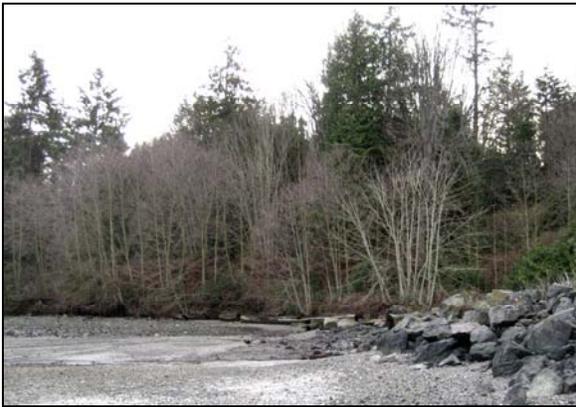
Figure 16. Modified historic feeder bluff along Tommy Thompson trail.

Restoration options within drift cell SK-D-1-1 are also limited by current land uses, or more specifically, the Tommy Thompson Trail. As mentioned earlier, the bluffs that historically supplied sediment to Weaverling Spit are impounded behind the original Great Northern railway revetment that currently functions as the Tommy Thompson trail. It is unlikely that the residents of Anacortes will be amenable to giving up the trail system to restore the cross shore connectivity, which will likely exacerbate the already eroding base of the spit. Erosion of the spit and larger accretion shoreform will progressively worsen under sea level rise conditions without a sediment source to replenish the beach. Continual beach nourishment may be required along the toe of the armoring to maintain beach habitats and the down-drift accretion shoreform. Both surf smelt and sand lance spawning have been documented along this reach of shore such that mitigating for the lost sediment supply should be regarded as a relatively high priority (WDFW 2000).

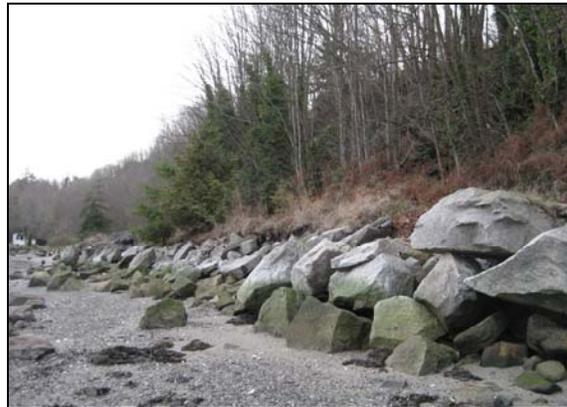
Figure 17. Modified historic feeder bluff along Tommy Thompson trail.

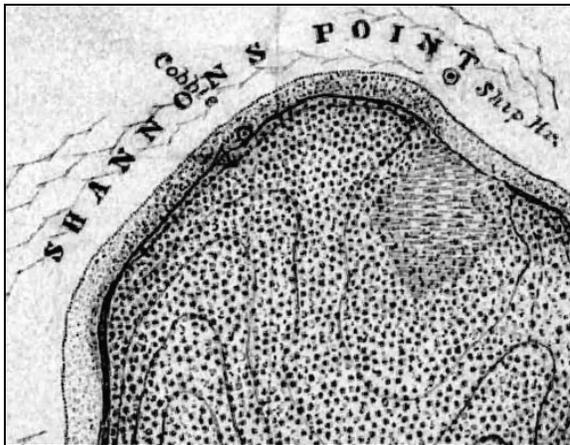
Figure 18. Historic T-sheet no 1667 showing configuration of wetland and possible tide channel along eastern shore (US Coast and Geodetic Survey 1885).

Cannery Lake, located just west of the Washington State Ferry terminal along the eastern shore of the Shannon Point property, is an intriguing coastal wetland, the historic configuration of which is largely unknown. Research into whether or not this coastal wetland was historically connected to the marine environment was inconclusive. However, the historic T-sheet appears to show a tide channel connecting the embayment to marine waters (on the eastern shore of the embayment, Figure 18) and the bank impounding the wetland appears to be constructed of fill as part of the historic railroad dike/revetment that runs along the North Fidalgo Island shore (Figure 19). Similarly configured coastal wetlands are frequently observed throughout the region however, it is very rare for a naturally occurring bank of moderate height to be observed waterward of a wetland, and the genesis of such a coastal feature is highly questionable. For these reasons and using the best professional judgment acquired from (cumulative) decades of local coastal expertise, it is the preliminary opinion of CGS staff that this “Lake” was originally an estuarine embayment. The restoration of the tide channel seems entirely feasible, though additional research should be undertaken to document and assess its historic condition, the appropriate tide channel configuration, and to determine the approximate tidal elevation to which it should be restored. It is likely that since its impoundment, the sedimentation rate within the wetland has increased due to the absence of tidal flushing.

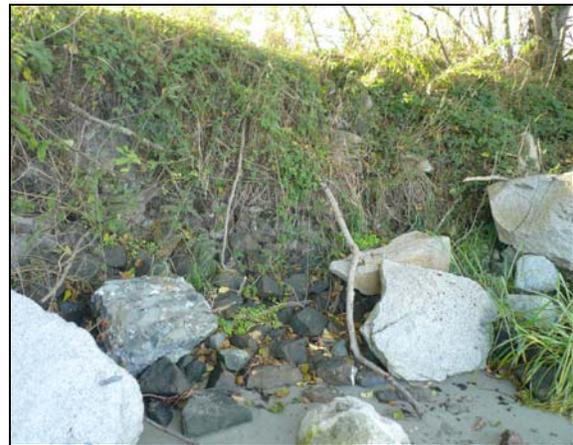
Figure 19. Armoring at base of dike/fill that impounds Cannery Lake wetland.

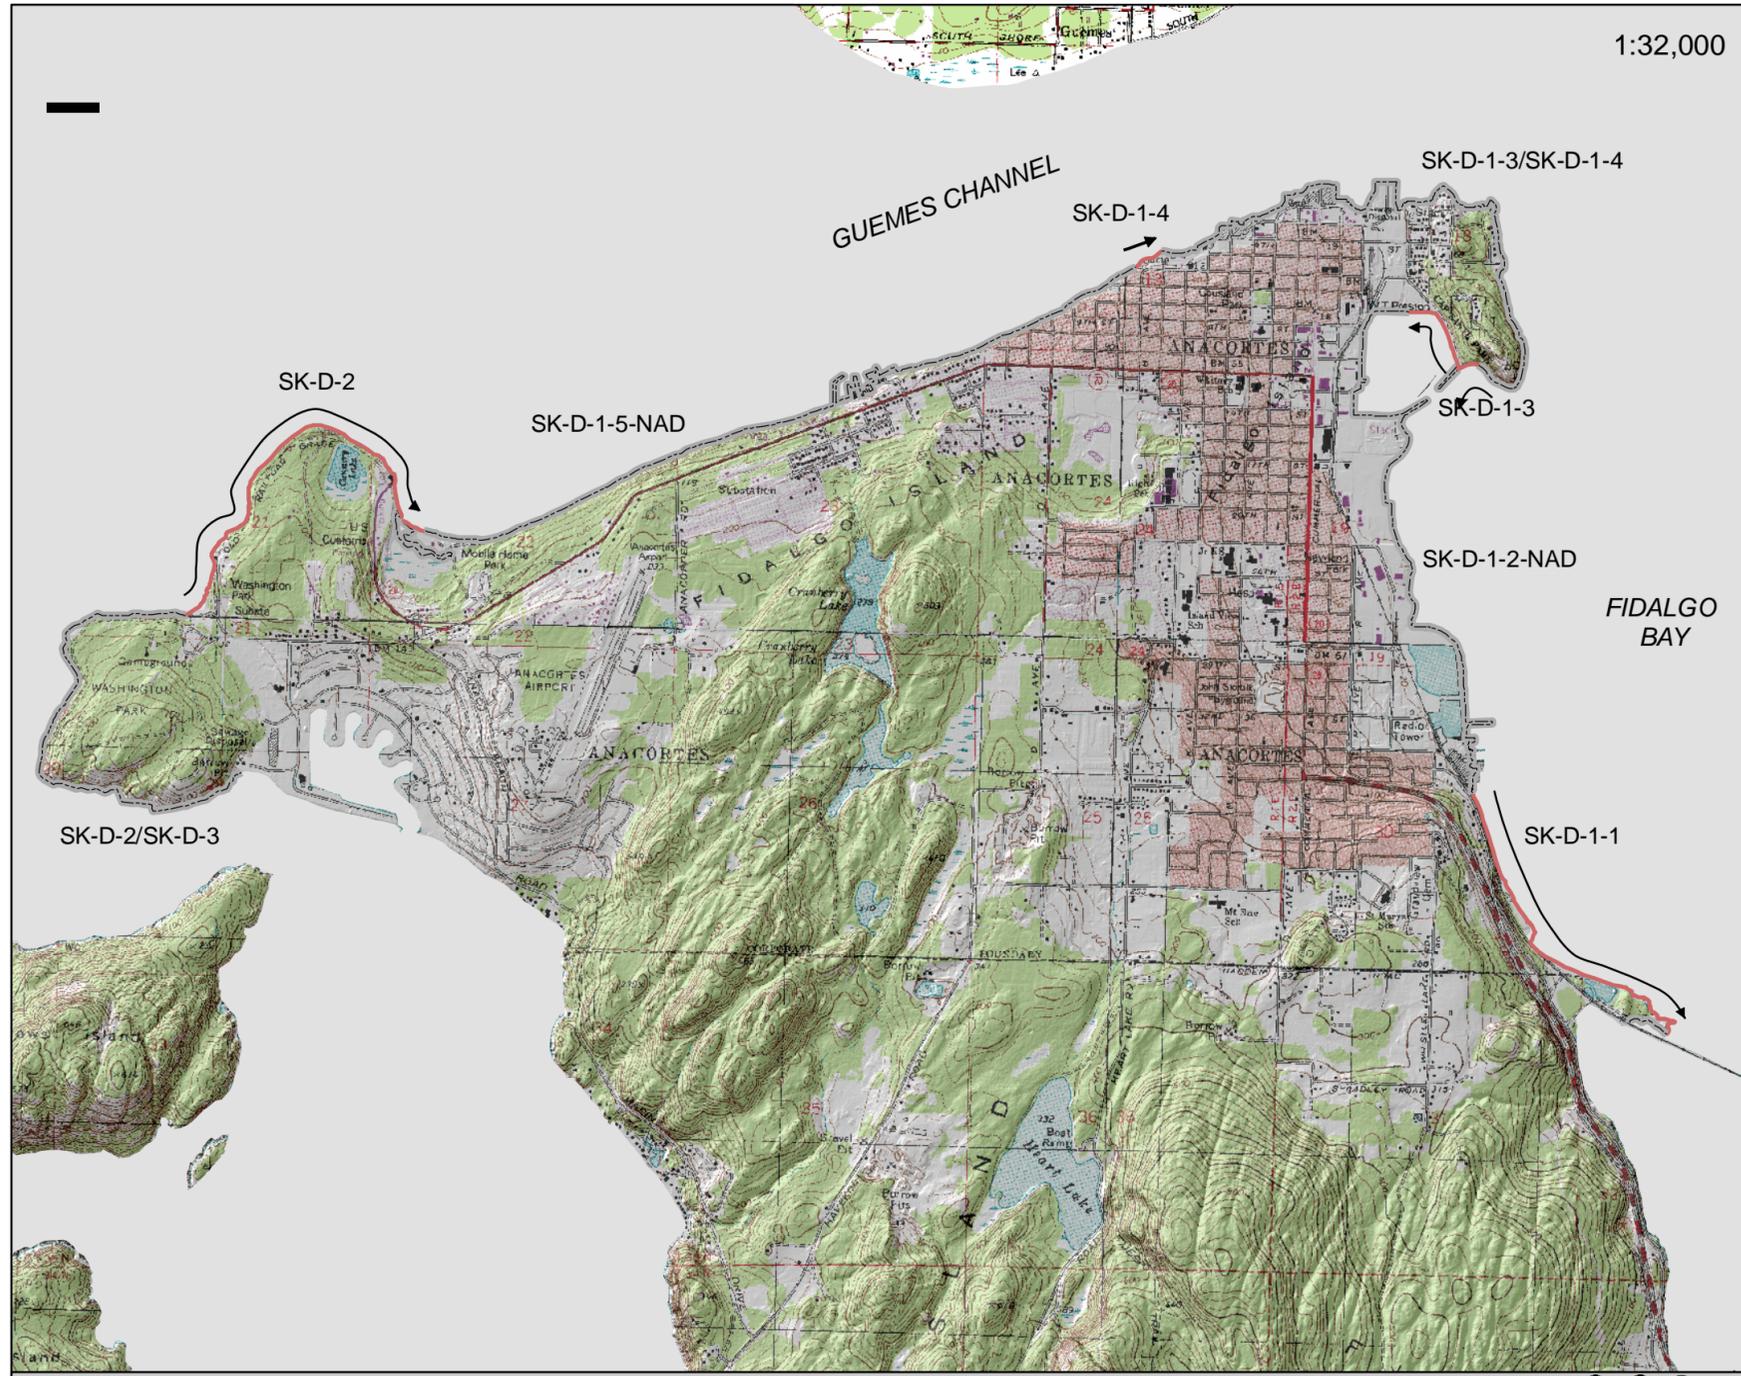
Figure 1a. Current net-shore drift mapping along the North Fidalgo Island shores.
 North Fidalgo Island Geomorphic Assessment and Drift Cell Restoration Prioritization
 USGS 1:24,000 topographic map with 2006 LiDAR hillshade shown

The revised current conditions net shore-drift mapping for the North Fidalgo shore was conducted using the same methods as mentioned above. A general description of each of the current drift cells that comprise the study area is displayed in Table 6. Table 7 displays and describes the contrasts between current and historic net shore-drift within the study area.

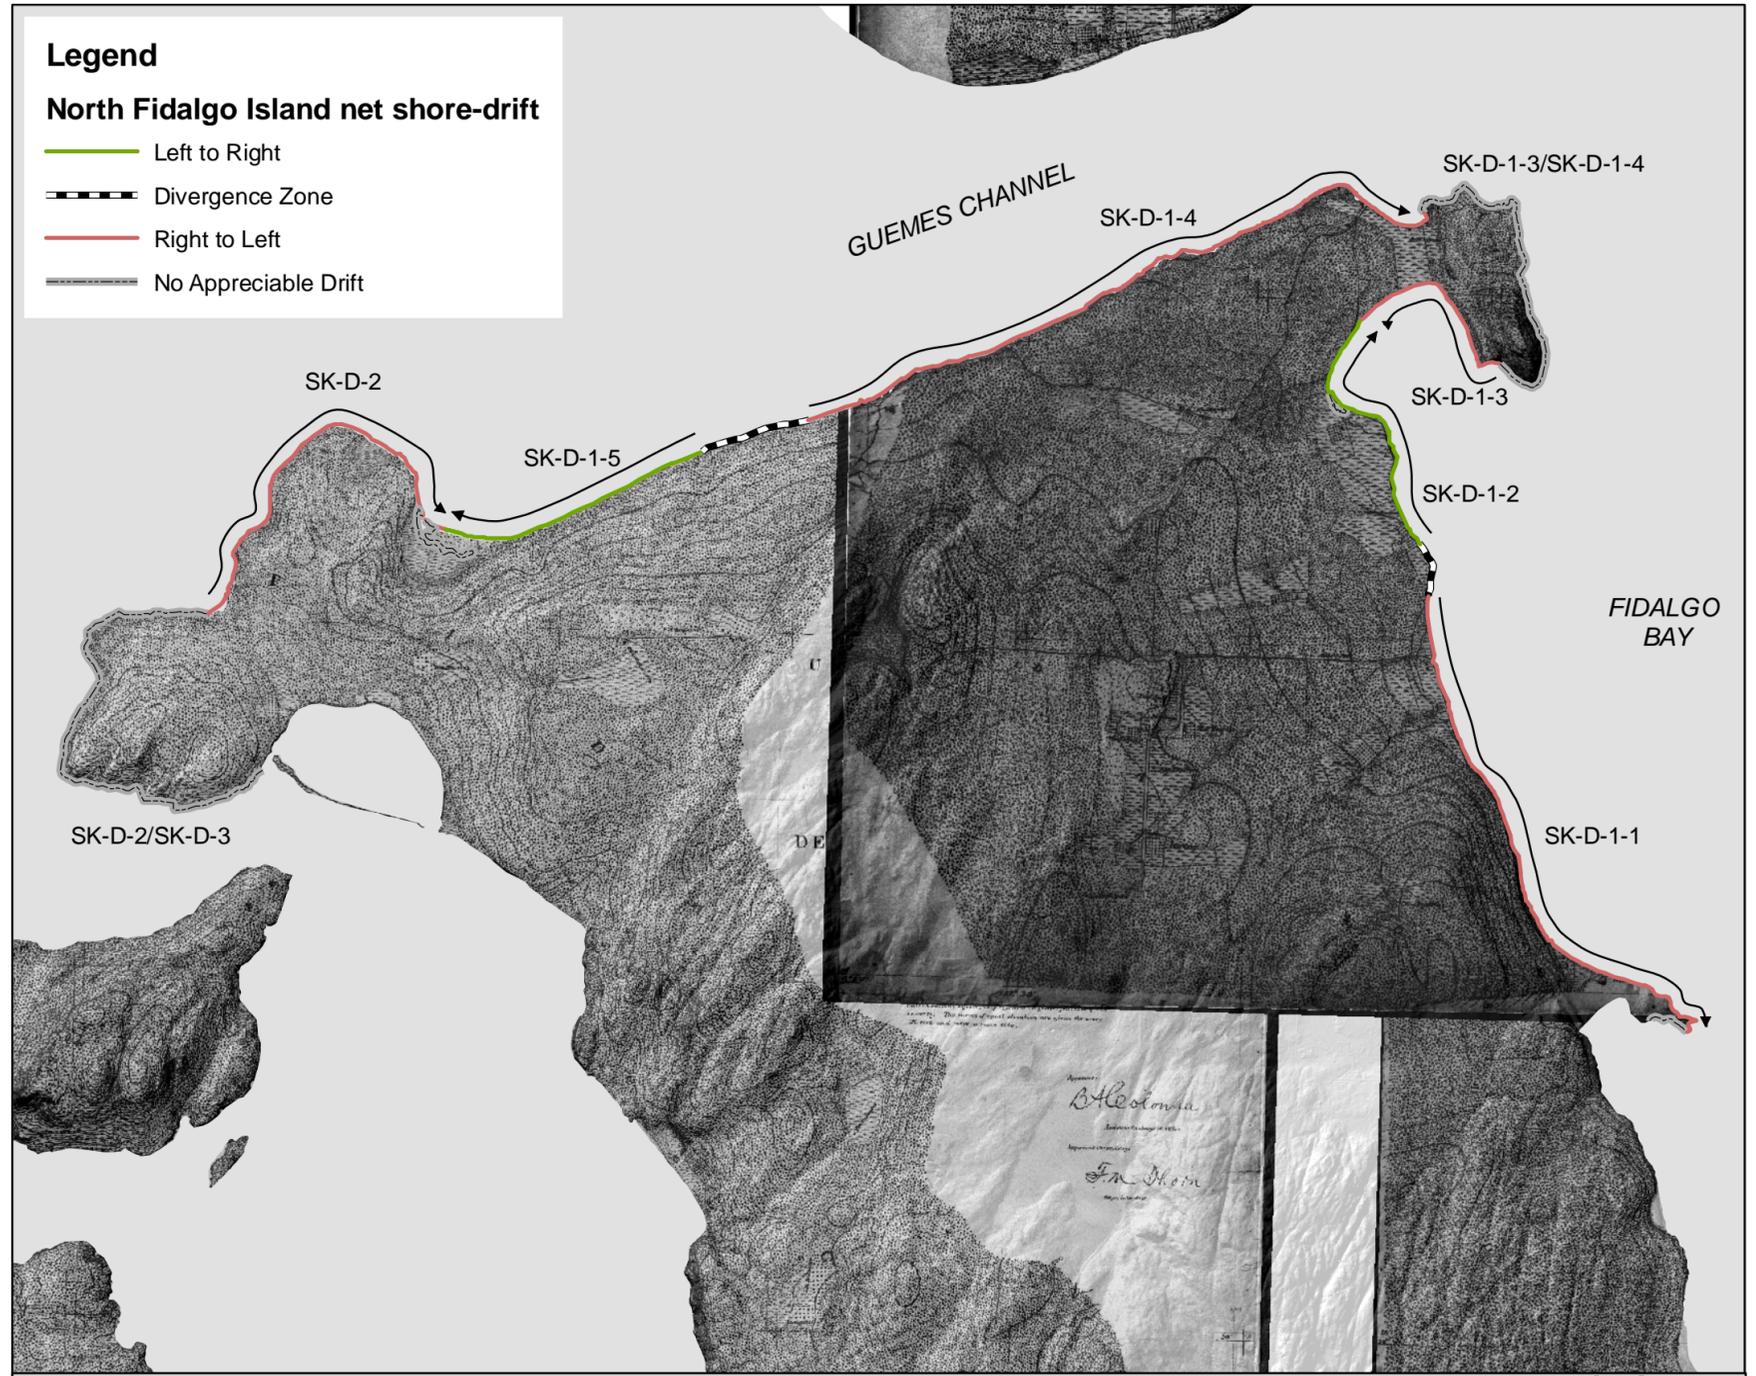
Figure 1b. Historic net-shore drift mapping along the North Fidalgo Island shores.
 North Fidalgo Island Geomorphic Assessment and Drift Cell Restoration Prioritization
 US C&GS T-Sheets with 2006 LiDAR hillshade shown

Based on field assessment methods (Jacobson and Schwartz 1981), previous mapping efforts and air photo interpretation, net shore-drift within the study area was revised by CGS in both its current and historic condition. Historic conditions net shore-drift mapping was originally conducted throughout the Puget Sound region by CGS, as part of a larger team of restoration scientists working for the Puget Sound Nearshore Partnership contracted through the US Army Corps of Engineers. Minor revisions were applied to produce the mapping displayed in Figure 1. Historic conditions mapping was snapped to the historic T-sheet shoreline (interpreted by Collins and Sheikh 2005) where the current shore deviated considerably from its historic position.

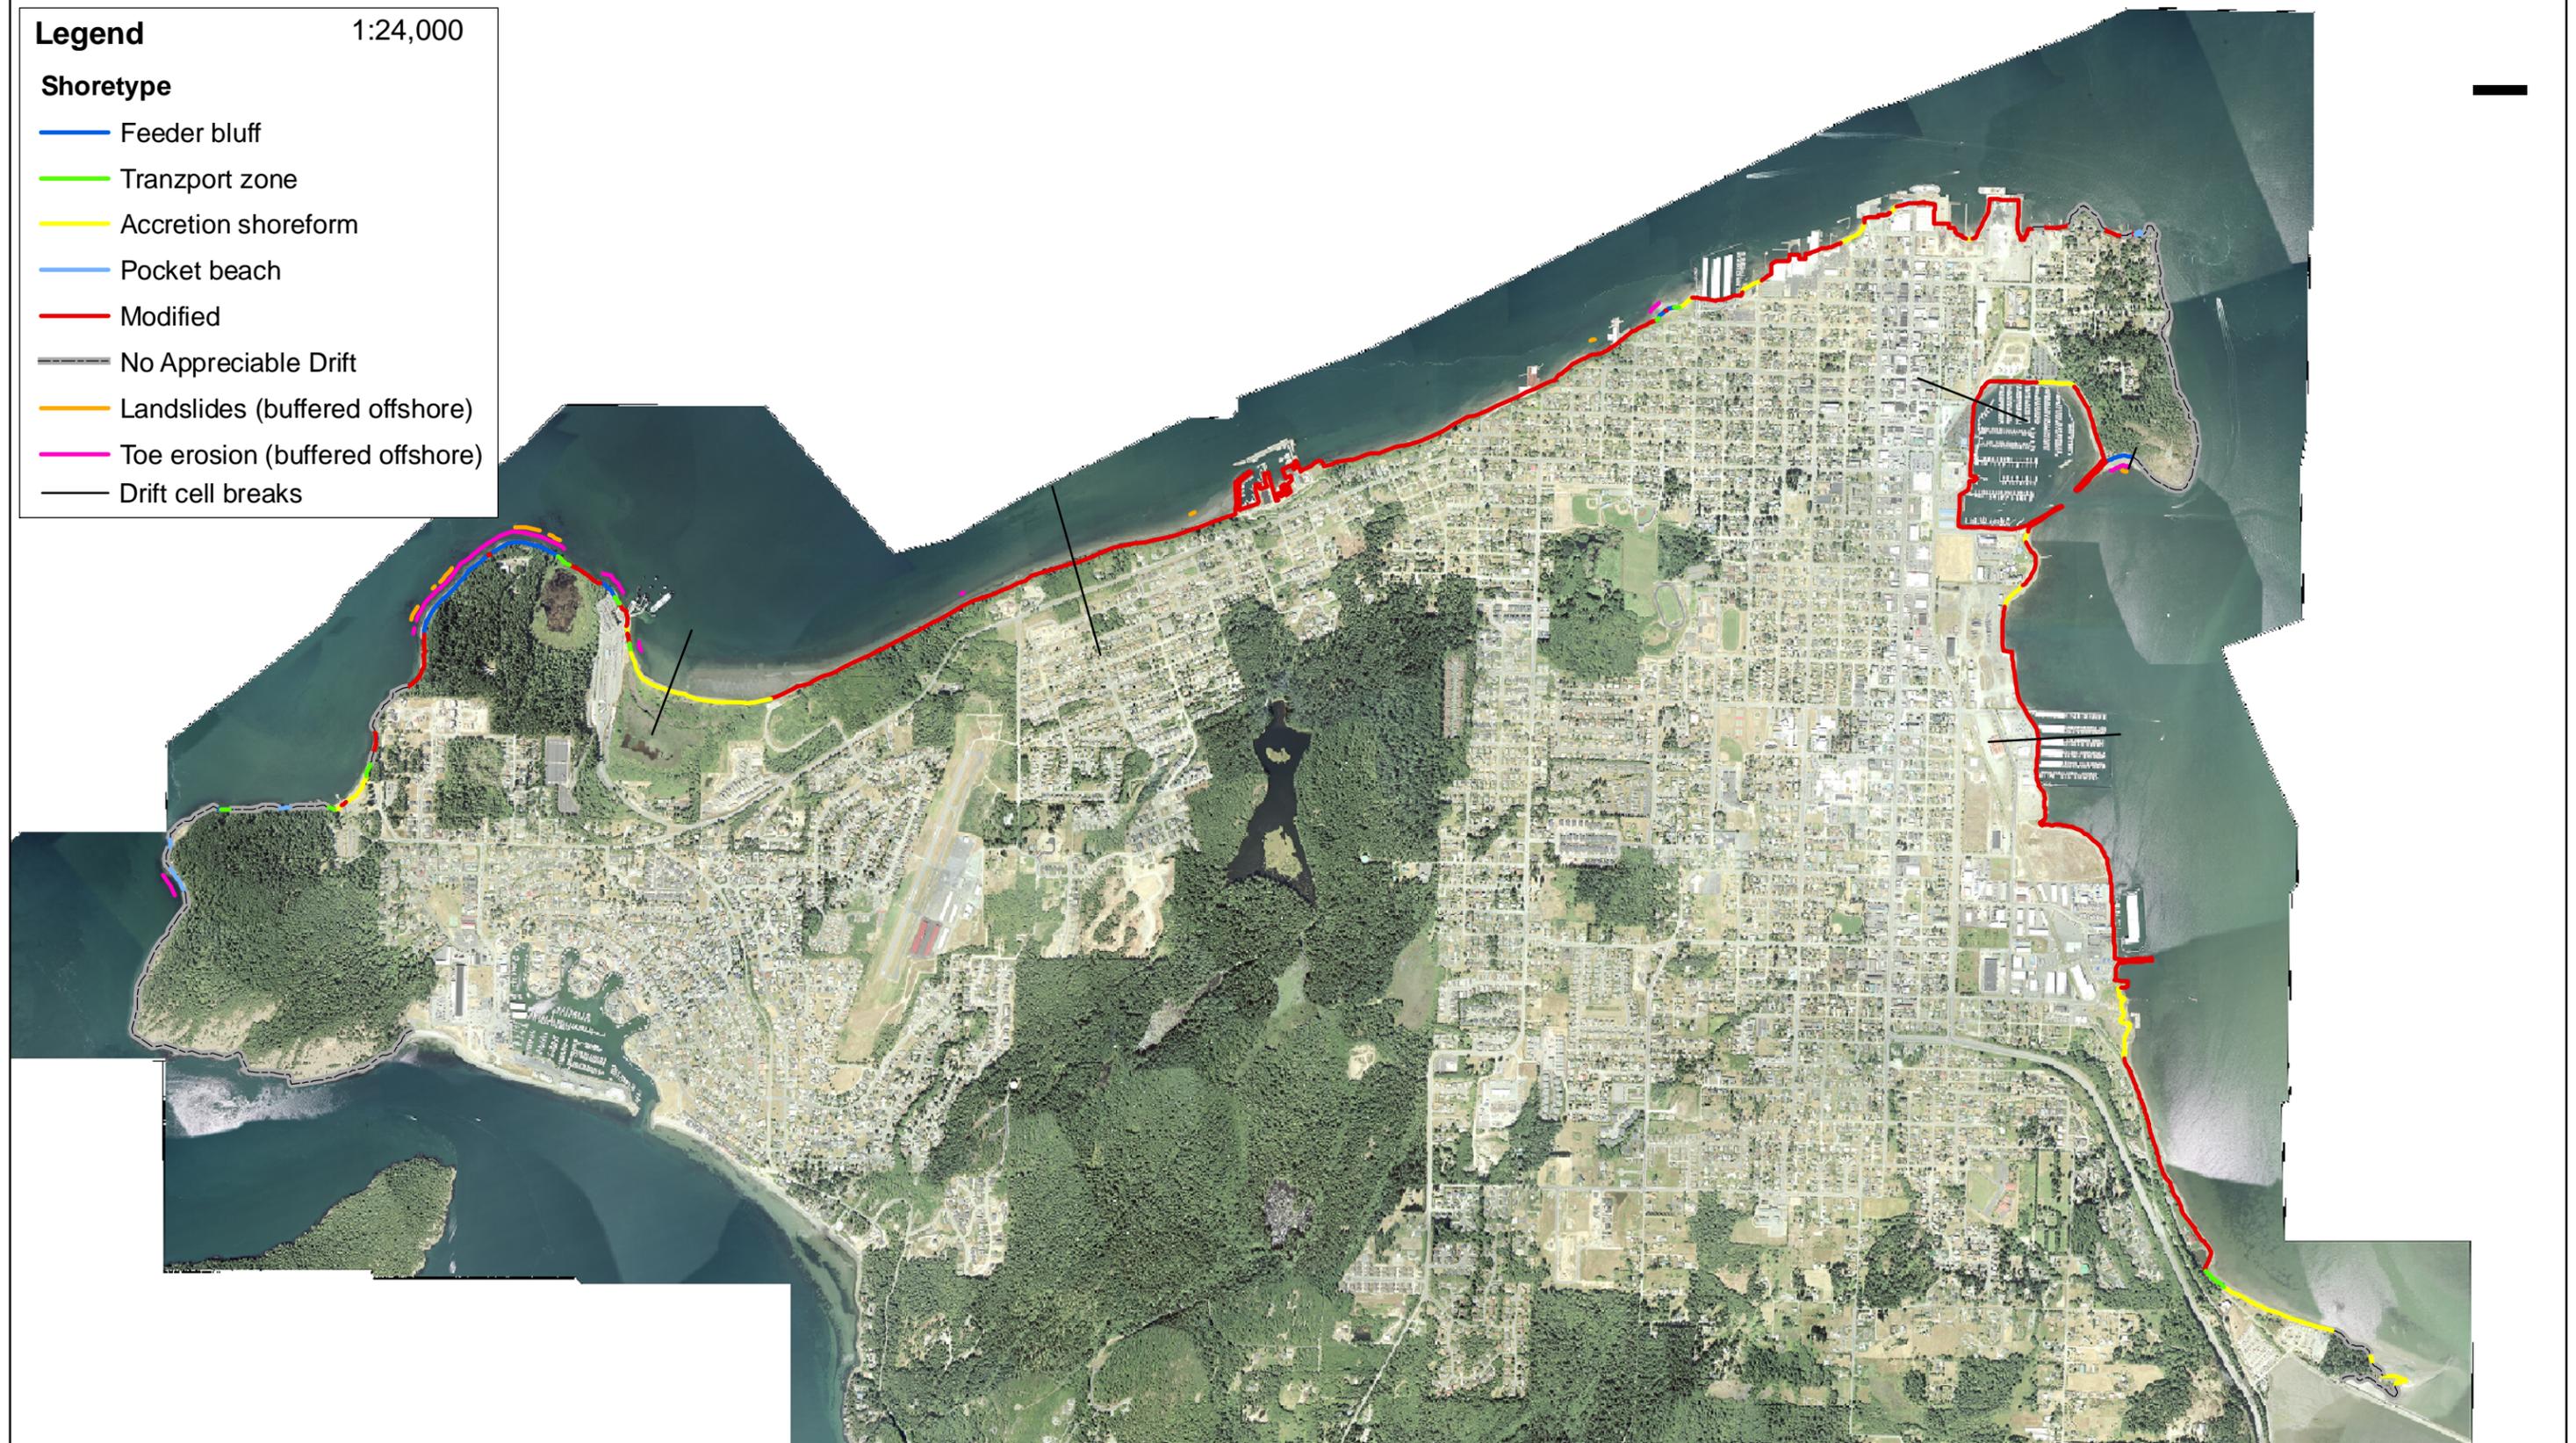
Figure 3. Current geomorphic conditions of the North Fidalgo Island shores.
North Fidalgo Island Geomorphic Assessment and Drift Cell Restoration Prioritization

The distribution of the shoretypes that make up each drift cell varied considerably across the study area. Sediment sources or feeder bluffs cumulatively made up only 5% of the study area in its current condition and were most abundant along the northwest shores of the study area near Shannon Point. Accretion shoreforms were scattered throughout the study area, cumulatively representing 13% of the area. Landslides and toe erosion were uncommon and were observed most frequently within the feeder bluffs surrounding Shannon Point. Detailed results of current conditions geomorphic mapping can be found in Table 8 and Figure 3.

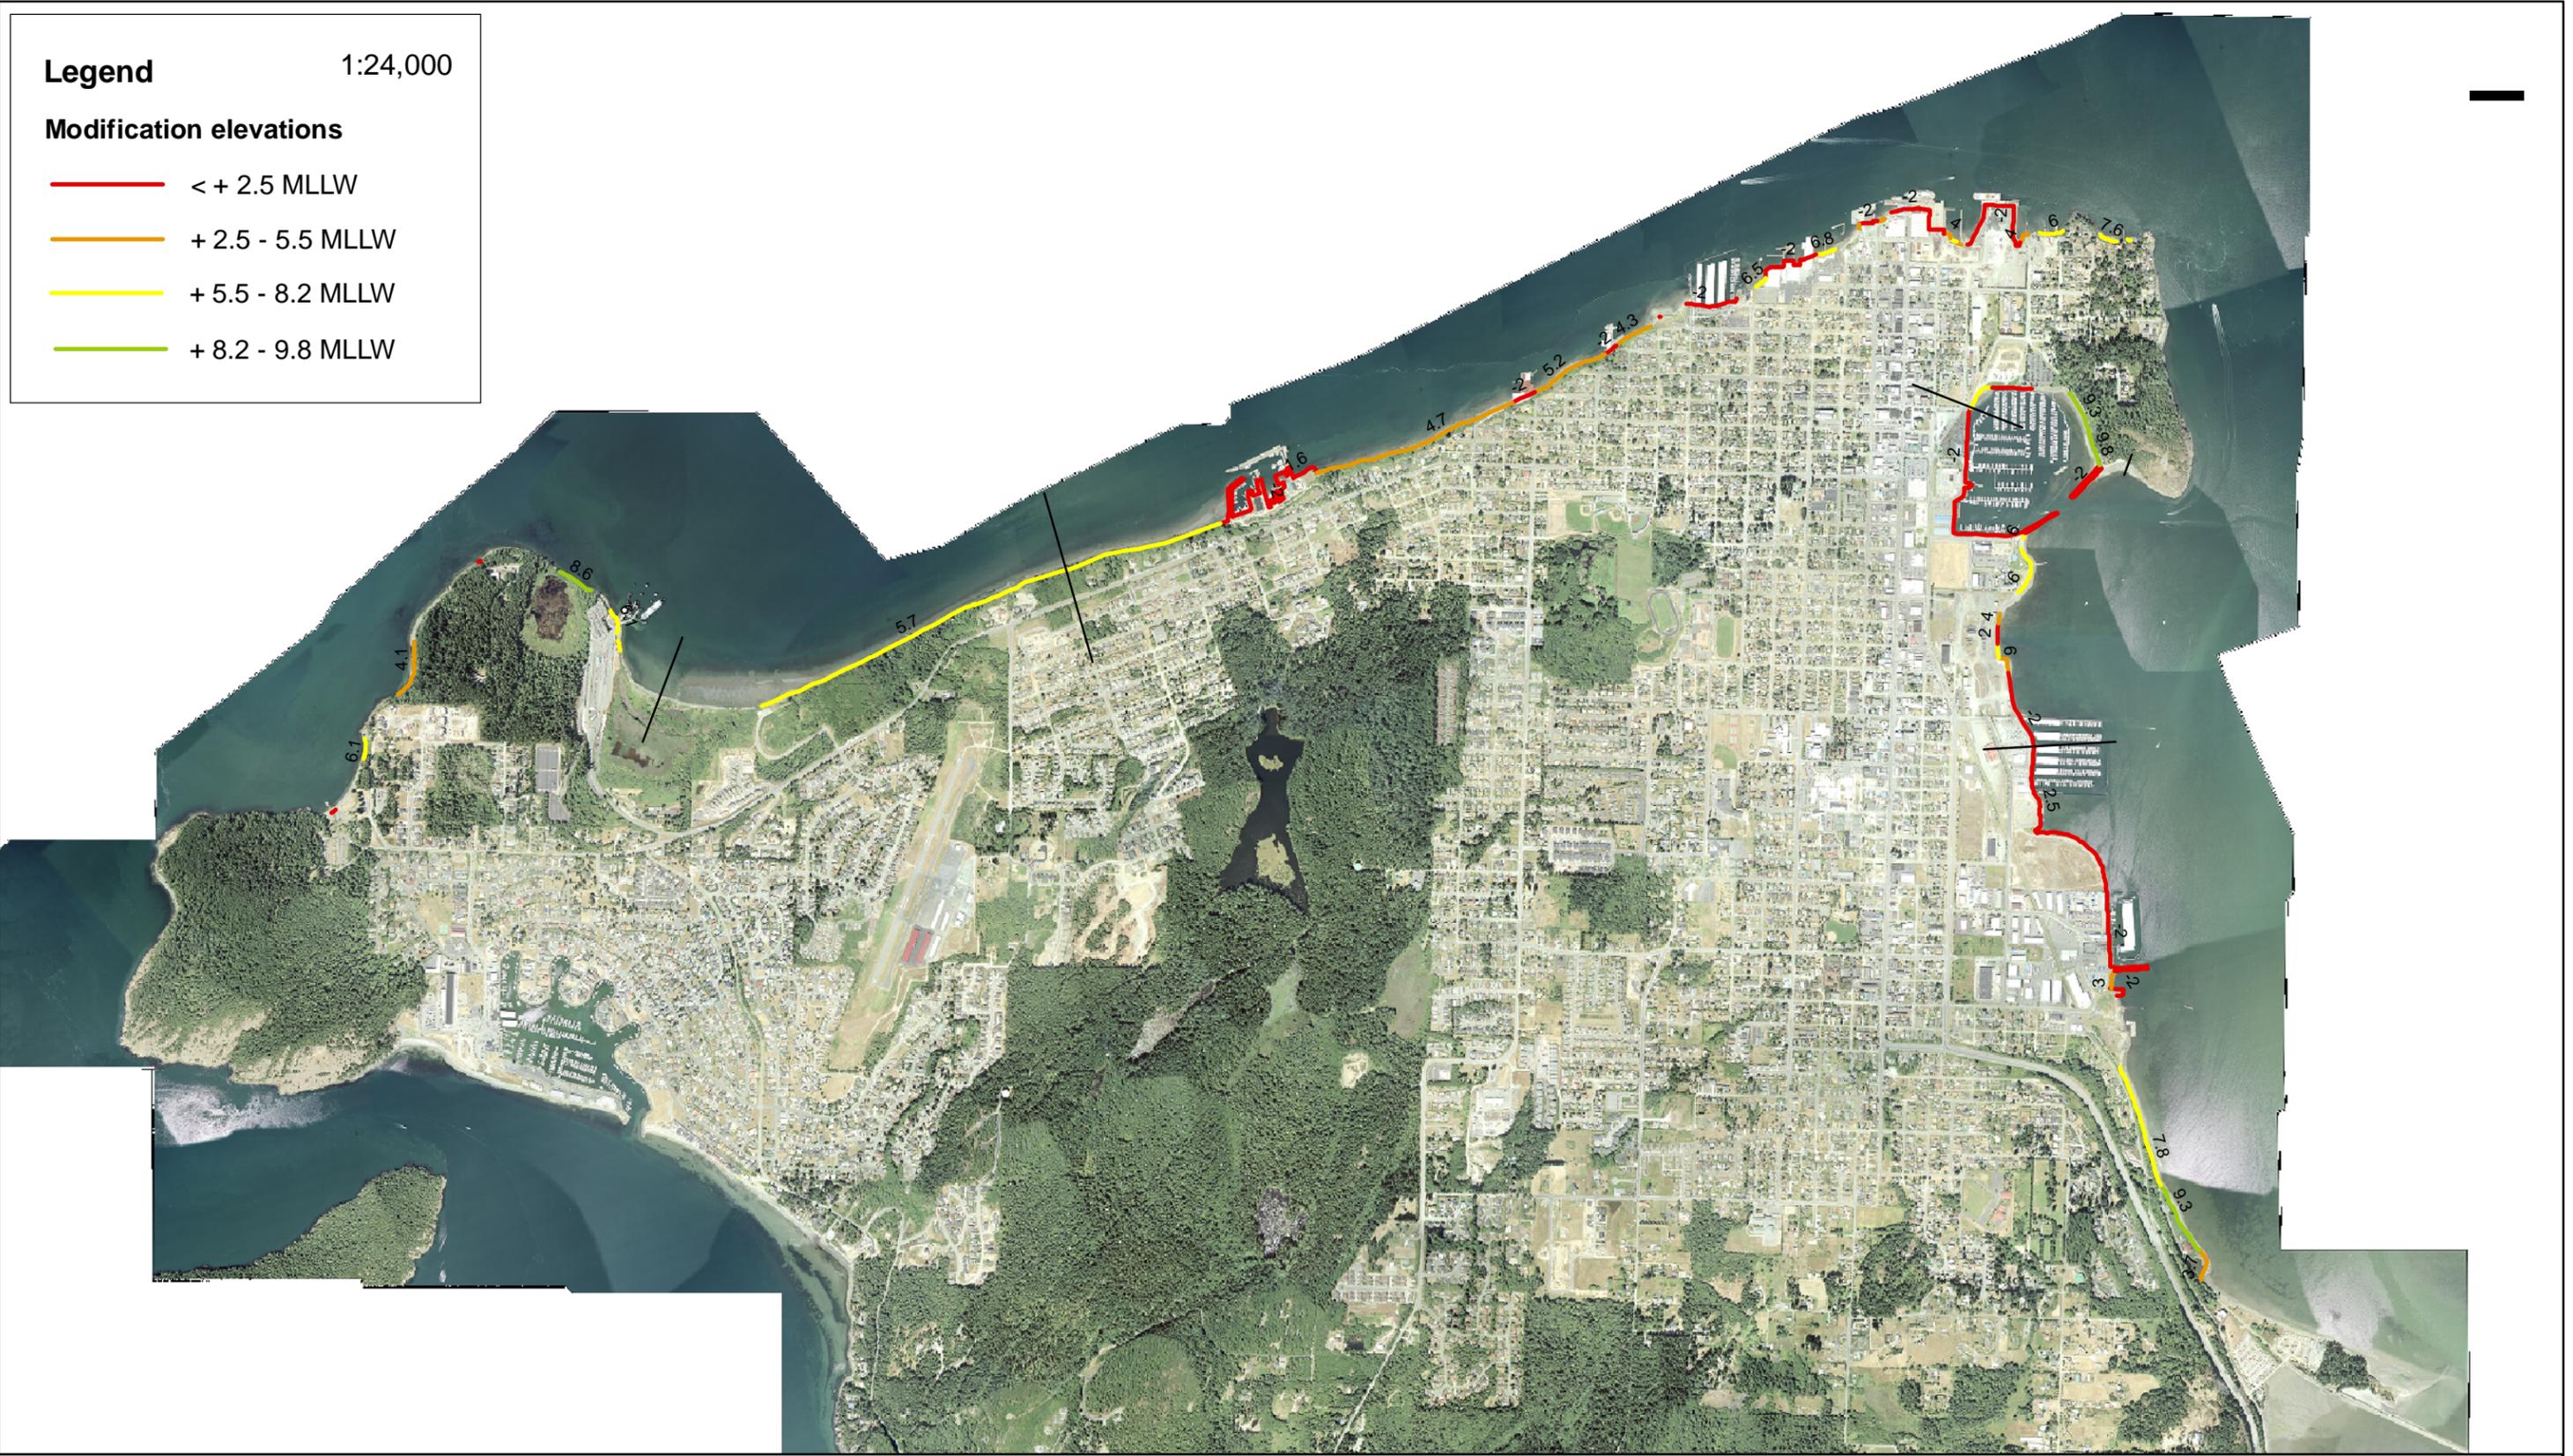
Figure 4. Elevation of all shore modifications along the North Fidalgo Island shores.
 North Fidalgo Island Geomorphic Assessment and Drift Cell Restoration Prioritization

North of the bedrock promontory (mapped as NAD in Figures 4 and 7), current sediment sources are largely intact excluding a long section of riprap that is impounding sediment along the southern portion of the Shannon Point property (Figure 7), a very small segment of armored feeder bluff exists at the north end of the Point, which currently protects an access point and boat ramp. Another two segments of historic feeder bluff and potential feeder bluff are associated with the Washington State Ferry landing. These sediment sources in cell SK-D-2 provide sediment that is predominantly transported northeastward toward the drift cell terminus in Ship Harbor. Cumulatively 27% of the historic sediment sources in this drift cell are currently impounded behind shore modifications (Table 11).
