North Fidalgo Island Geomorphic Assessment & Drift Cell Restoration Prioritization

Prepared for:
Skagit County Marine Resources Committee

Prepared by:
Coastal Geologic Services, Inc.
Andrea MacLennan, MS and
Jim Johannessen, LEG, MS

April 24, 2008

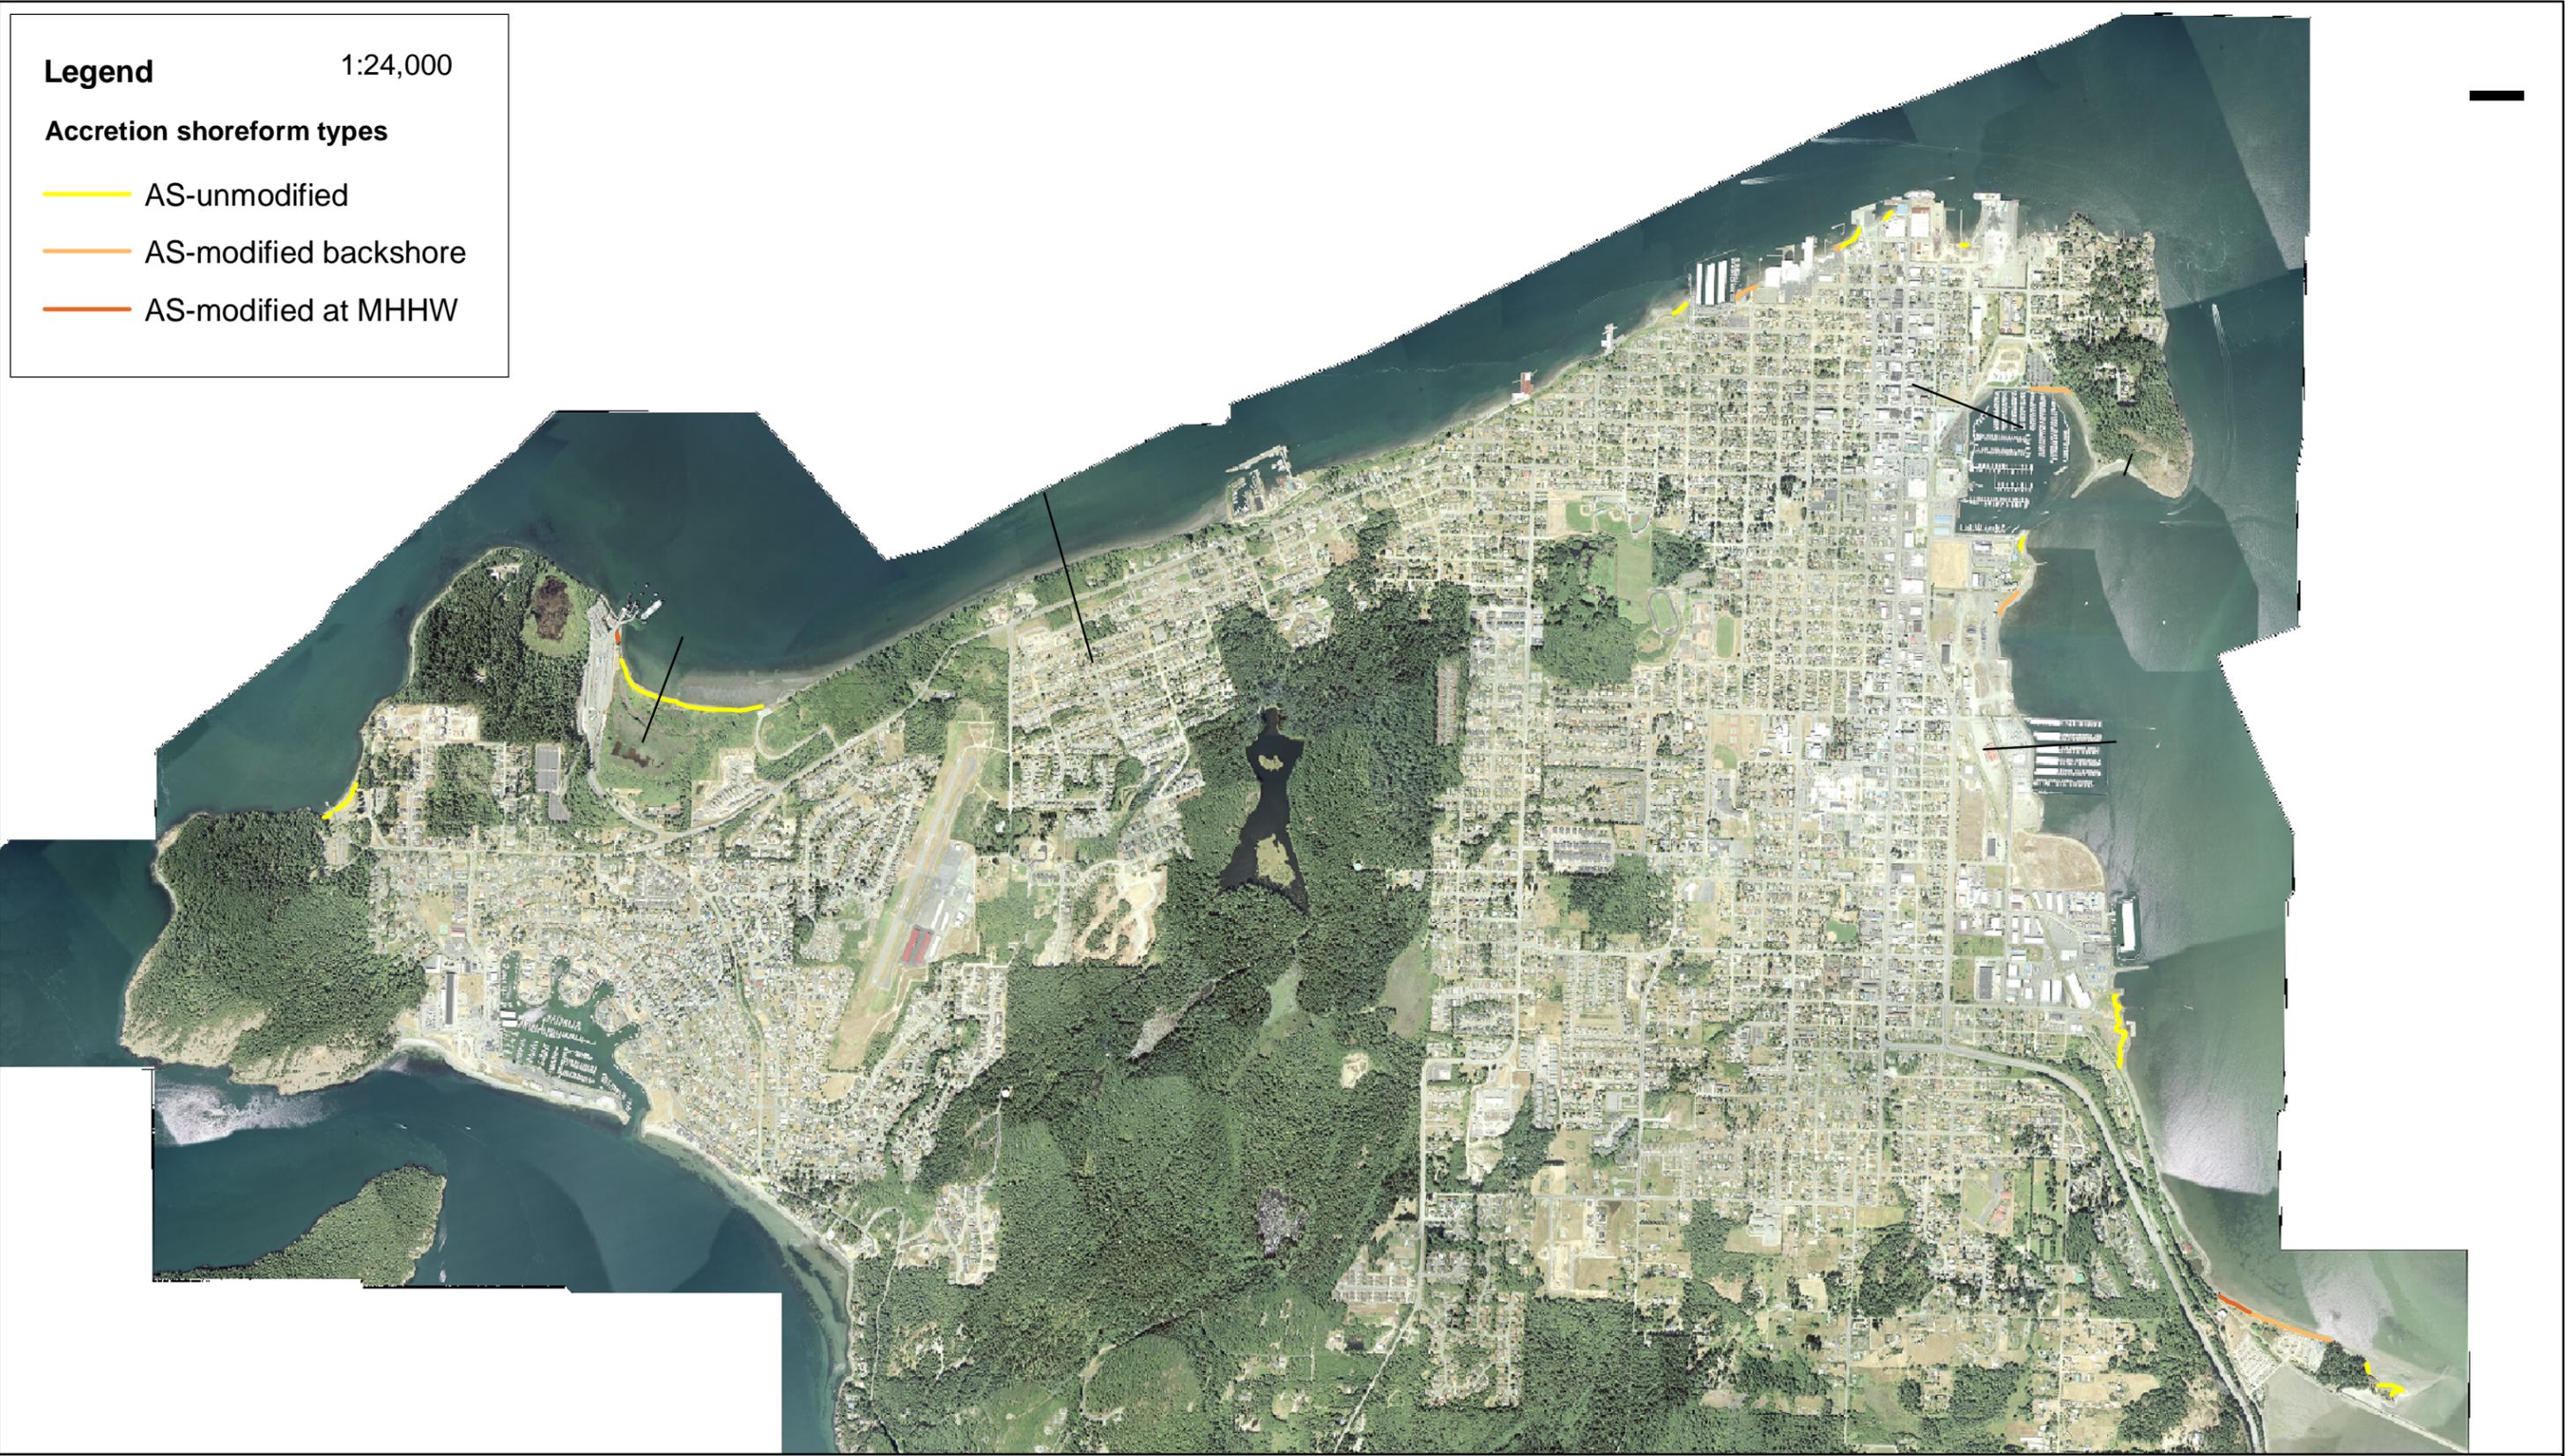
Figure 4. Elevation of all shore modifications along the North Fidalgo Island shores.
 North Fidalgo Island Geomorphic Assessment and Drift Cell Restoration Prioritization

North of the bedrock promontory (mapped as NAD in Figures 4 and 7), current sediment sources are largely intact excluding a long section of riprap that is impounding sediment along the southern portion of the Shannon Point property (Figure 7), a very small segment of armored feeder bluff exists at the north end of the Point, which currently protects an access point and boat ramp. Another two segments of historic feeder bluff and potential feeder bluff are associated with the Washington State Ferry landing. These sediment sources in cell SK-D-2 provide sediment that is predominantly transported northeastward toward the drift cell terminus in Ship Harbor. Cumulatively 27% of the historic sediment sources in this drift cell are currently impounded behind shore modifications (Table 11).

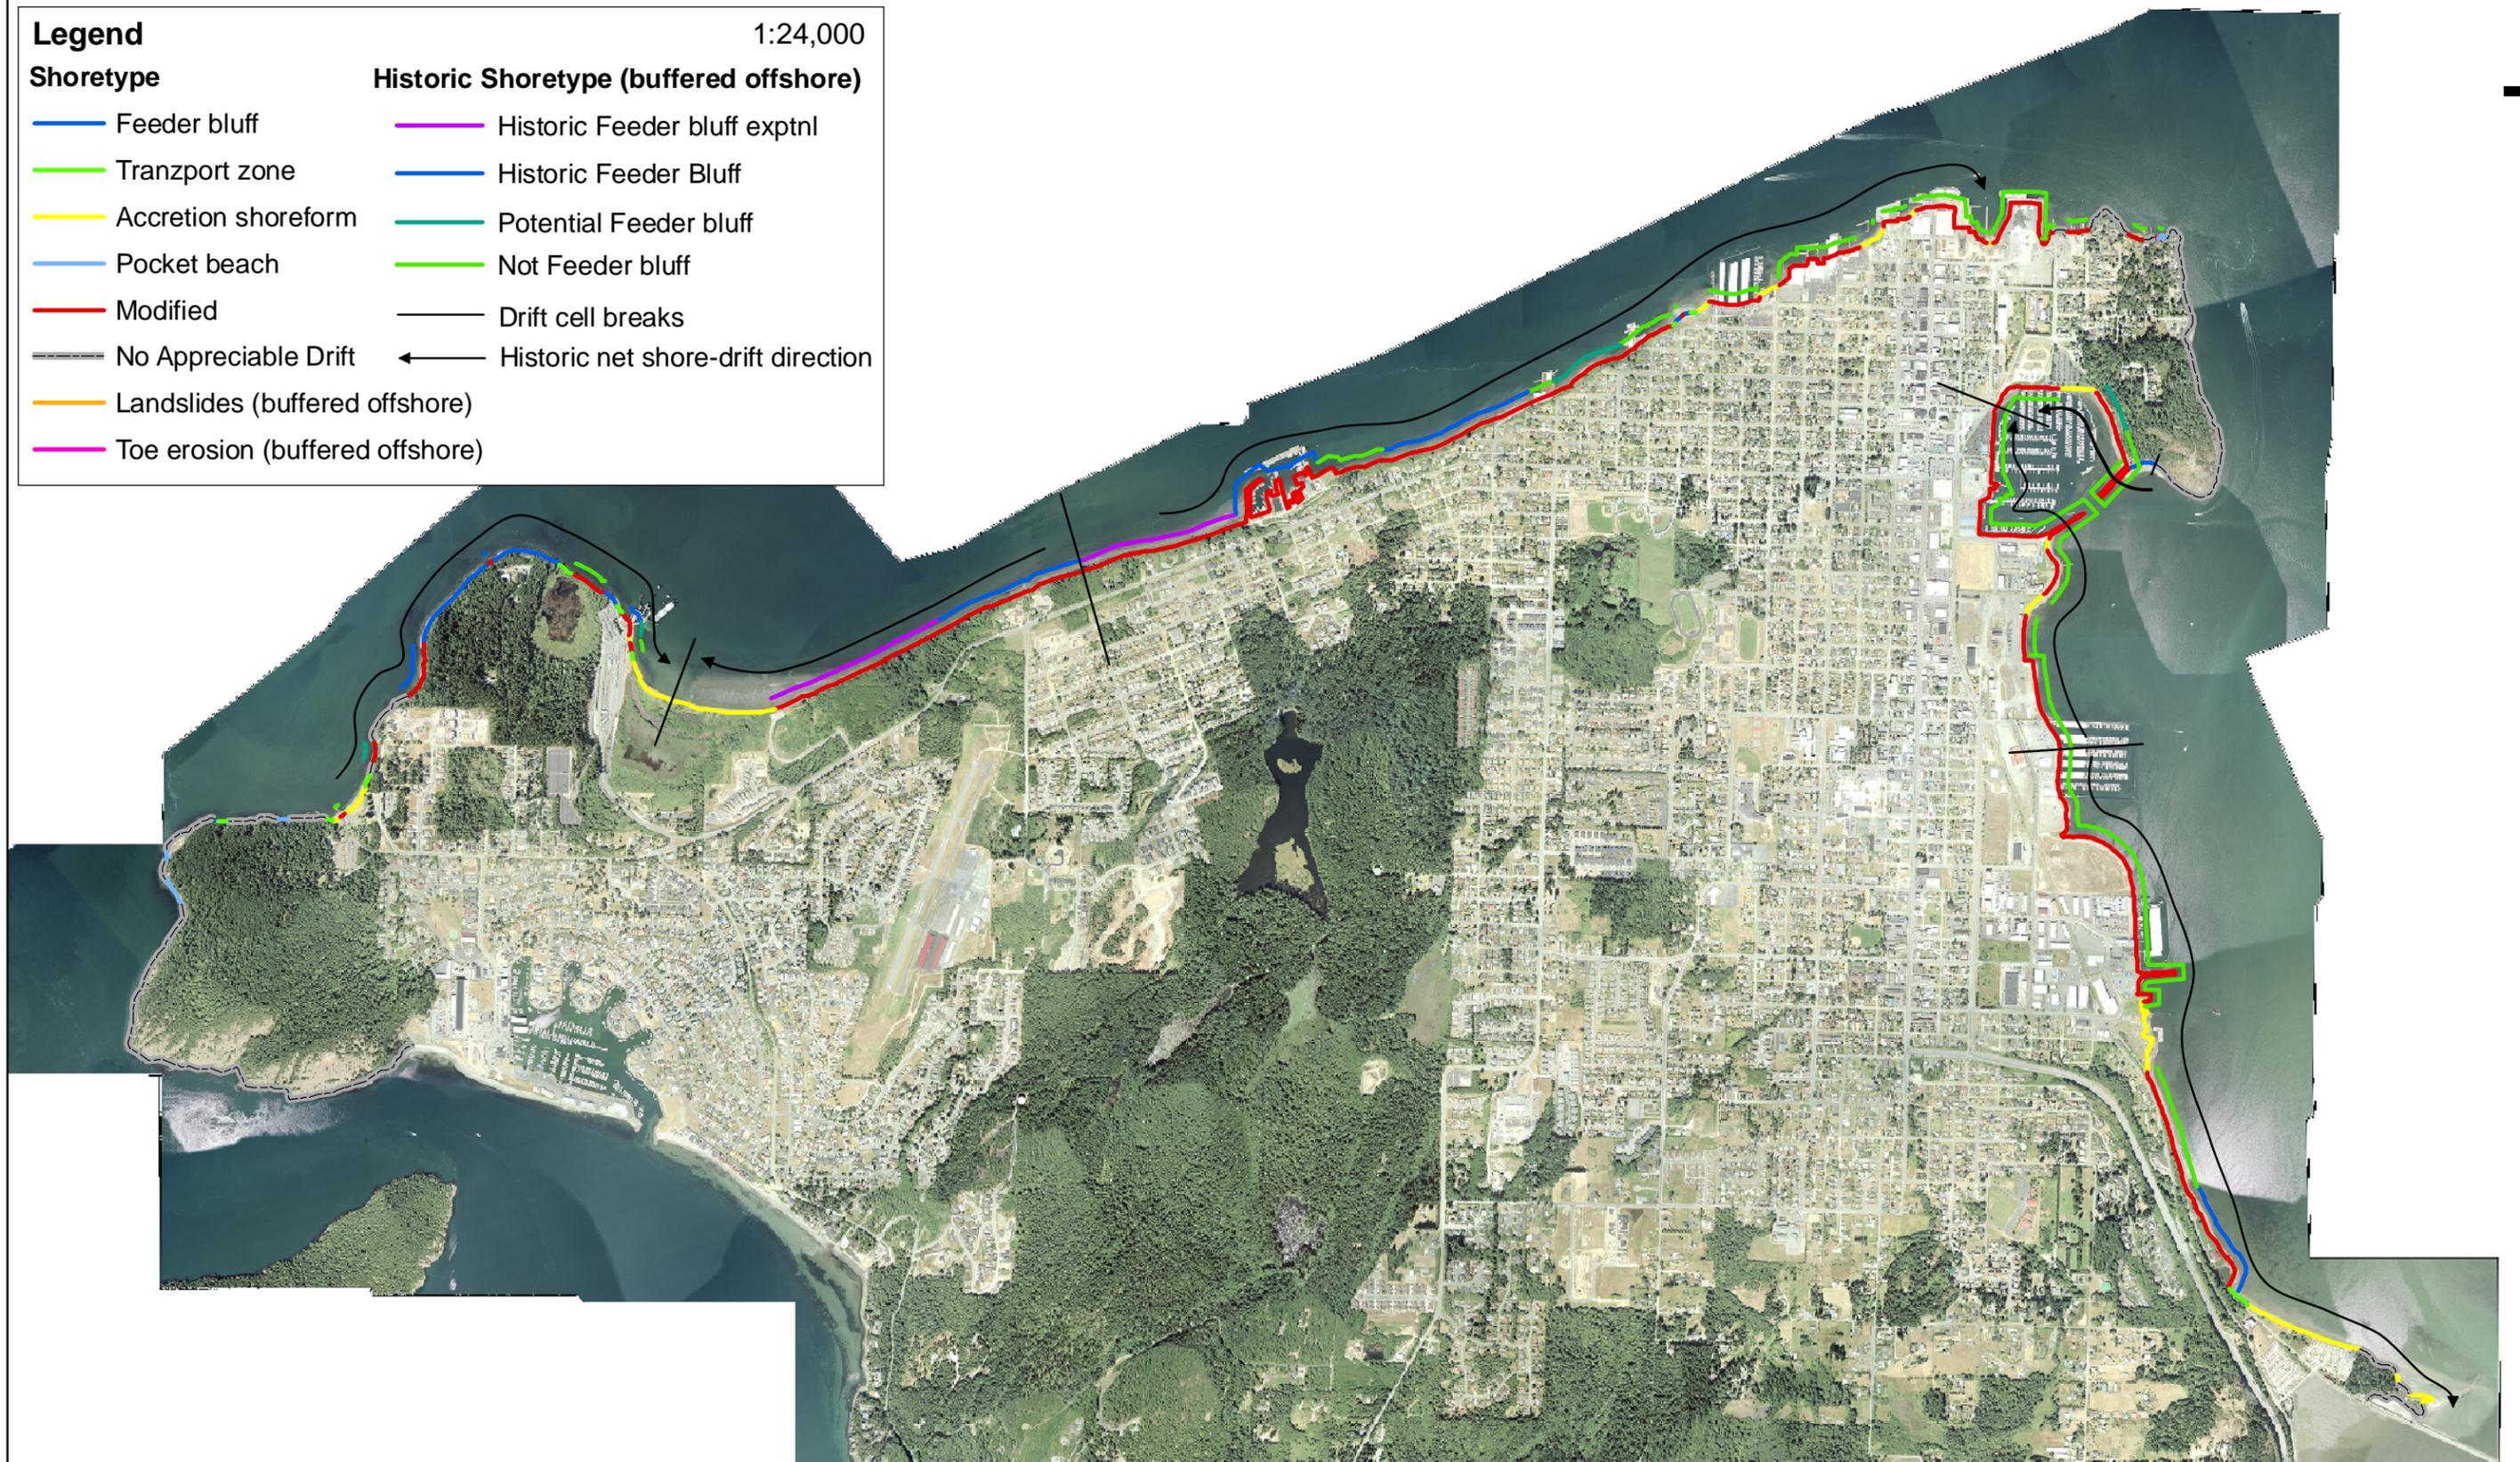
Figure 6. Current and historic geomorphic conditions of the North Fidalgo Island shores.

The greatest loss of nearshore sediment sources that the drift cells of North Fidalgo Island have incurred are found along Guemes Channel and the shores just north of Weaverling Spit, along the Tommy Thompson Trail (Figure 6, Table 10). Both of these historic feeder bluffs were originally armored at the time that the Great Northern Railway was constructed back around 1890 (Terry Slotemaker, pers. comm.). Some of the highest scoring historic sediment sources in the study area occurred along the north shore (in cells SK-D-1-5 and SK-D-1-4, Table 10). The sediment derived from these bluffs likely sustained the beaches at Ship Harbor, and the (historic) accretion shoreforms to the northeast, including the historic embayed salt marsh located just west of Cap Sante (Figure 1b). The historic sediment sources just north of Weaverling Spit were some of the only significant sediment sources along the east shore, excluding a narrow stretch of potential feeder bluff on the southwest shore of Cap Sante Park, that likely did not contribute much sediment to the nearshore. Verifying historic erosion along these eastern armored bluffs was challenging due to the installation of the railway and other shore modifications prior to many of the historic resources used in this assessment. The steep topography of the bluff, its exposure to northwesterly winds and waves, its geologic make-up and its close proximity to the shore affirmed the likelihood as a historic source of nearshore sediment. Several other intermittent stretches of historic feeder bluff were documented along the western shore of the Island, the largest of which was located just north of Washington Park (Figure 6).

Results of historic conditions mapping shows that prior to development, sediment sources accounted for approximately 28% of the North Fidalgo Island study area, while currently only 5% of the study area shore remains feeder bluff. This represents an 82% loss in sediment supply (by length) throughout the study area. A loss of this magnitude has undoubtedly lead to depleted down-drift beaches (Table 11 and Figure 6).

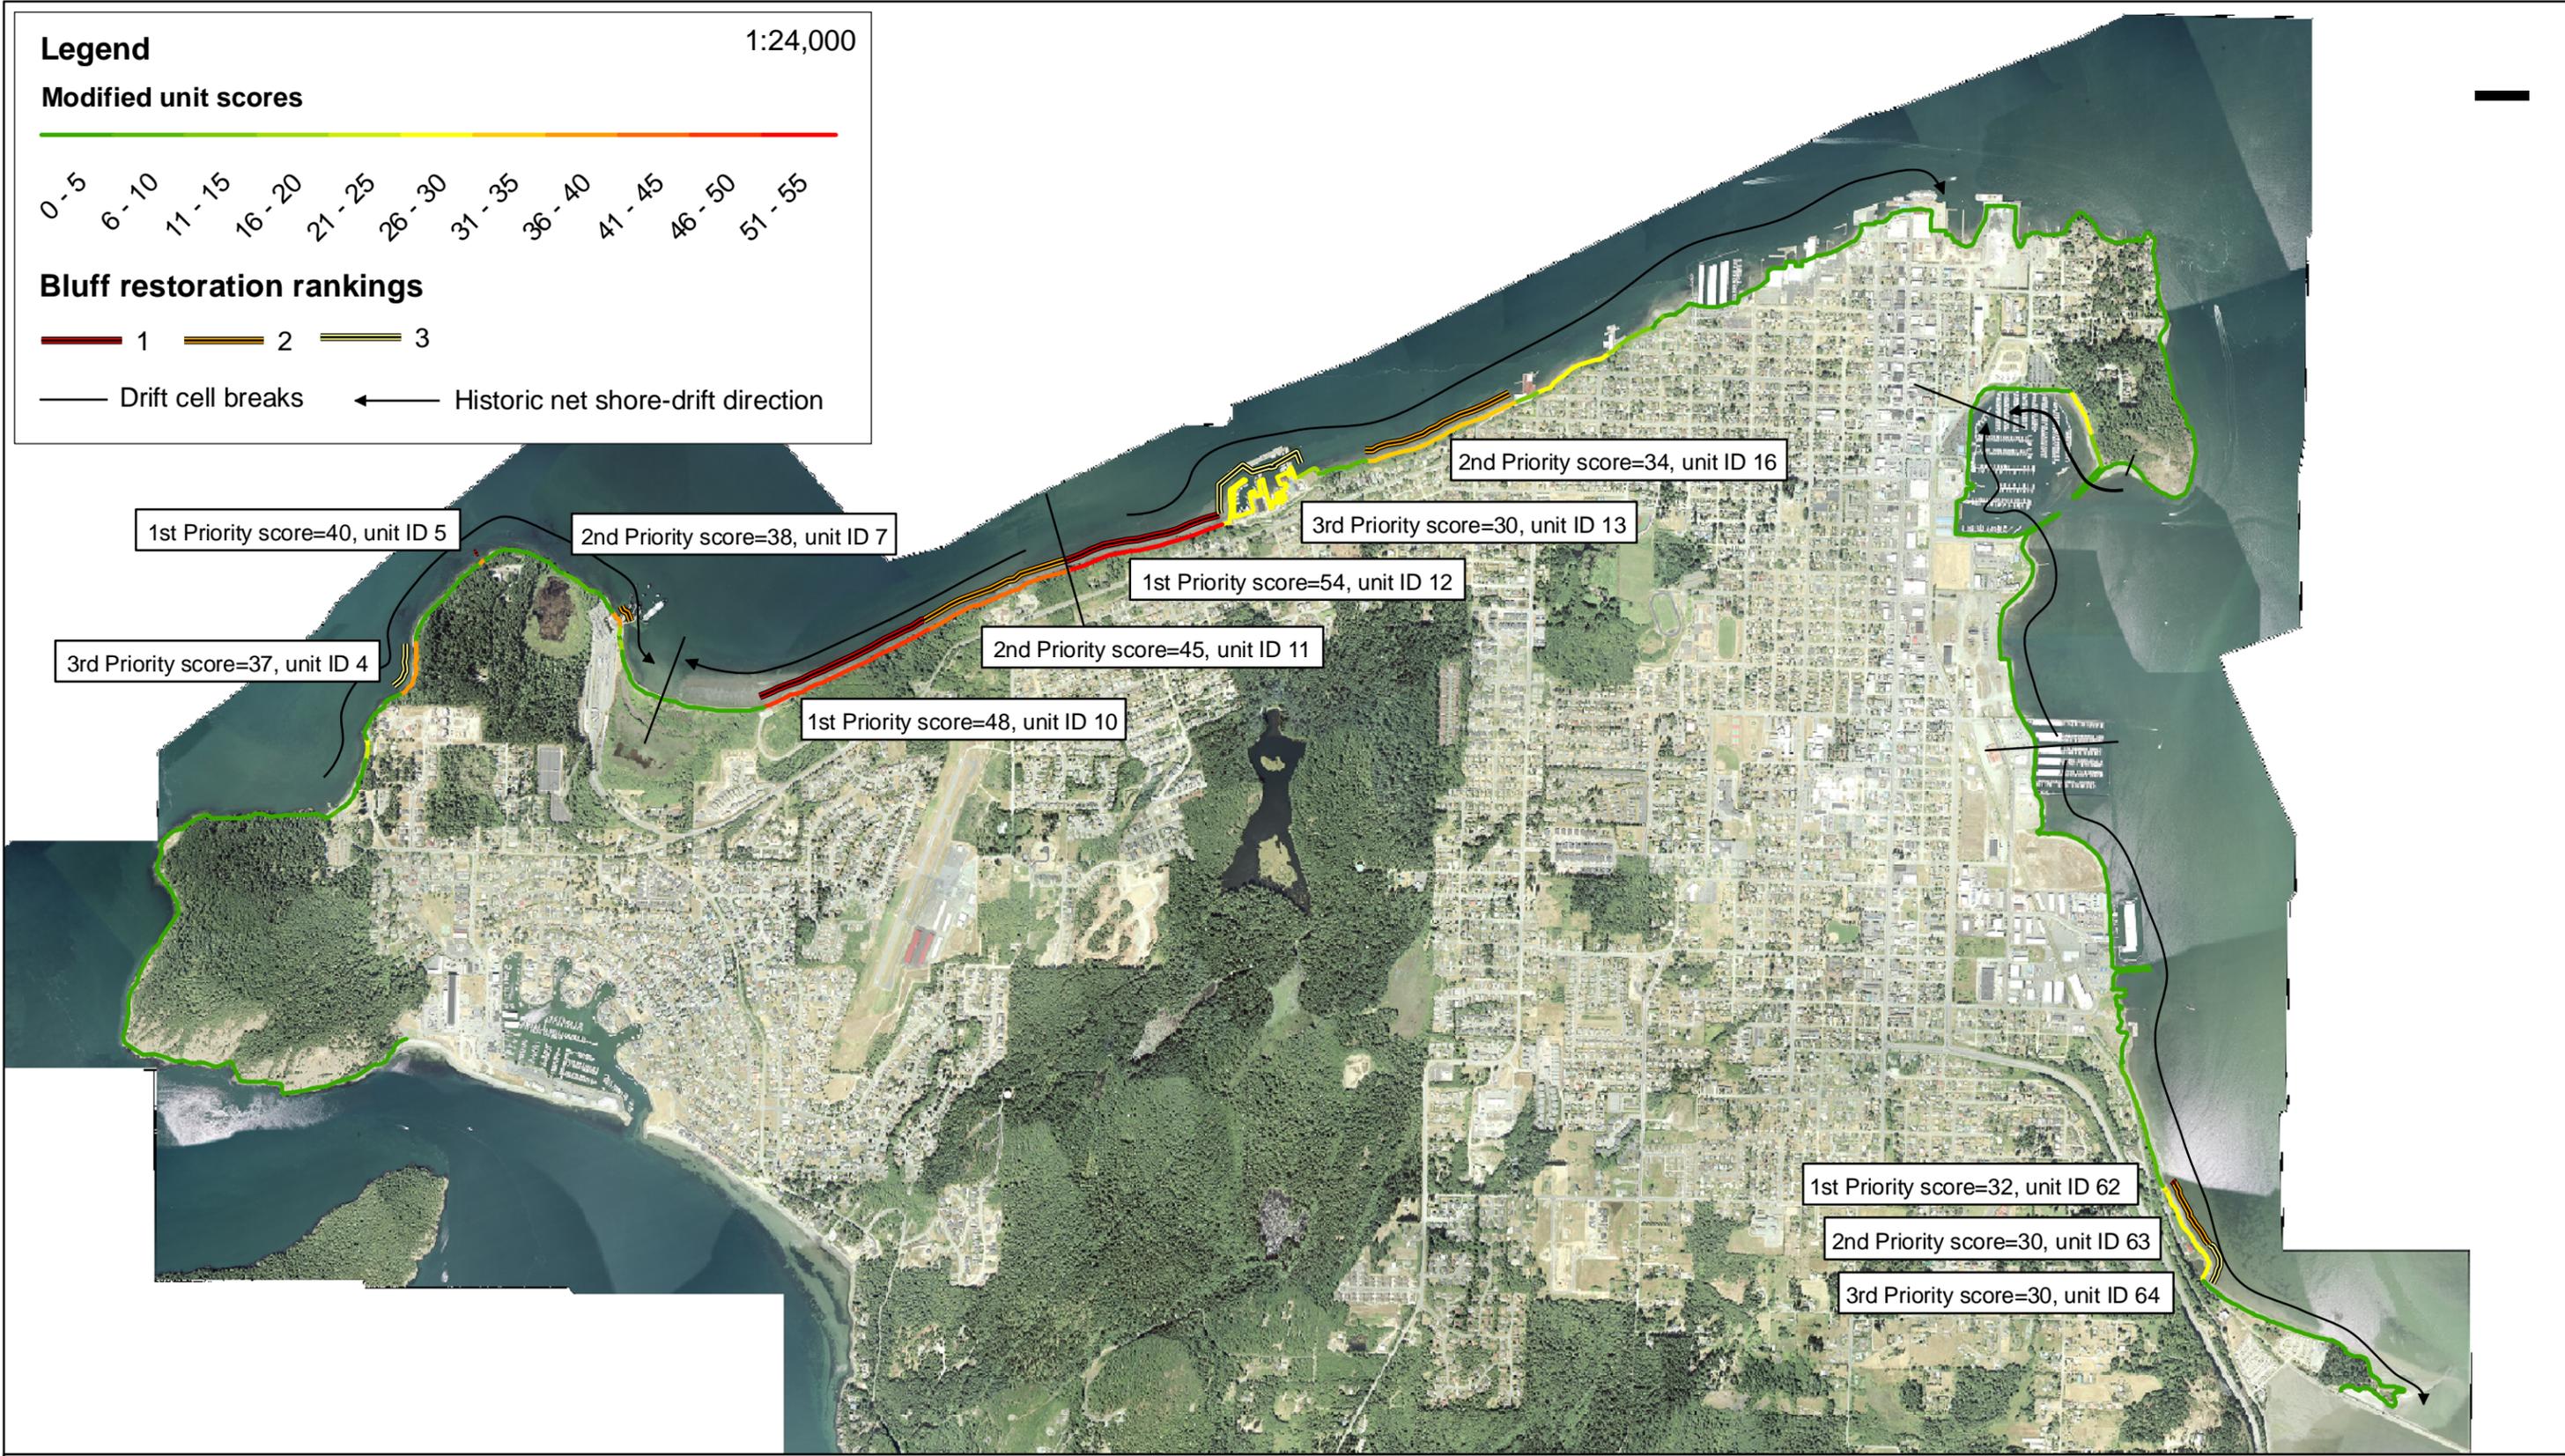
Figure 12. Unit scores for all North Fidalgo Island modified shores and priority bluff restoration units (buffered offshore).

In drift cell SK-D-1-5, the top ranking sediment sources for restoration (bluff units 10 and 11, Figure 12) are located east of the Ship Harbor accretion shoreform. Currently there is minimal development along the unit 10 portion of the bluff, and removing the armoring at the base of the bluff could both restore sediment supply and reclaim beach area/substrate (and potential forage fish spawning habitat) that is currently buried beneath the riprap. The riprap extends (on average) down to +5.6 ft MLLW, which is considerably below mean higher high water for the area of +7.7 ft MLLW. The second ranking sediment source to restore in the drift cell, unit 11, is the eastern adjacent bluff segment. The westernmost 650 ft of unit 11 are largely undeveloped; however homes are located close to the bluff crest in the eastern portion of the unit. For this reason, removing the riprap along only the western portion of the bluff would be feasible without threatening the eastern homes.
