Skagit Shoreline Needs Assessment- High Priority Areas Report

Skagit County Shoreline Needs Assessment –
High Priority Areas
TECHNICAL REPORT

Skagit County Marine Resources Committee
December 2025

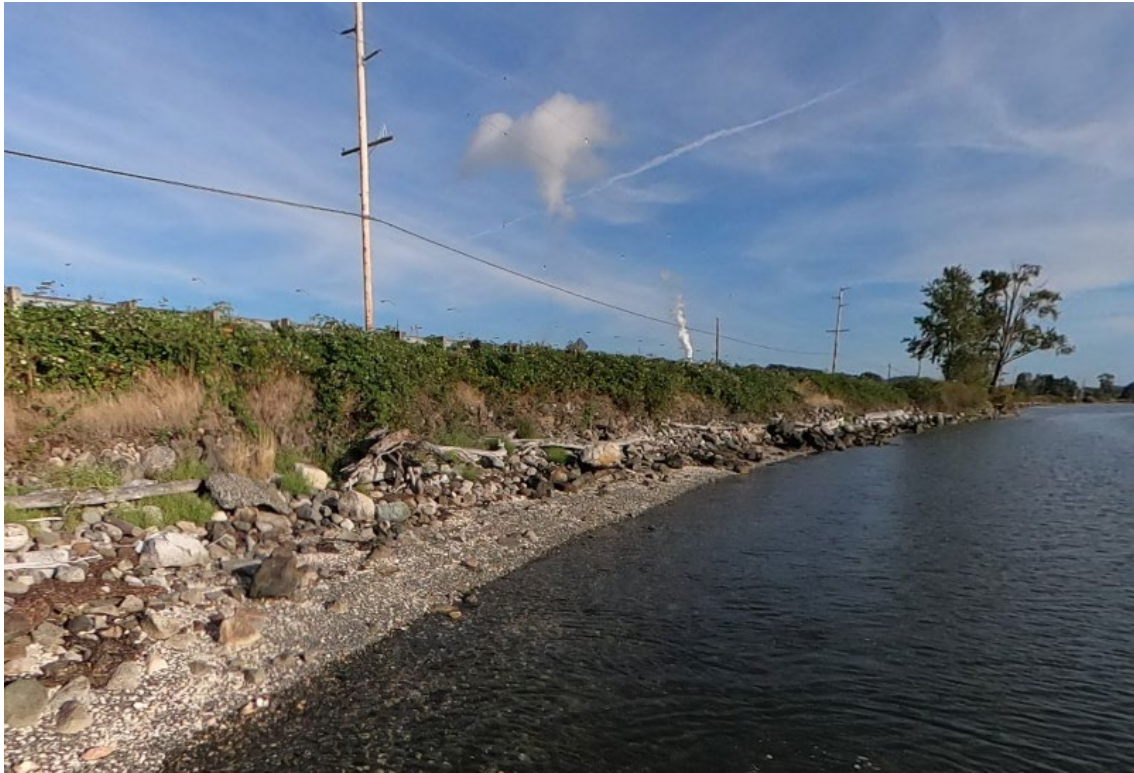
Figure 1. Riparian condition south of Crandall Spit. Opportunity for invasive species removal and riparian enhancement.

- Riparian planting around shore side of March Point Road
 - Particularly along the southwest shoreline, the current vegetation south of Crandall Spit is dominated by non-native vegetation between the road edge and the shoreline. Replacing this vegetation with native vegetation and selectively planting woody vegetation that could grow to overhang the intertidal habitats would enhance nearshore food production and temperature regulation.

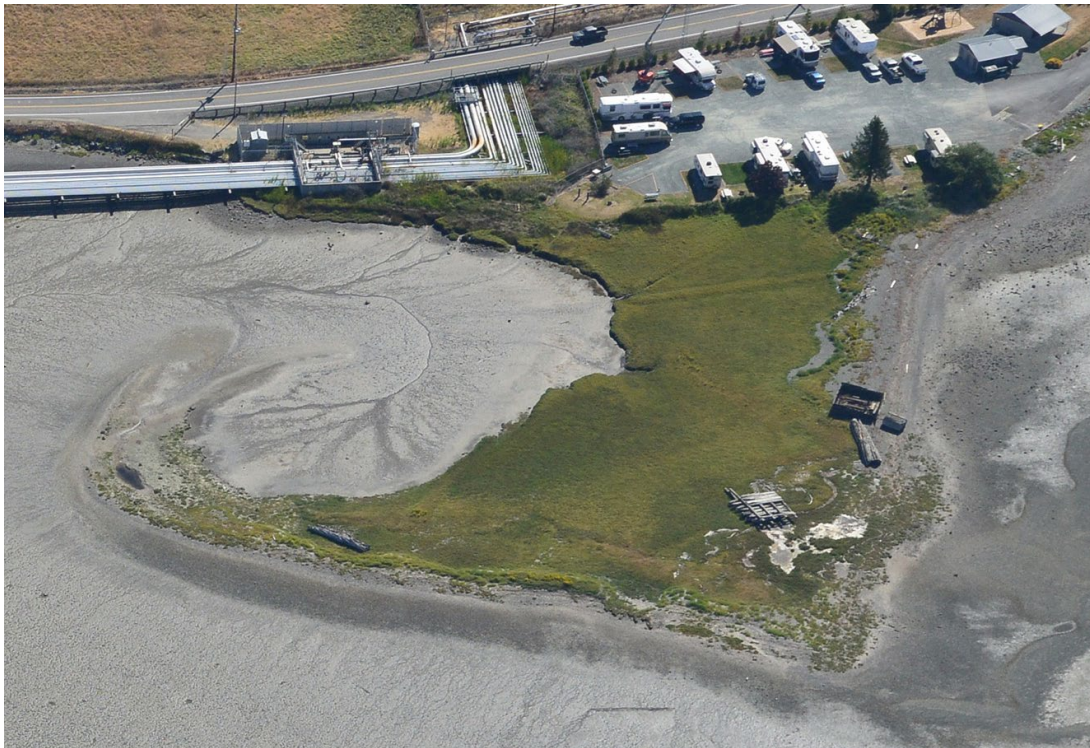
Figure 2. Wetland south of Crandall Spit. Employee recreational area and wooden debris within wetland.

- Strategic restoration along shoreline
 - Derelict structures and debris are noted on the wetland spit just south of Crandall Spit. Removal of these structures could prevent further impacts to this wetland and support wetland recovery.

- The current Shell Puget Sound Refinery Employee Recreation Area which appears to be managed to support temporary housing/RV park on the spit south of Crandall Spit represents a high potential for habitat restoration and reduced conflicts with wildlife. Actions at this site could include:

- Planting a riparian buffer between the recreation area and adjacent wetlands to the west.
 - Wetland restoration by removing paved areas and buildings.

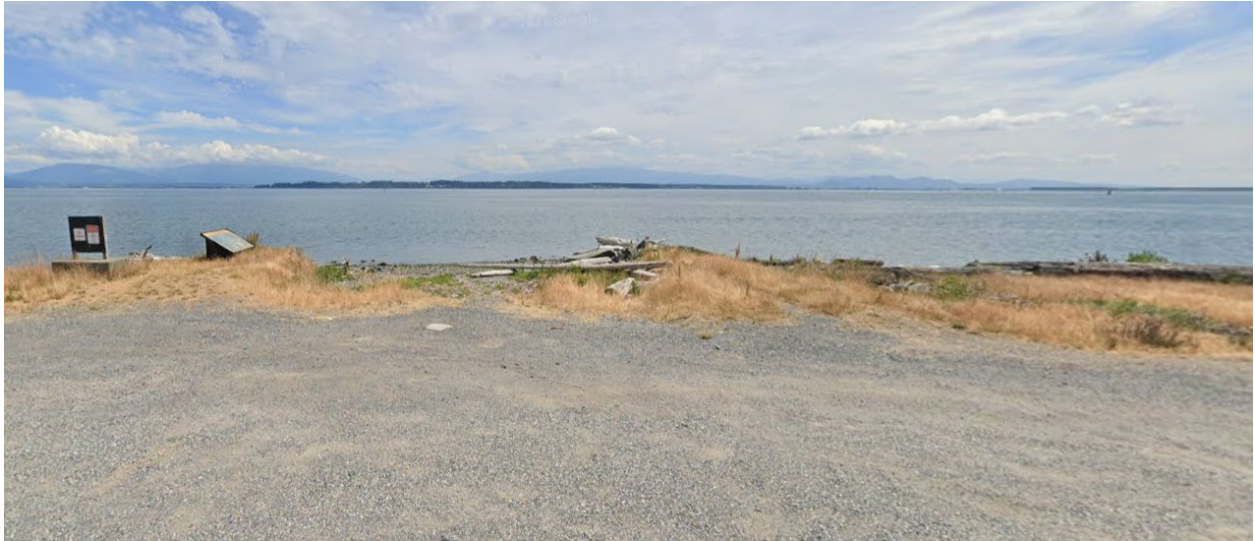
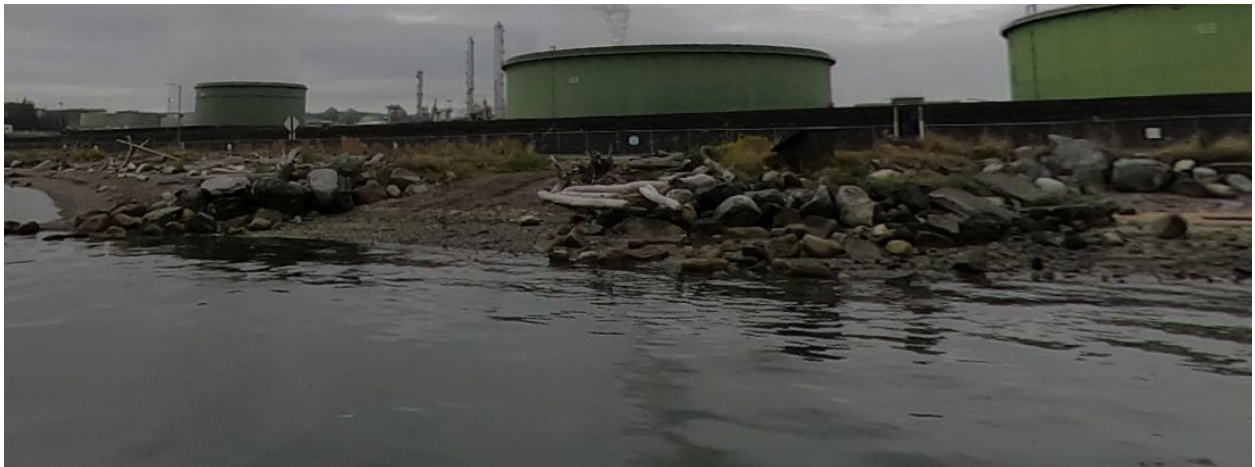
Figure 4. March Point Beach Access Point/Historic Boat Ramp near NE corner of March Point.
Top picture: Looking from road towards water; Bottom Picture: Looking from water towards historic boat ramp.

- At the NE corner of March point there is an historic boat ramp and associated parking area. While the site appears to continue to be used for public access to the shoreline, the use as a boat ramp has been abandoned. The site is marked on online maps as a Beach Access point and appears popular with users. However, there are restoration opportunities associated since the boat ramp has been abandoned. Consider removing the rip-rap which lines the former boat ramp and planting riparian vegetation to supplement the grasses at the site. The historic boat ramp could be further narrowed to a trail access point. The area may have limited groundwater and soil amendments may be necessary to support riparian vegetation due to extensive historic gravelling at the site. There is currently no riparian vegetation along this stretch of shoreline and overhanging vegetation would shade and provide food resources to shoreline dependent organisms.

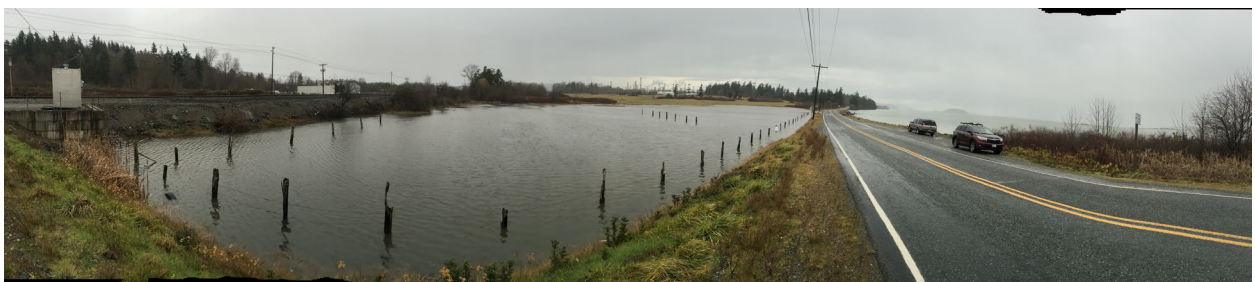
Figure 5. Estuarine wetland at SE corner of March Point.

- At the southeast corner of March Point there is a substantial estuarine wetland complex upstream of March Point Road. The current culvert structure connecting the wetland complex to Swinomish Slough/Padilla Bay is undersized and likely a velocity barrier for fish movement during most tidal exchanges. This estuarine wetland represents a potentially valuable pocket estuary for rearing salmonids and is likely used by non-natal Chinook salmon for rearing. Replacing the undersized culvert with a bridge would enhance fish access and provide a more natural estuarine hydrograph. Additional restoration within the wetland including filling borrow ditches and reconfiguring channels could be considered after the hydraulic connection is addressed.

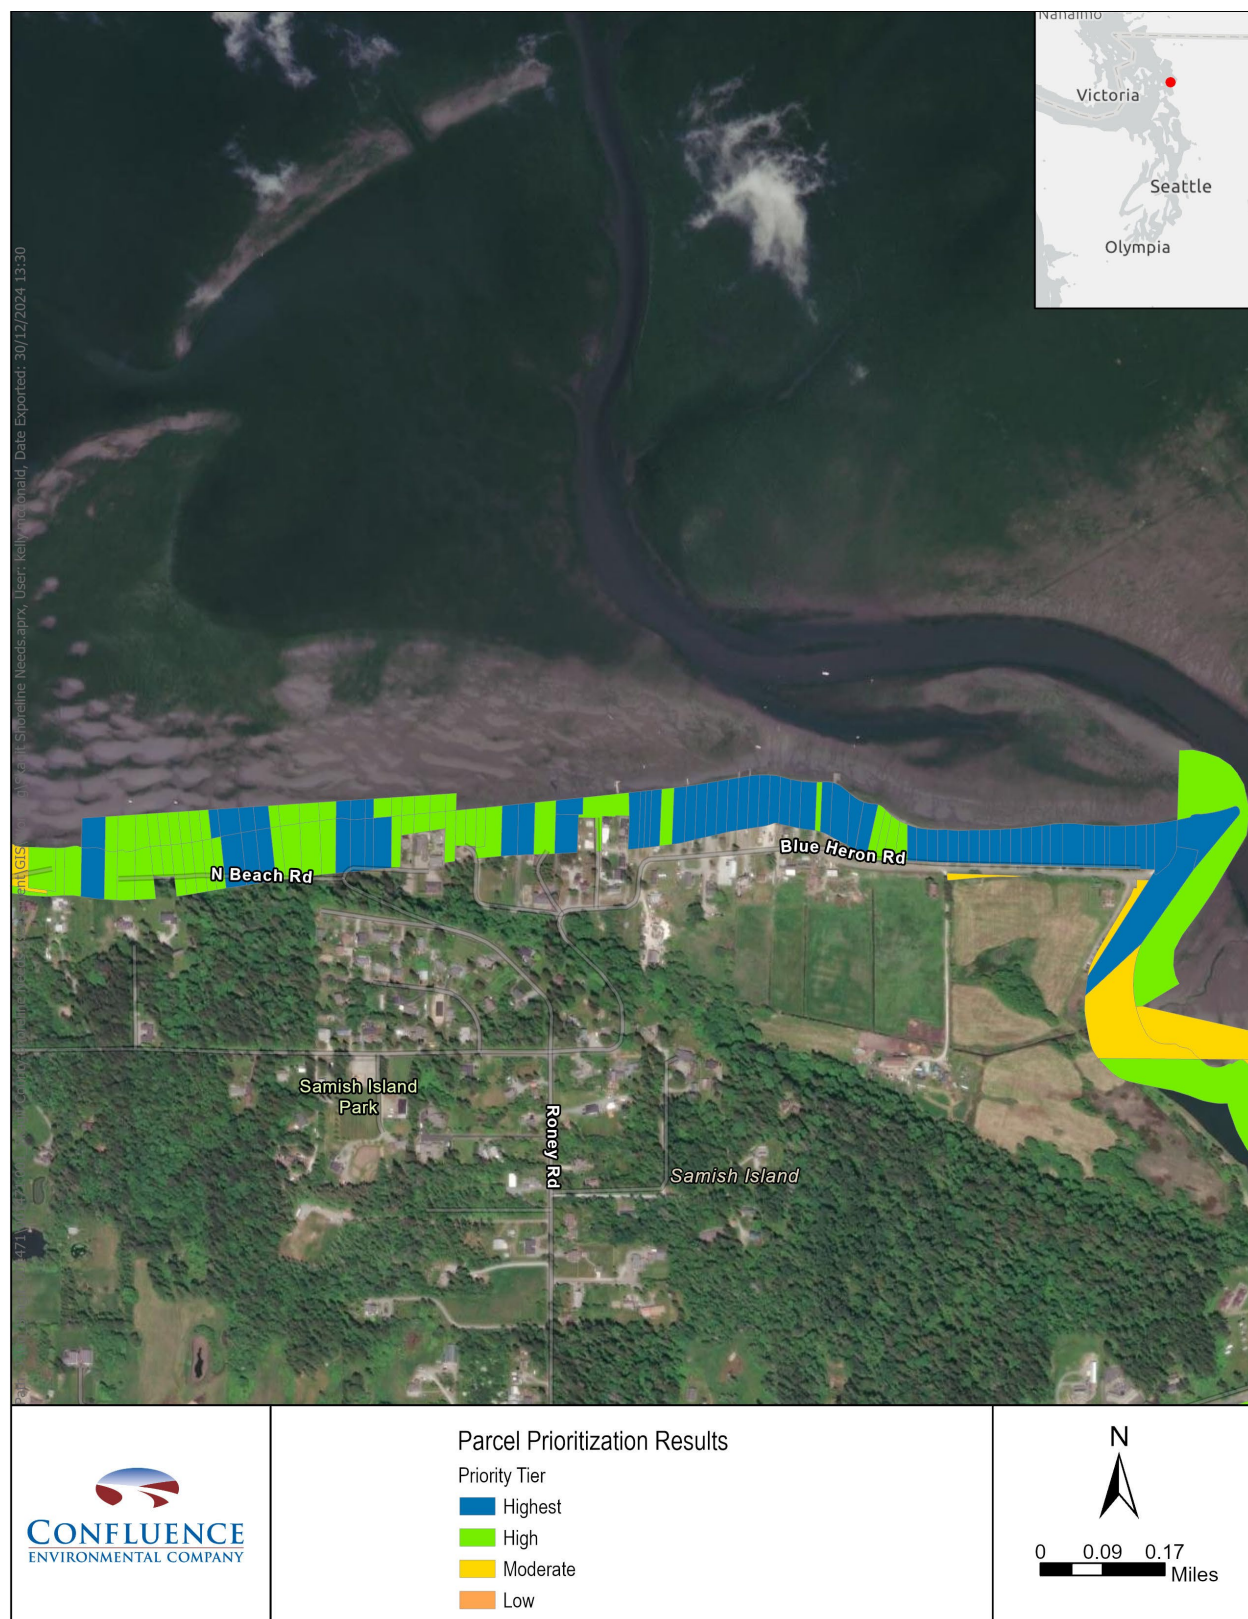
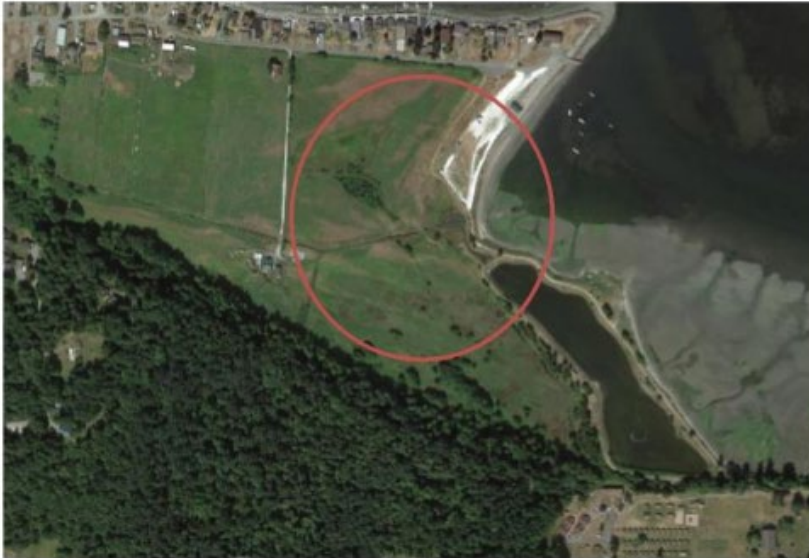
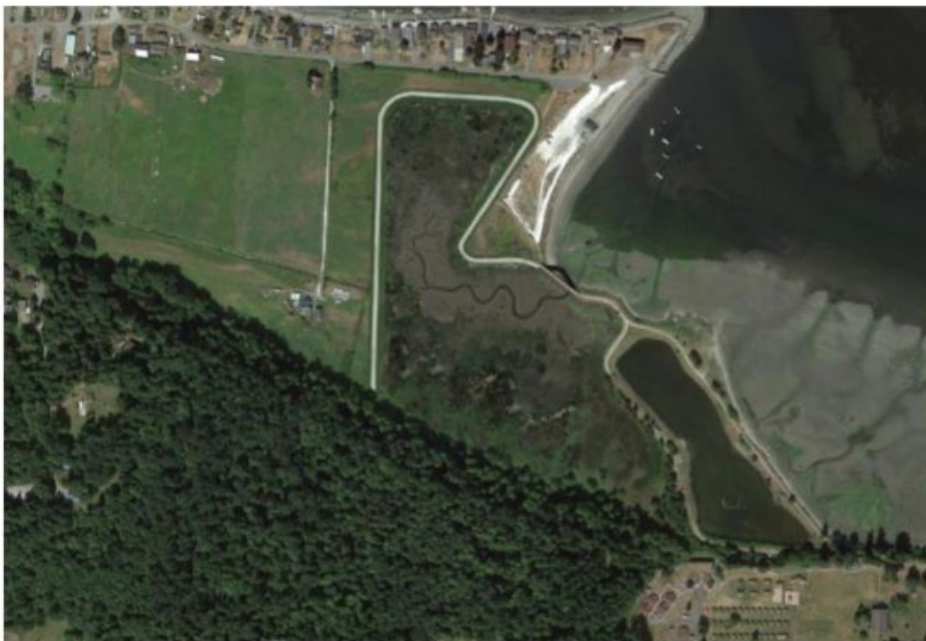
Figure 8. Freestad Lake – Restoration Concept

Current Conditions

Expected Future Conditions

- Re-evaluation of Freestad Lake estuary restoration concepts. Freestad Lake is a saltwater lagoon constructed as a recreational amenity for the Community of Christ Church campground on the east side of Samish Island. While initial designs for restoring a barrier lagoon were led by Skagit County Public Works circa 2015-2017, this project appears to be dormant and without a sponsor at present. Conceptual designs suggest the potential to restore functions of a pocket estuary while preserving existing uses.
- Evaluation of residential, commercial and recreational moorages along the north side of Samish Island suggest that there may be benefits to improved planning and management. While many of the vessels and buoys appear to be located outside of eelgrass or have de minimis effects on eelgrass, some appear to be having ongoing impacts to eelgrass beds.

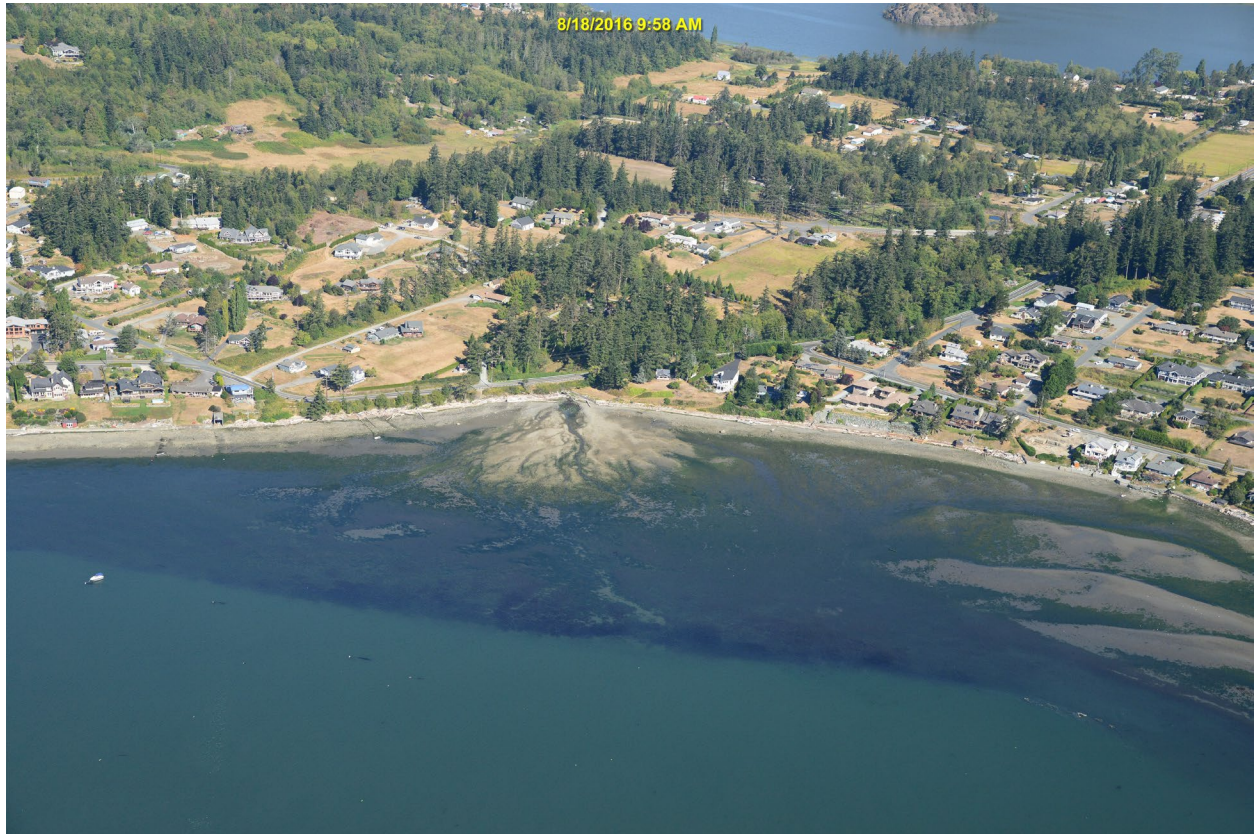
Figure 10. Image of Campbell Lake Creek Mouth and delta.

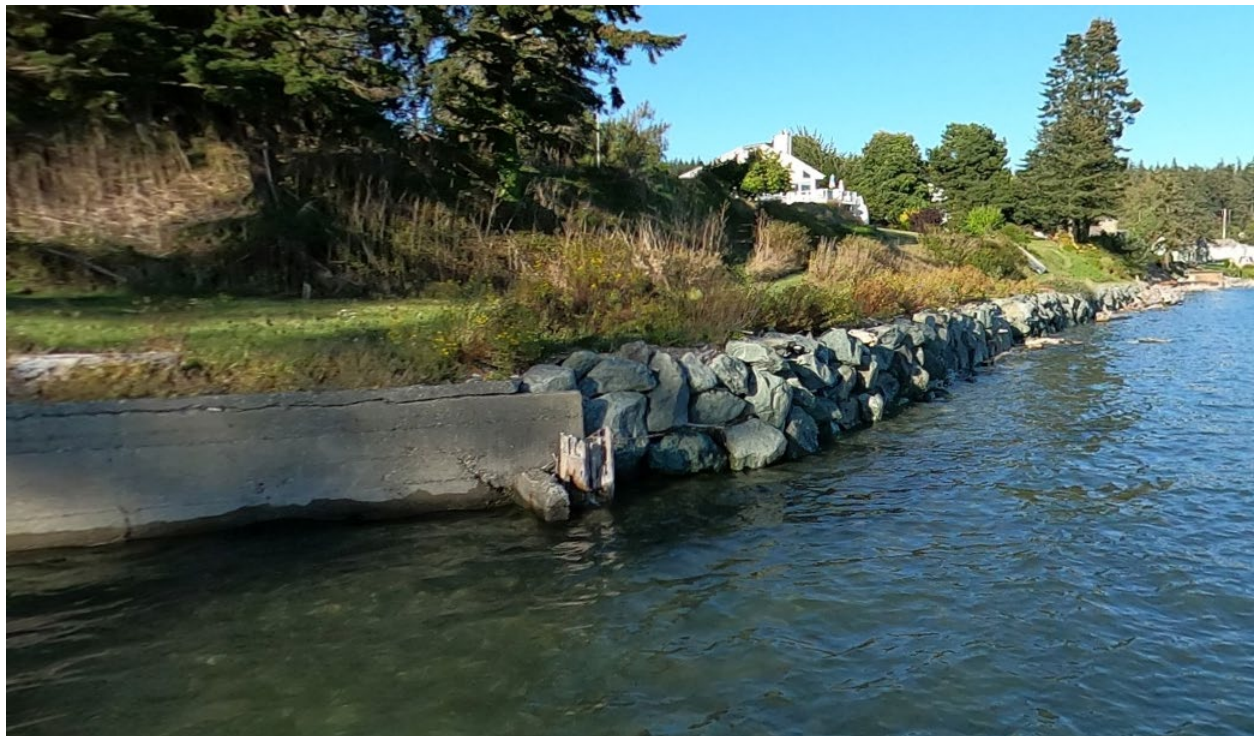
Figure 11. Shoreline Armoring Restoration Opportunity – East of Creek Mouth

- Potential shoreline armor removal projects immediately north/west of the stream including properties including Skagit County parcels P73301 and P73296. Approximately 300 linear feet of shoreline armor appears to be suitable for removal which would provide benefits to in-stream fish (prey items) and potentially beach spawners.

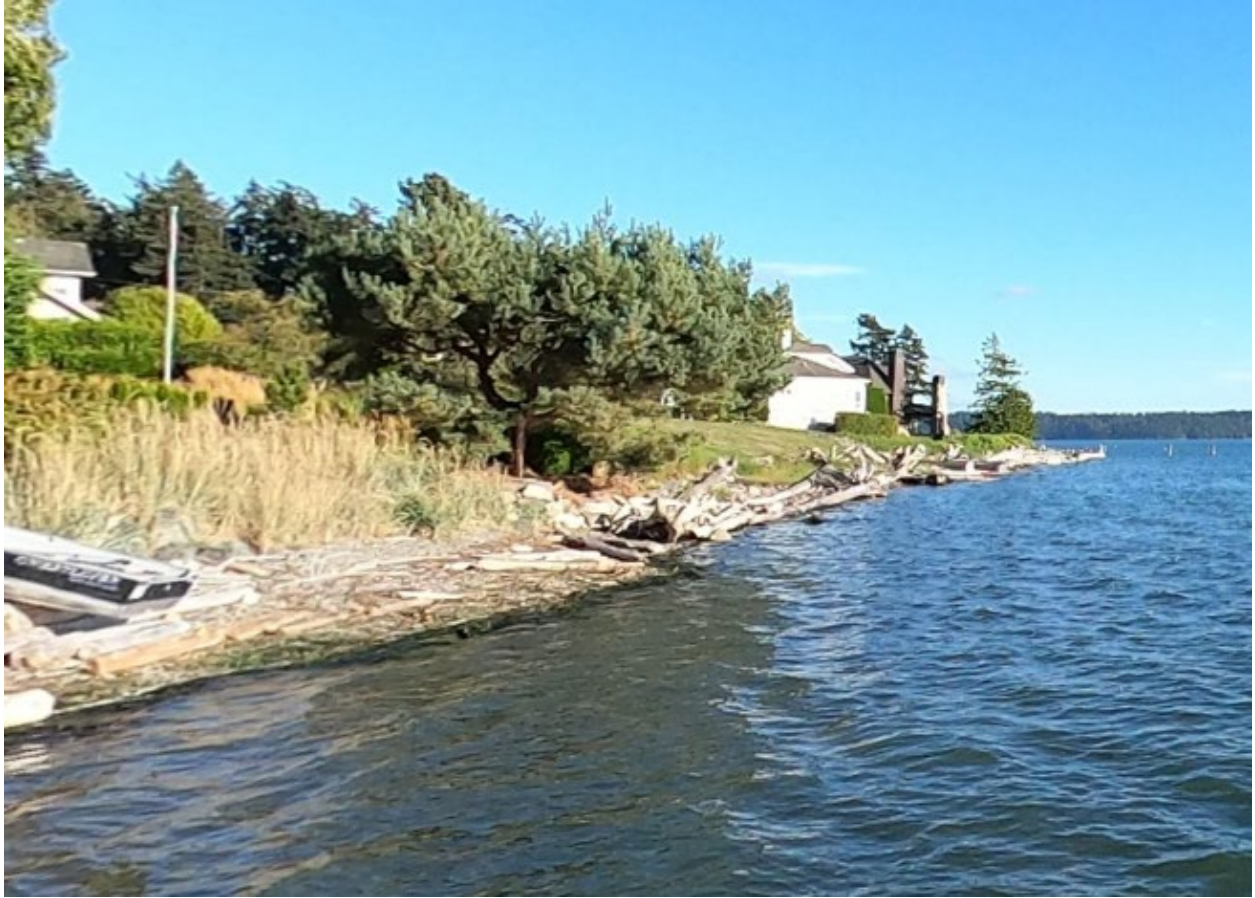
Figure 12. Representative example of soft bank armoring from within shoreline segment

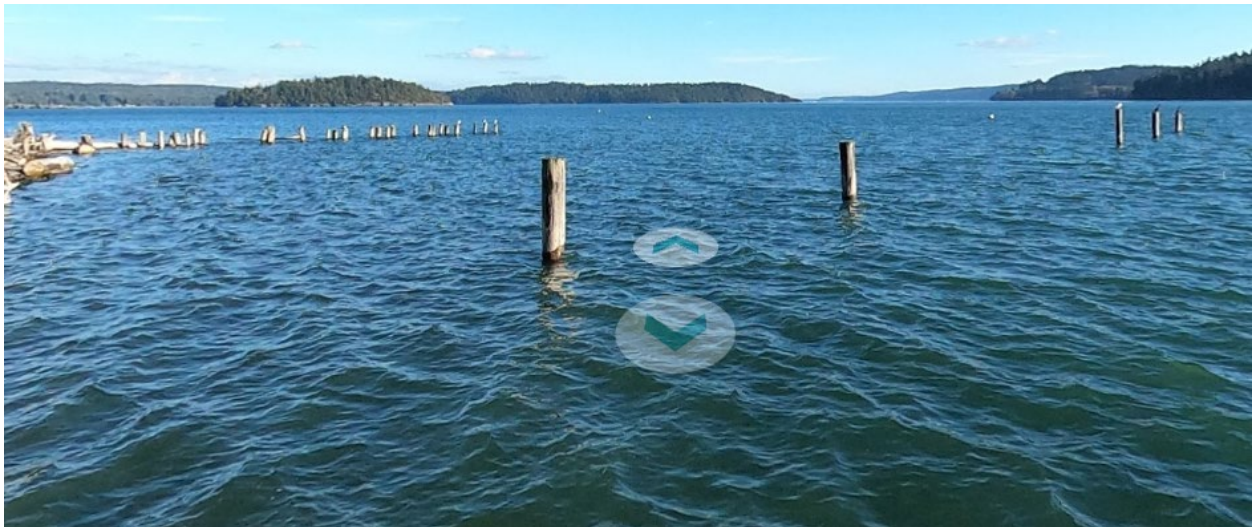
Figure 13. Derelict pilings in intertidal.

- Piling removal associated with point east of Lake Campbell Creek. Approximately 37 derelict pilings are in the intertidal area and are likely creosote pilings.

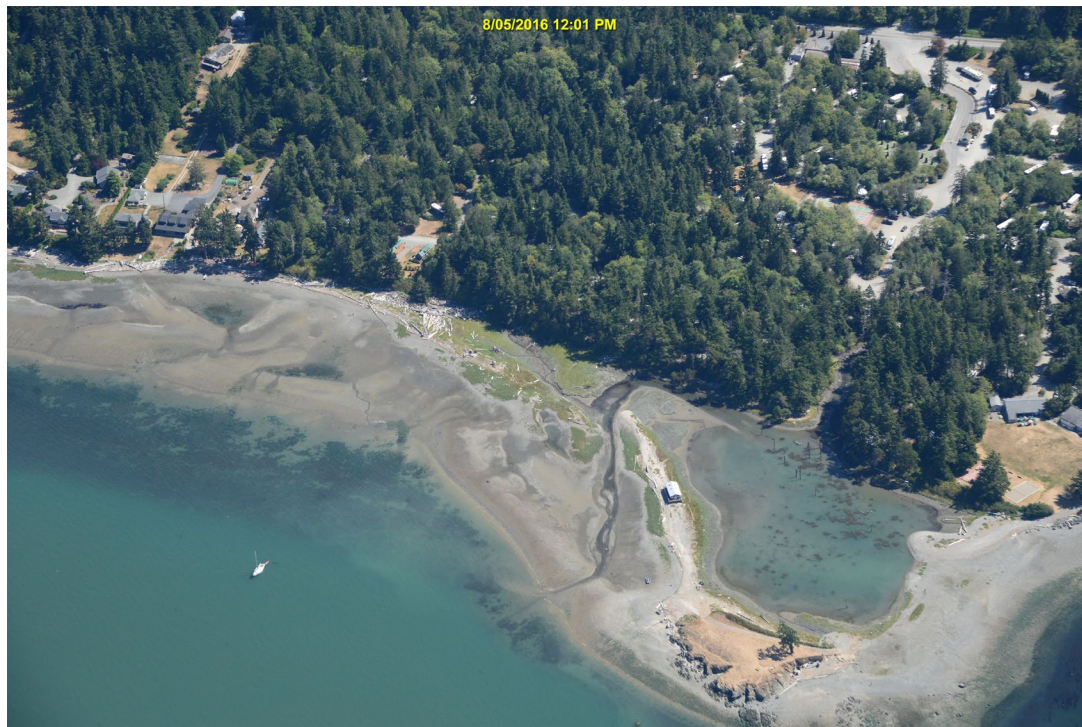
Figure 15. Swinomish Tribal Land Allotment associated with Lone Tree estuary wetland.

- Evaluate restoration potential for historic estuarine wetland associated with Snee Oosh beach.
- Map kelp resources

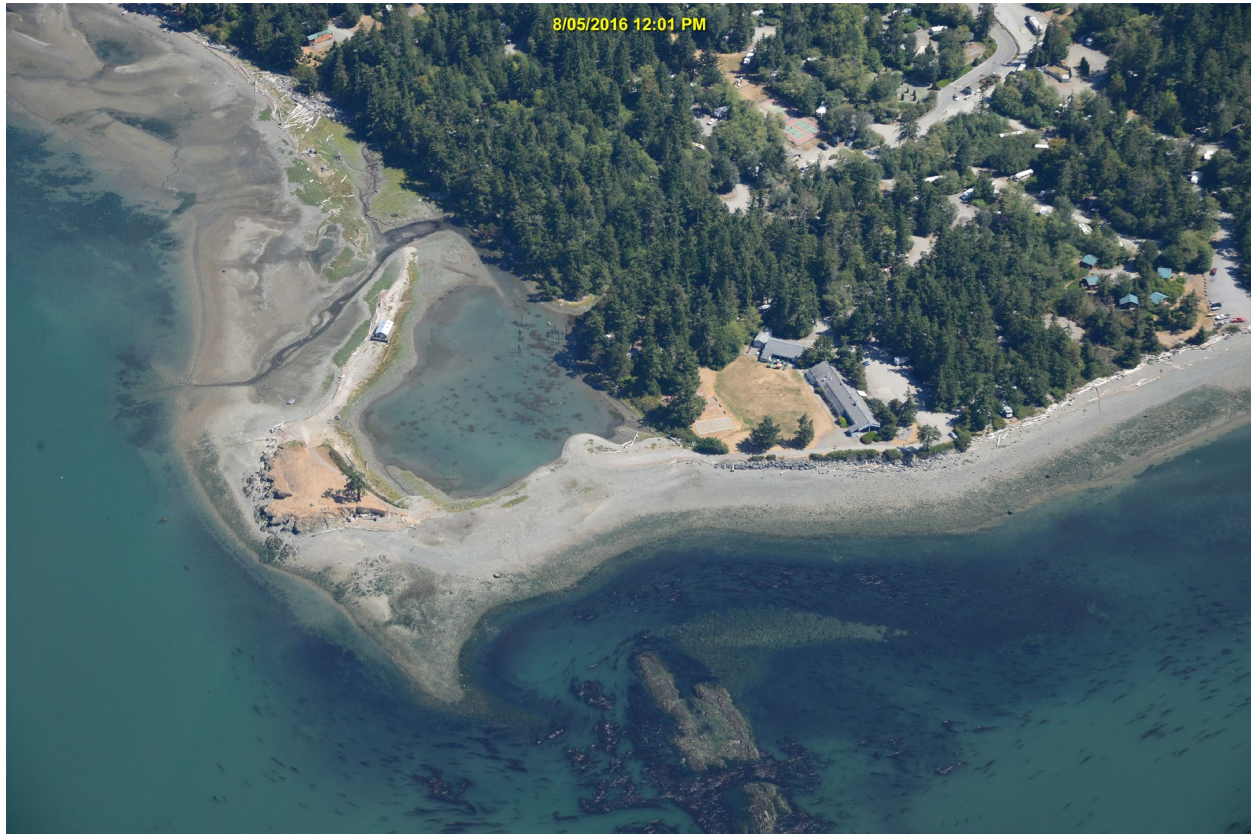
Figure 16. Kelp resources near Snee-Oosh Point.

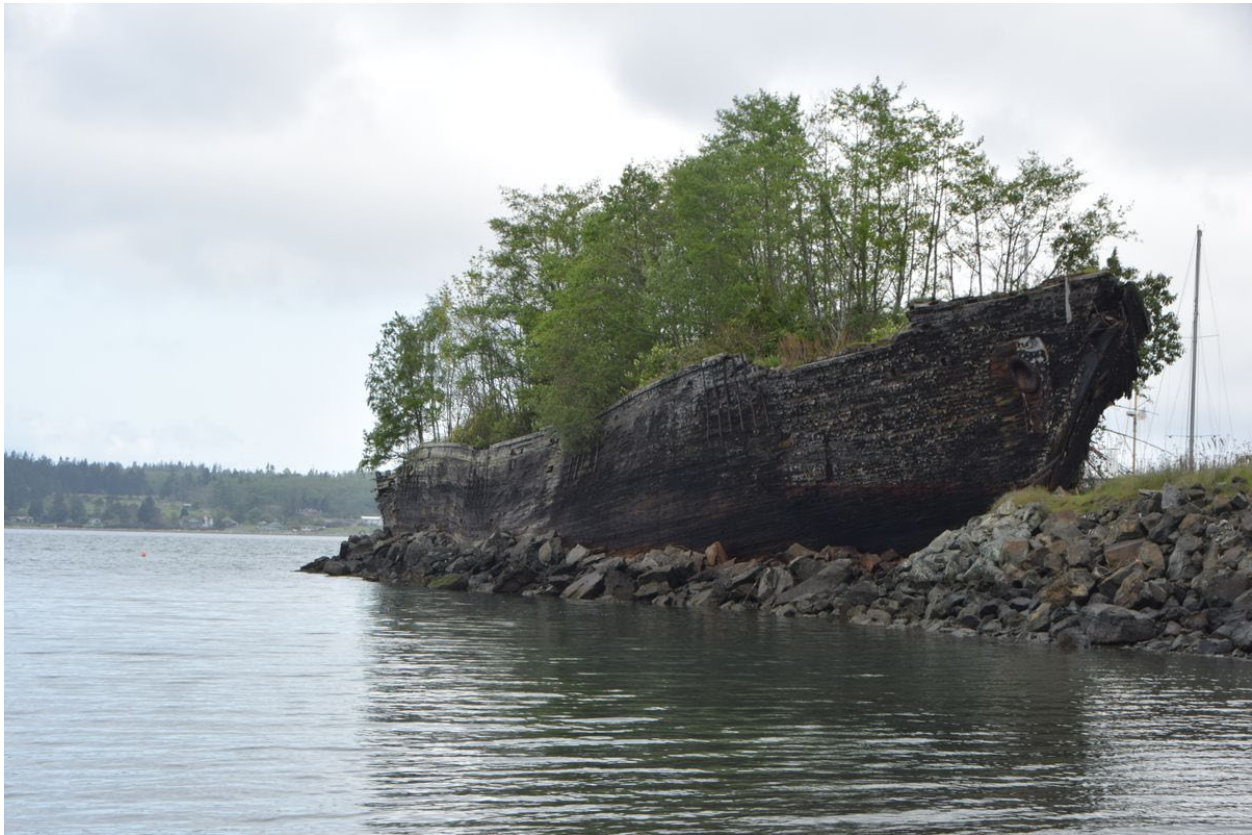
The La Merced is a historic schooner that was built in 1917 and scuttled in 1966 to serve as shoreline protection breakwater for Guemes Channel Marina and Stabbert Marine & Industrial. The La Merced has been listed on the national historic register of historic places, and is now overgrown with vegetation.

Figure 17. La Merced Historic Vessel used as portion of breakwater

The breakwater and related structures comprise a major interruption to sediment movement along the shoreline with large amounts of sediment and broader intertidal west of the breakwater and evidence of sediment starved shorelines and much narrower intertidal areas east of this site. Ecology and Stabbert Marine and Industrial signed an agreement to initiate clean-up at the site in 2024. Stabbert Marine has been working to redevelop the site since its acquisition and has disposed of several derelict vessels, abandoned vehicles, scrap metal and truckloads of soil that were contaminated with solvents and other historic maritime chemicals.

With relatively new ownership in place that has a vision for maintaining the site as a deepwater moorage facility, there may be opportunities to consider shoreline enhancements and a long-term restoration plan for this site that facilitates both ecological restoration and preserves maritime use at this site.

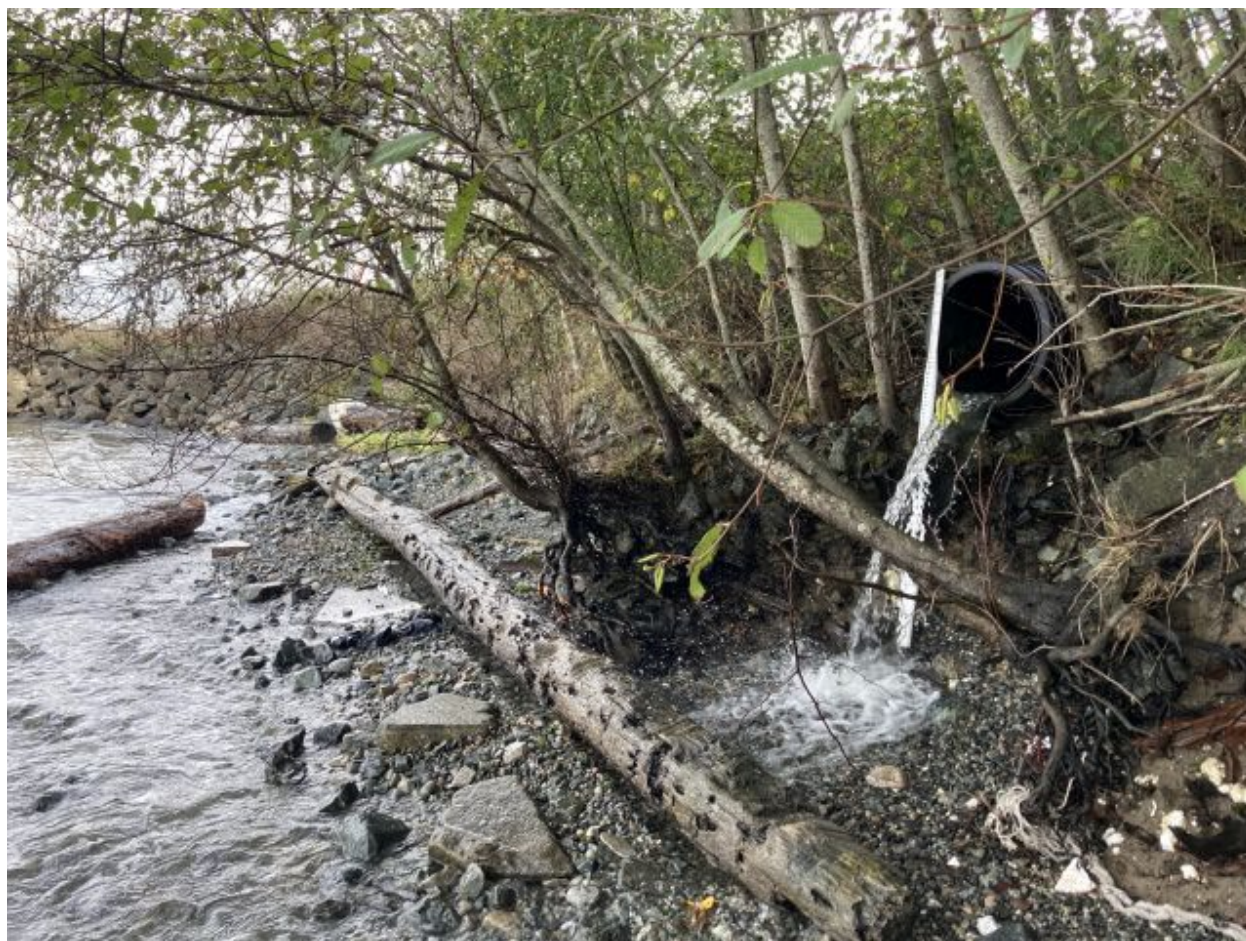
Small Cranberry Lake Creek is a stream that outlets to Guemes Channel. At its outlet, this creek is identified by WDFW as expected to support Coho, steelhead, sea run cutthroat and resident trout. The current stream outlet is above OHWM for the Salish Sea and discharges through an undersized, 24-inch diameter, round PVC pipe. The upstream channel is identified as having an average width of 5.19 meters (17 foot) width. This suggests that the stream may convey substantial flows at times and likely that the culvert creates upstream impoundment during high flow events.

Figure 18. Cranberry Lake Creek Outfall to shoreline.

- Coordination with the City of Anacortes and WSDOT to evaluate potential culvert or stream channel restoration opportunities.
- Mapping/monitoring eelgrass habitat along this section of shoreline
- Mapping/monitoring nearshore fish movement through this area
- Engaging La Merced maritime facility to identify restoration opportunities and opportunities to link habitats up- and down-drift of their facility.

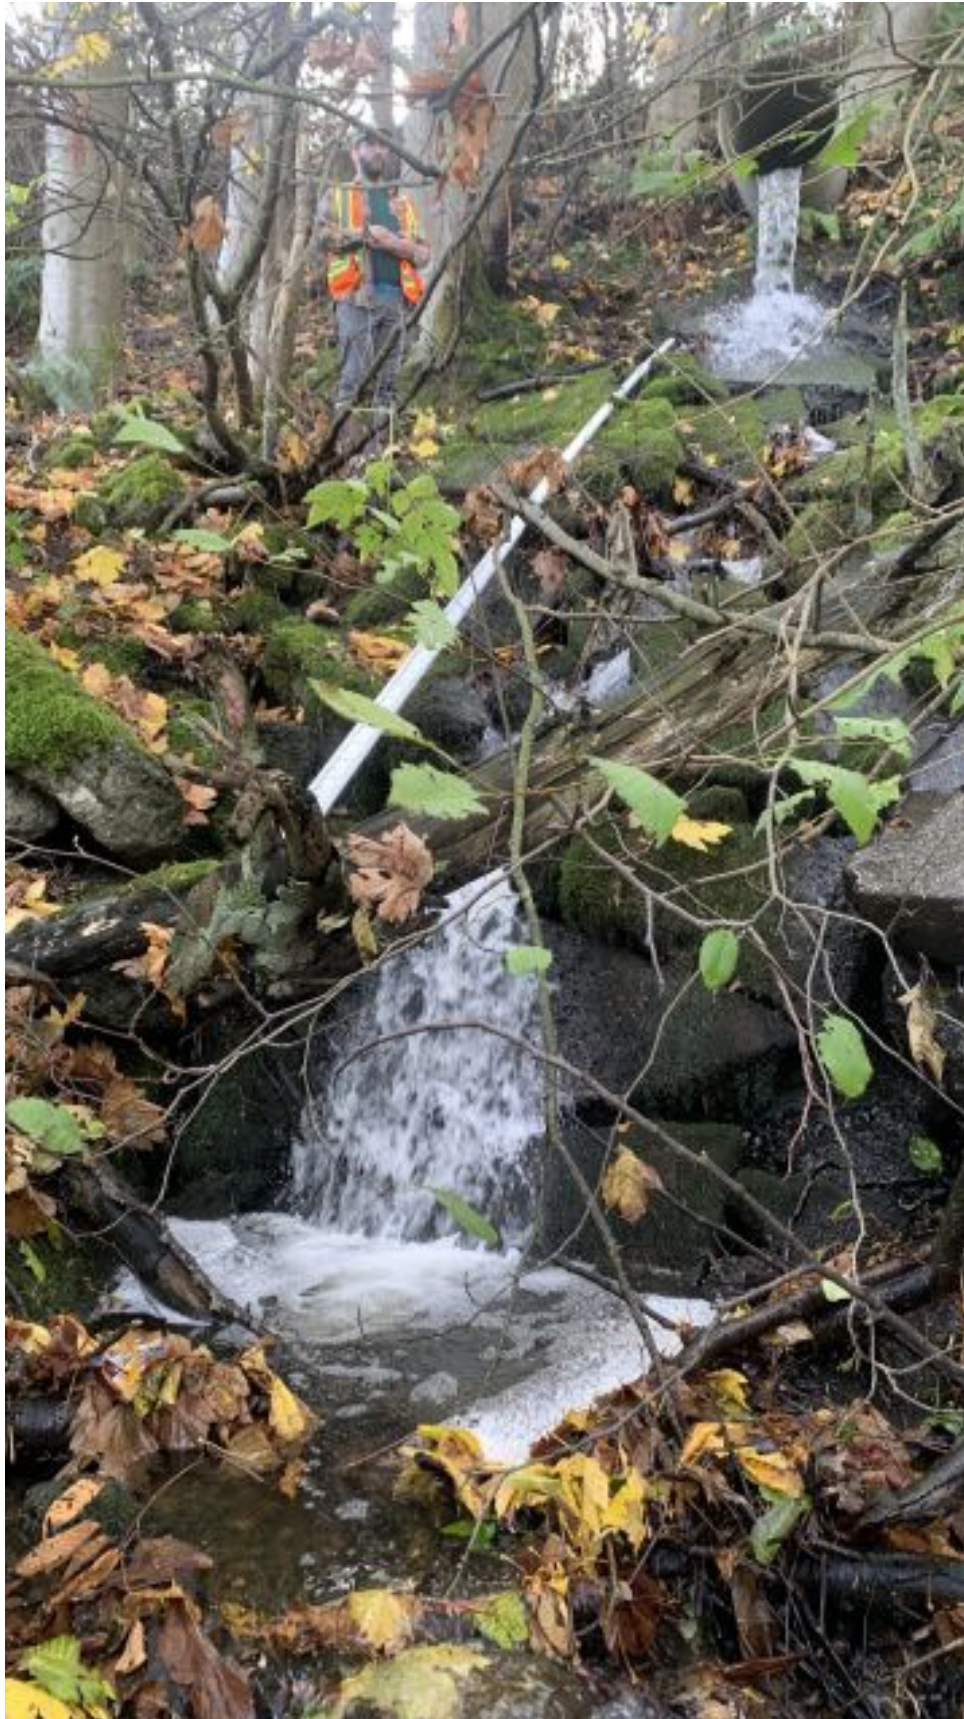
A short distance upstream, there are additional culverts under Oakes Avenue/SR 20. There are structures conveying the stream owned and managed by both WSDOT and City of Anacortes at this location. WSDOT determined that the relatively steep hillslope at and downstream of these culverts is a natural barrier at this point and that anadromous fish are unlikely to move upstream of these barriers. WDFW reports that there are approximately 2,382 m of lineal habitat upstream of this point including 717 m of spawning habitat and 20,179 square meters of rearing habitat.

Figure 19. Cranberry Creek outfall at roadway.
