# *Skagit County Creosote Inventory and Removal Project: Phase II*

**Skagit County Marine Resources Committee**

**Final Report -- June 2007**

PROJECT TITLE: Treated Wood Inventory and Removal

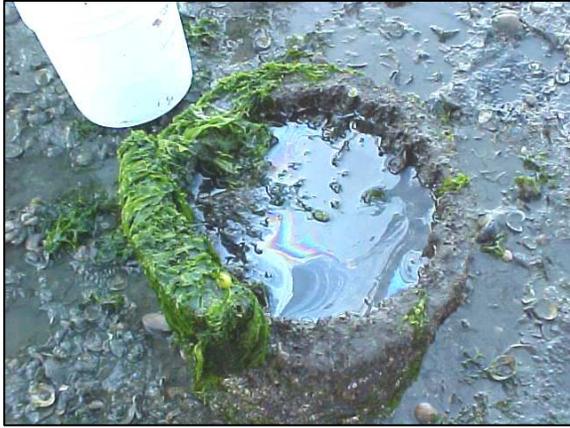
Figure 1. Creosote compounds leaching from an old piling in South Fidalgo Bay.

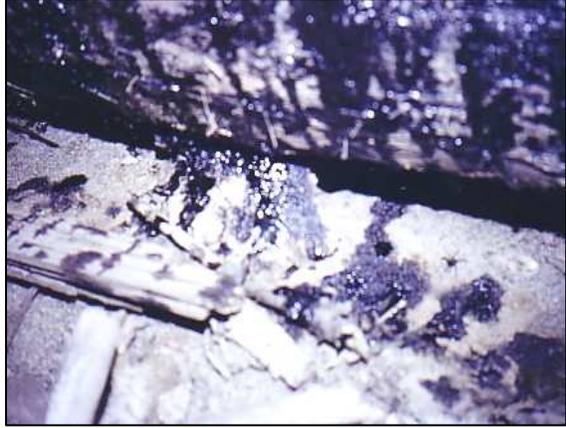
Figure 2. Creosote compounds leaching from a beached log (source: <http://www.pscap.net/id19.htm>).

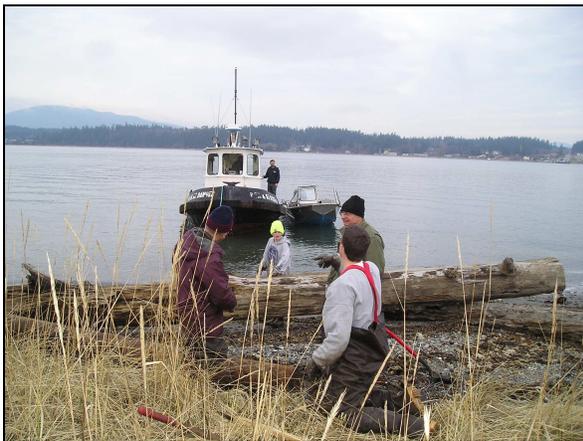
Figure 5. Pulling a treated log from beach.

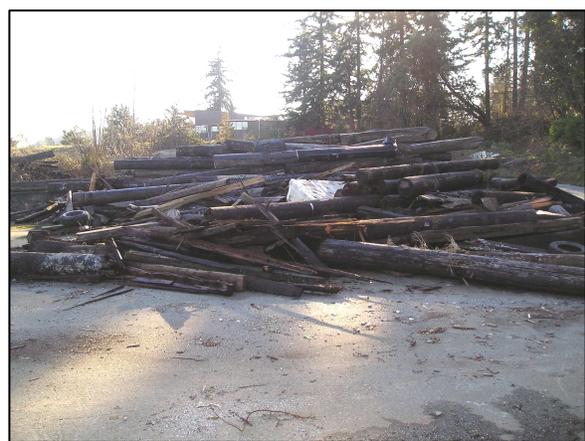
Figure 6. Part of the treated wood recovered from Skagit County beaches in 2006-07.

All recovered treated wood products and old tires were stored at Dunlap Towing's log yard until disposal (Fig. 6). Disposal was accomplished by loading the treated wood and tires into large cargo containers, which were then trucked to Bellingham. From Bellingham, the containers were transported by rail to the hazardous waste landfill site located at Roosevelt, WA.

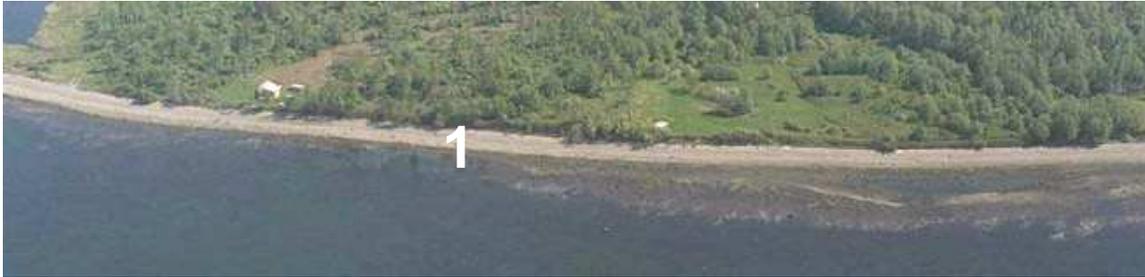
Northwest side Sinclair Island  
 Shoreline Aerial Photo #SKA0002  
 Surveyed by Ferdi Bussinger, August-October 2006

1. Creosote log, 6' x 12'' dia.

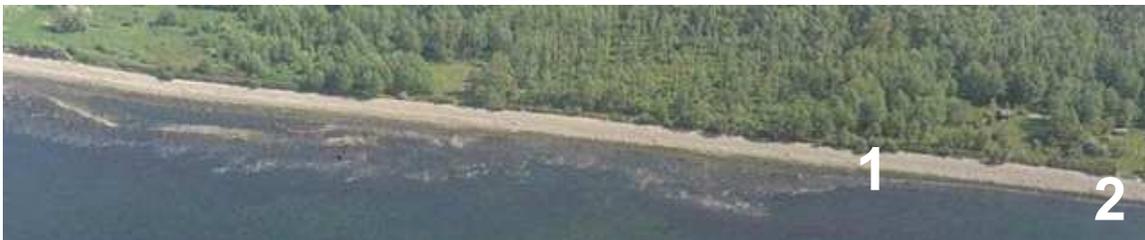
West side of Sinclair Island  
 Shoreline Aerial Photo #SKA0003  
 Surveyed by Ferdi Bussinger, August-October 2006

1. Creosote log, 3' x 16'' dia.
2. Creosote log, 5' x 12'' dia.

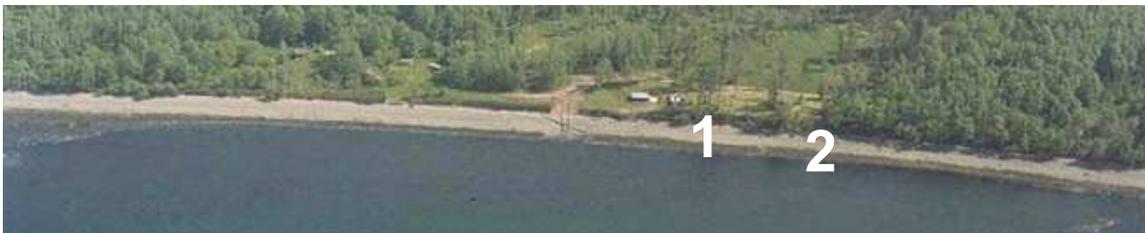
West side of Sinclair Island  
 Shoreline Aerial Photo #SKA0004  
 Surveyed by Ferdi Bussinger, August-October 2006

1. Creosote stub, 2' x 14'' dia.
2. Creosote stub, 3' x 10'' dia.

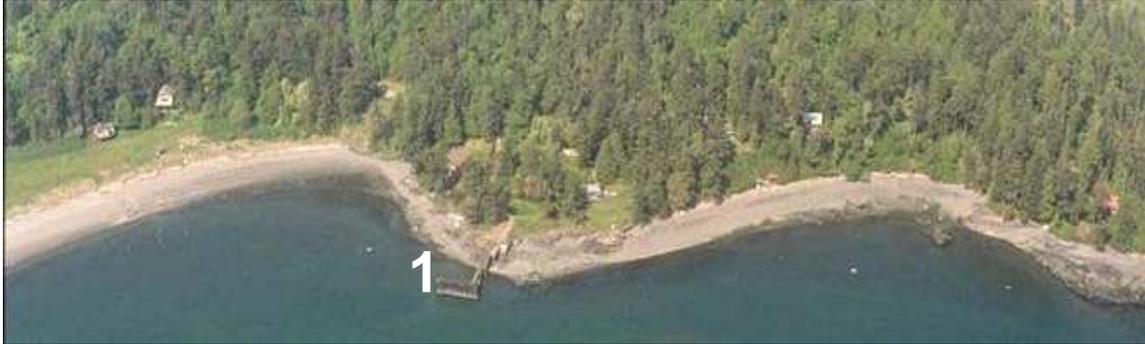
Southwest side of Sinclair Island  
Shoreline Aerial Photo #SKA0009  
Surveyed by Ferdi Bussinger, August-October 2006

1. Unknown number of creosote pilings (county dock)

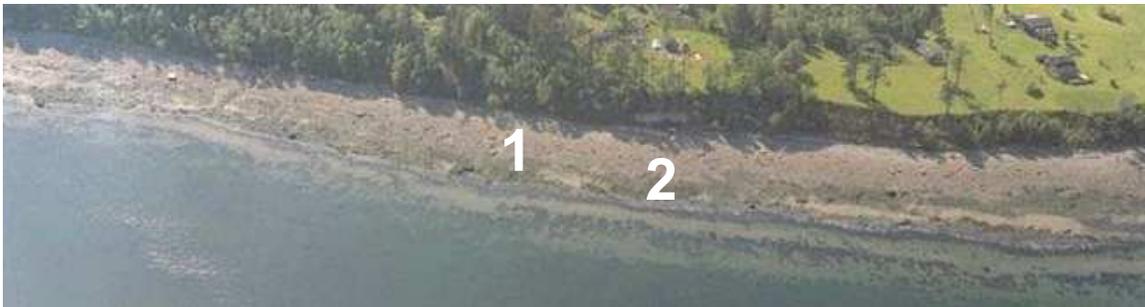
East side of Sinclair Island  
Shoreline Aerial Photo #SKA0021  
Surveyed by Ferdi Bussinger, August-October 2006

1. L-shaped section of timber, no size given
2. Creosote log 10' x 14" dia.

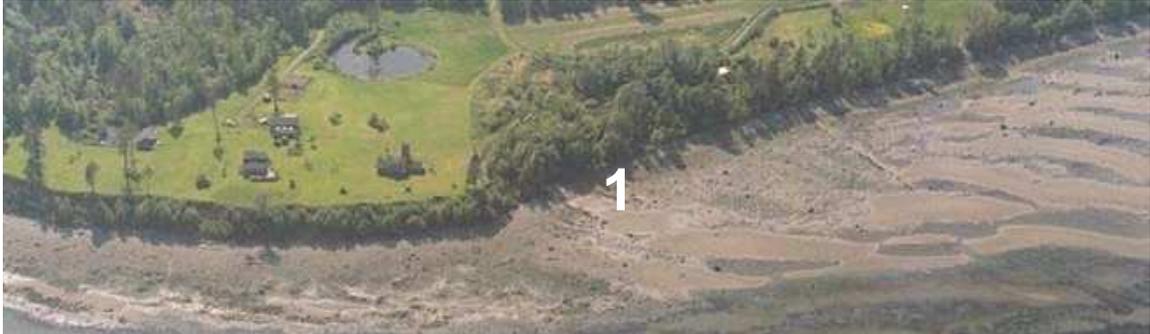
Northeast side of Sinclair Island  
Shoreline Aerial Photo #SKA0022  
Surveyed by Ferdi Bussinger, August-October 2006

1. Creosote stub, 3' x 15" dia.

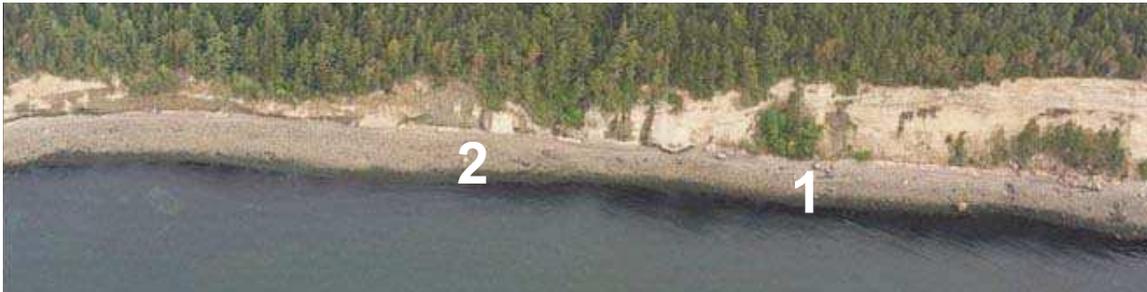
Shoreline Aerial Photo #SKA0153

1. Creosote timber, 48" x 16" x 8"
2. Creosote log, 72" x 7" dia.

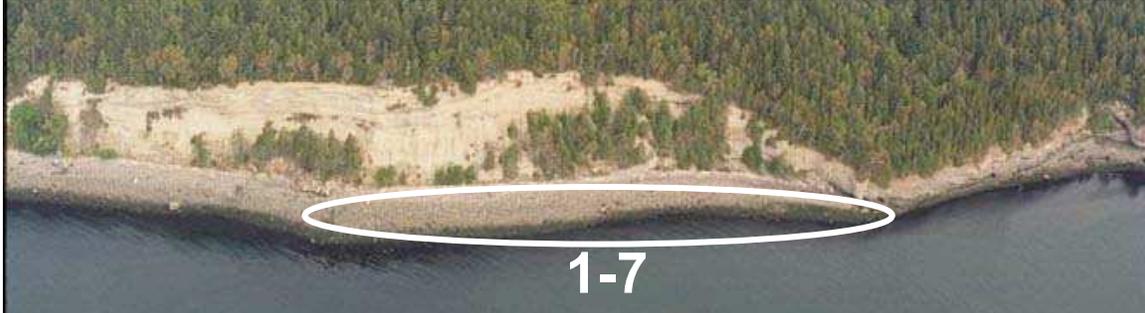
South Cypress Island  
Shoreline Aerial Photo #SKA0154  
Surveyed by Sean Hewitt, October 2006

1. Creosote timber, 30" x 16" x 5"
2. Creosote railroad tie, 50" x 9" x 9"
3. Creosote timber, 36" x 2" x 4"
4. Creosote timber 72" x 8" x 3"
5. Creosote timber 120" x 10" x 3"
6. Creosote railroad tie 60" x 9" x 9"
7. Creosote log 30" x 14" dia.

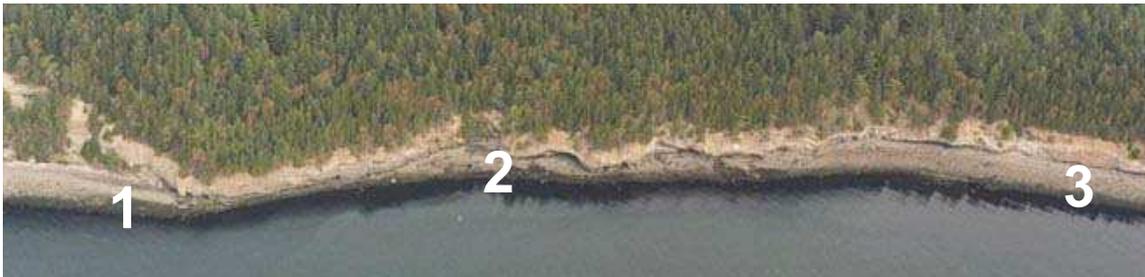
South Cypress Island  
Shoreline Aerial Photo #SKA0155  
Surveyed by Sean Hewitt, October 2006

1. Creosote log 60" x 10" dia.
2. Creosote log 60" x 14" dia.
3. Creosote log 240" x 12" dia.

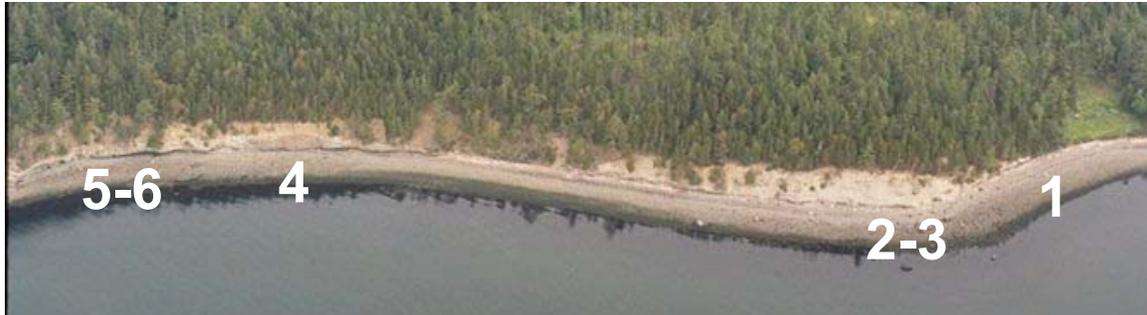
South Cypress Island  
 Shoreline Aerial Photo #SKA0156  
 Surveyed by Sean Hewitt, October 2006

1. Creosote timber 12" x 12" x 12"
2. Creosote timber 120" x 12" x 12"
3. Creosote timber 36" x 6" x 4"
4. Creosote timber 60" x 5" x 3"
5. Creosote timber 84" x 8" x 6"
6. Creosote and timber pieces 60" x 8" x 3"

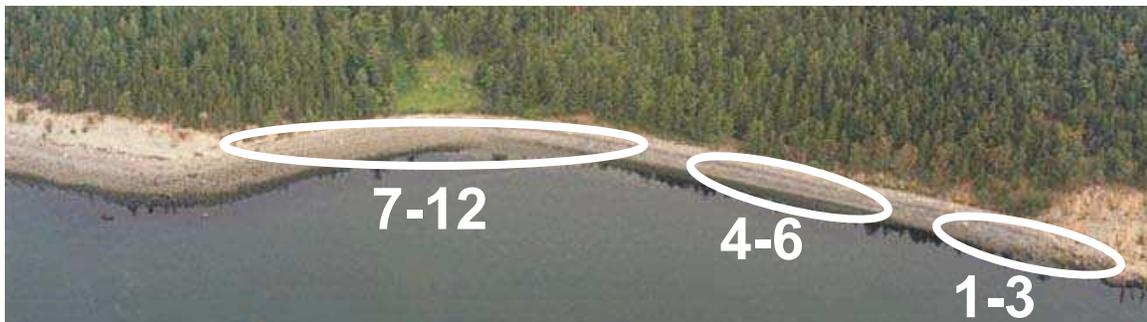
South Cypress Island  
 Shoreline Aerial Photo #SKA0157  
 Surveyed by Sean Hewitt, October 2006

1. Creosote timber 60" x 5" x 5"
2. Creosote timber 30" x 6" x 6"
3. Creosote log 120" x 12" dia.
4. Creosote timber 18" x 12" x 12"
5. Creosote timber 30" x 18" x 8"
6. Creosote railroad tie 24" x 9" x 9"
7. Creosote log 20" x 20" dia.
8. Treated timber 72" x 6" x 4"
9. Creosote timber 120" x 36" x 12"
10. Creosote timber 60" x 12" x 12"
11. Creosote timber 240" x 12" x 12"
12. Creosote log 48" x 16" dia.

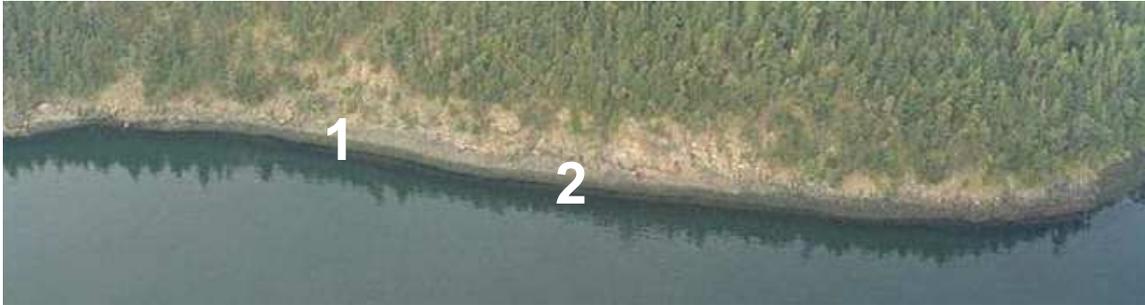
North of Cypress Head, Cypress Island  
Shoreline Aerial Photo #SKA0177  
Surveyed by Sean Hewitt, October 2006

1. Creosote log 54" x 6" dia.
2. Creosote timber 38" x 8" x 6"

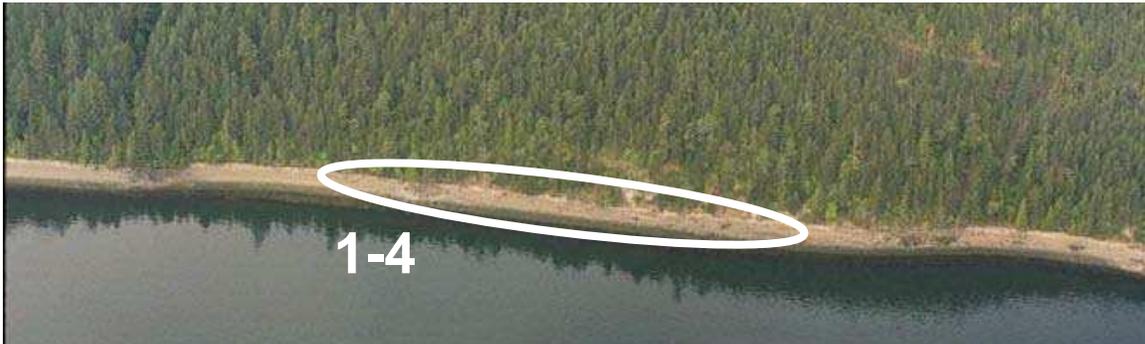
Between Cypress Head and Eagle Harbor, Cypress Island  
Shoreline Aerial Photo #SKA0180  
Surveyed by Sean Hewitt, October 2006

1. Creosote timber 18" x 8" x 6"
2. Creosote timber 30" x 6" x 4"
3. Treated timber 96" x 6" x 4"
4. Treated timber 50" x 4" x 4"

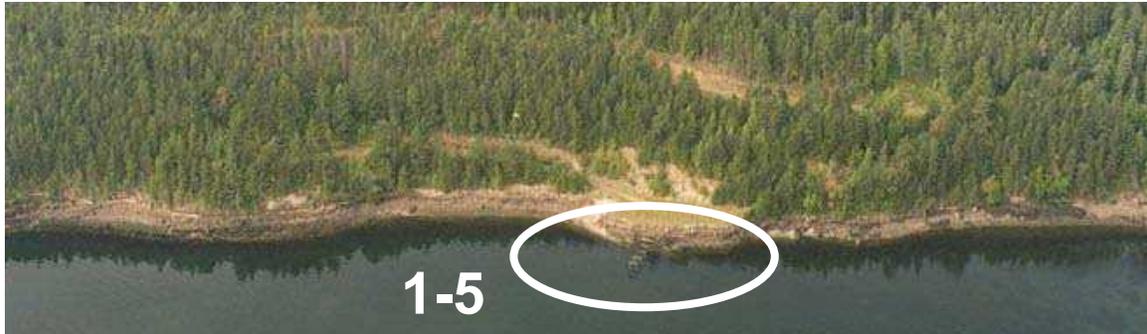
Just south of Eagle Harbor, Cypress Island  
Shoreline Aerial Photo #SKA0182  
Surveyed by Sean Hewitt, October 2006

1. 2 Creosote fixed pilings, each 480" x 10" dia.
2. Creosote log 560" x 10" dia.
3. Creosote timber 18" x 8" x 6"
4. Creosote timber 30" x 12" x 12"
5. Creosote log 60" x 10" dia.

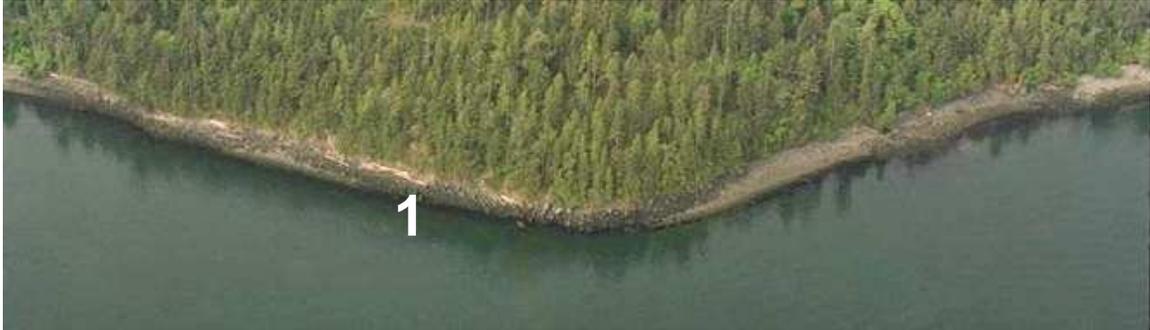
North of Eagle Harbor, Cypress Island  
Shoreline Aerial Photo #SKA0191  
Surveyed by Sean Hewitt, October 2006

1. Creosote log 168" x 11" dia.

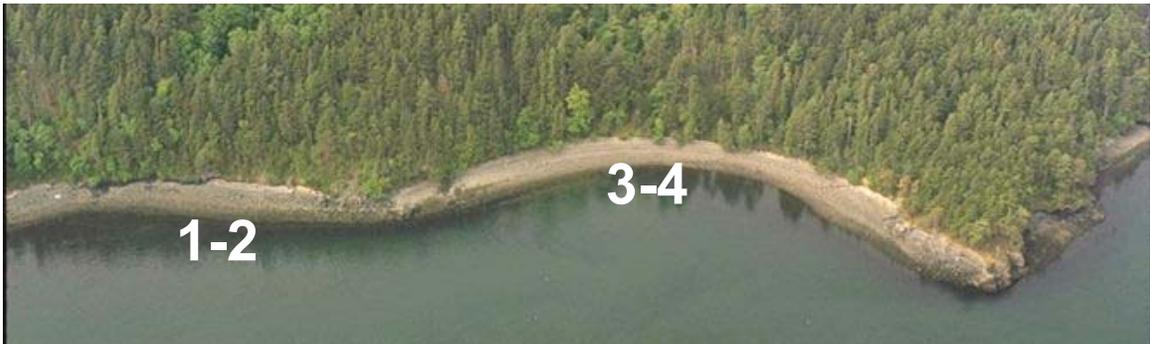
North of Eagle Harbor, Cypress Island  
Shoreline Aerial Photo #SKA0194  
Surveyed by Sean Hewitt, October 2006

1. Creosote timber 24" x 6" x 3"
2. Treated timber 12" x 6" x 6"
3. Creosote log 360" x 12" dia.
4. Creosote log 144" x 24" dia.

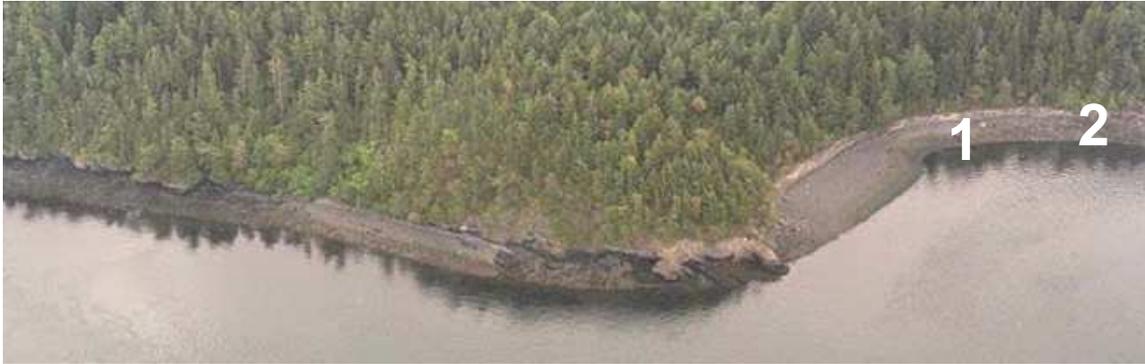
Northwest corner, Cypress Island  
Shoreline Aerial Photo #SKA0124  
Surveyed by Sean Hewitt, October 2006

1. Creosote timber 108" x 10" x 10"
2. Creosote log 264" x 11" dia.

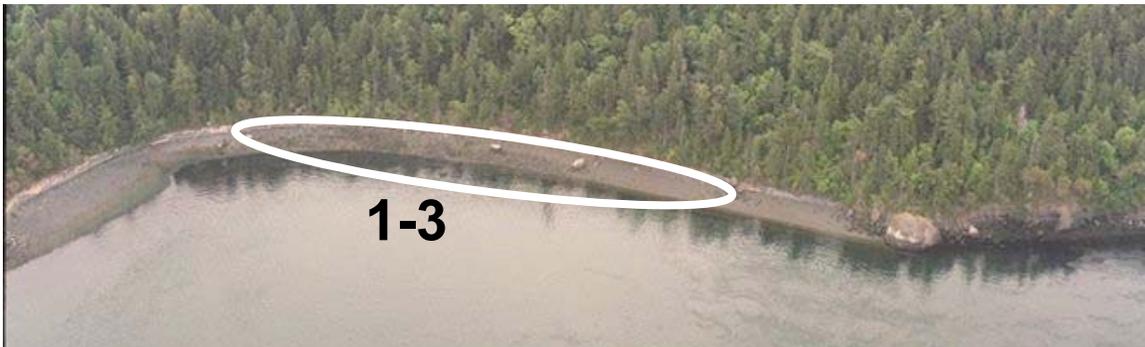
Northwest corner, Cypress Island  
Shoreline Aerial Photo #SKA0125  
Surveyed by Sean Hewitt, October 2006

1. Creosote log 72" x 20" dia.
2. Creosote log 60" x 14" dia.
3. Creosote log 40" x 12" dia.

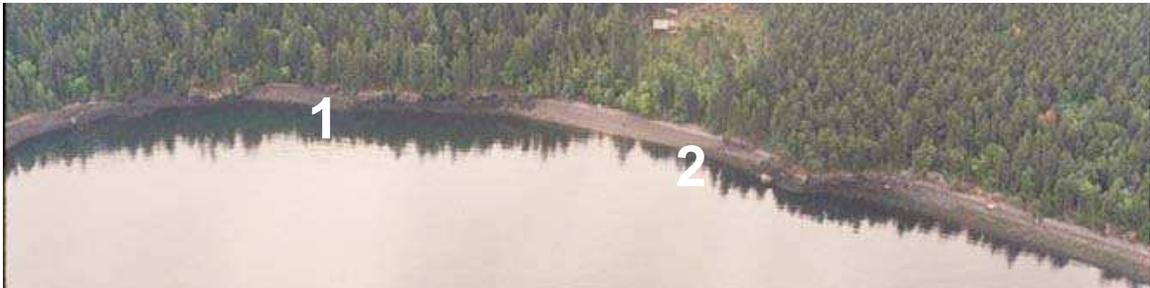
North of Tide Point, Cypress Island  
Shoreline Aerial Photo #SKA0131  
Surveyed by Sean Hewitt, October 2006

1. Creosote log 460" x 10" dia.
2. Creosote log 60" x 12" dia.

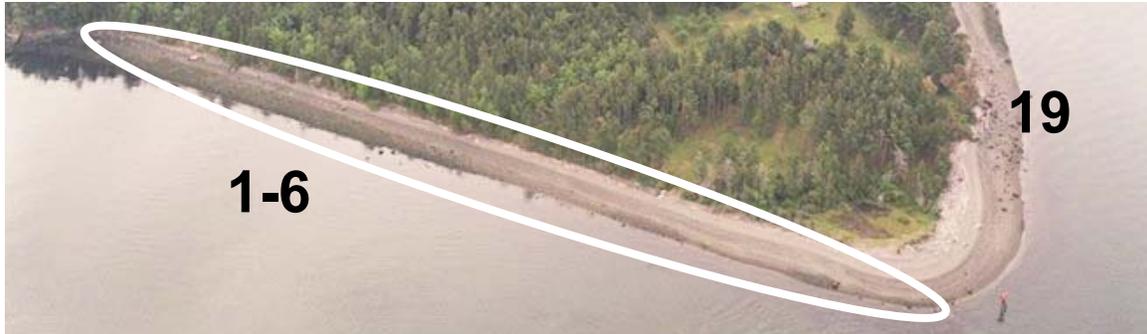
North side of Tide Point, Cypress Island  
Shoreline Aerial Photo #SKA0132  
Surveyed by Sean Hewitt, October 2006

1. Creosote log 48" x 11" dia.
2. Creosote log 72" x 10" dia.
3. Creosote log 204" x 14" dia.
4. Creosote log 36" x 11" dia.
5. Creosote timber 12" x 8" x 4"
6. Creosote log 84" x 14" dia.
7. Treated timber 54" x 6" x 6"
8. Treated timber 36" x 6" x 6"
9. Creosote timber 24" x 8" x 6"
10. Creosote log 24" x 12" dia.
11. Creosote timber 72" x 8" x 8"
12. Creosote timber 60" x 12" x 12"
13. Creosote timber 18" x 10" x 4"
14. Creosote timber 12" x 12" x 6"
15. Creosote timber 36" x 8" x 3"
16. Creosote log 24" x 10" dia.
17. Creosote timber 120" x 12" x 12"
18. Creosote timber 72" x 6" x 6"
19. Creosote timber 84" x 10" x 3"

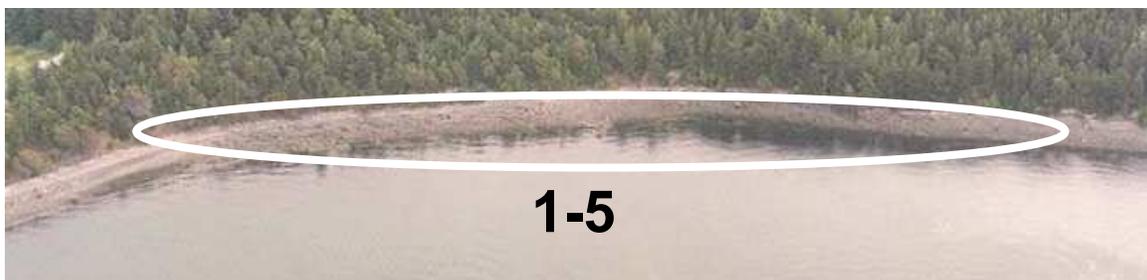
South side of Tide Point, Cypress Island  
Shoreline Aerial Photo #SKA0134  
Surveyed by Sean Hewitt, October 2006

1. Creosote timber 30" x 12" x 2"
2. Treated timber 36" x 12" x 2"
3. Treated timber 84" x 6" x 2"
4. Treated timber 96" x 4" x 2"
5. Treated timber 36" x 6" x 2"

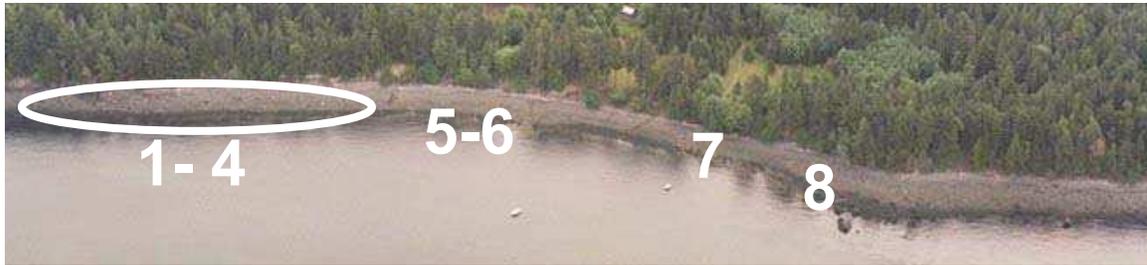
South of Tide Point, Cypress Island  
 Shoreline Aerial Photo #SKA0135  
 Surveyed by Sean Hewitt, October 2006

1. Treated timber 84" x 6" x 6"
2. Creosote timber 3" x 6" x 2"
3. Treated log 36" x 14" dia.
4. Creosote log 30" x 14" dia.
5. Creosote timber 6" x 3" x 2"
6. Creosote timber 72" x 6" x 4"
7. Creosote log 84" x 10" dia.
8. Creosote log 72" x 12" dia.

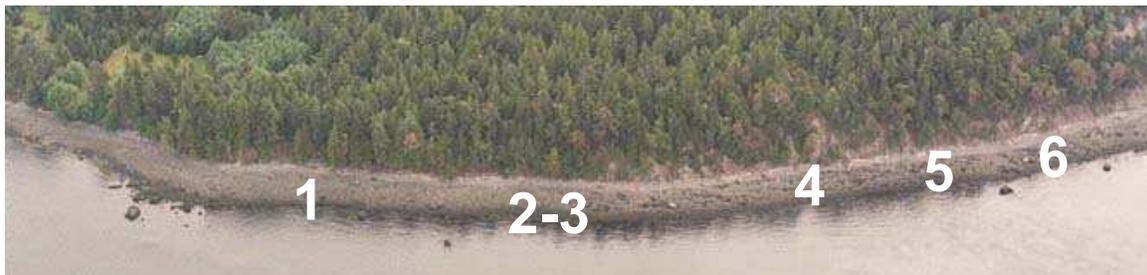
South of Tide Point, Cypress Island  
 Shoreline Aerial Photo #SKA0136  
 Surveyed by Sean Hewitt, October 2006

1. Treated log 30" x 20" dia.
2. Creosote timber 48" x 5" x 4"
3. Creosote log 60" x 12" dia.
4. Creosote timber 30" x 4" x 4"
5. Creosote log 30" x 14" dia
6. Creosote log 96" x 12" dia.

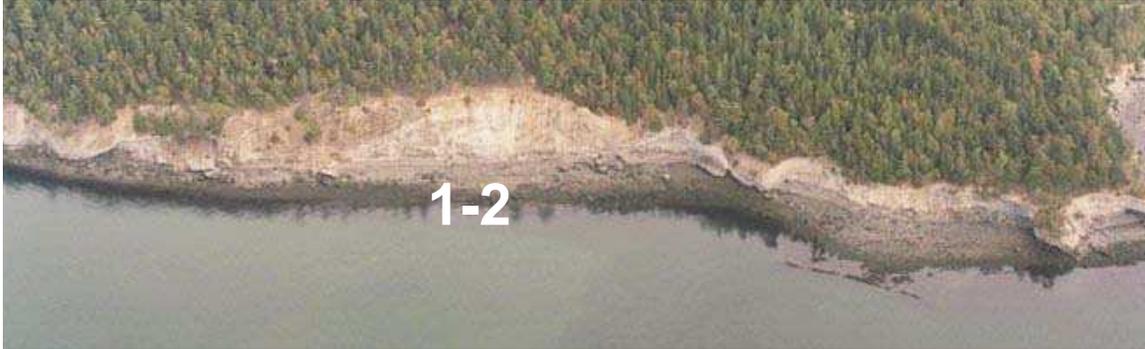
North of Strawberry Bay, Cypress Island  
Shoreline Aerial Photo #SKA0139  
Surveyed by Sean Hewitt, October 2006

1. Creosote log 12" x 12" dia.
2. Creosote log 72" x 9" dia.

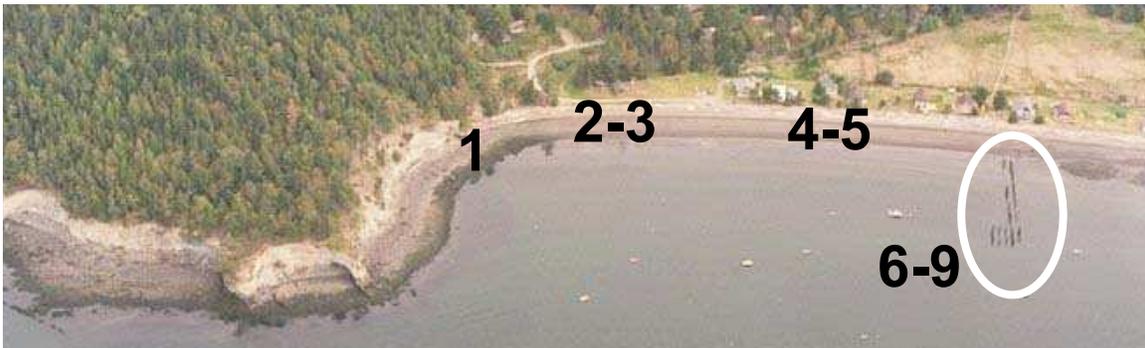
Strawberry Bay, Cypress Island  
Shoreline Aerial Photo #SKA0140  
Surveyed by Sean Hewitt, October 2006

1. Creosote timber 24" x 12" x 12"
2. Creosote log 48" x 12" dia.
3. Creosote log 240" x 12" dia.
4. Creosote log 60" x 20" dia.
5. Creosote log 24" x 16" dia.
6. Creosote fixed piling 168" x 10" dia
7. Creosote fixed piling 168" x 10" dia.
8. 44 Creosote fixed pilings, each 168" x 10" dia.
9. Creosote fixed piling 168" x 10" dia.

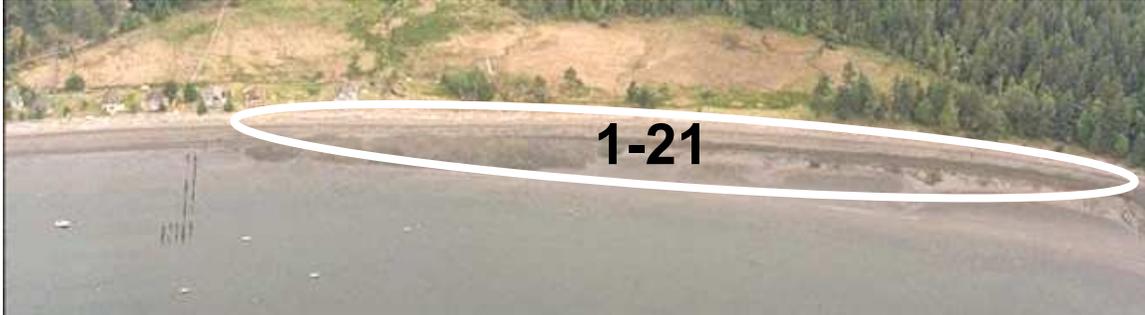
Strawberry Bay, Cypress Island  
Shoreline Aerial Photo #SKA0141  
Surveyed by Sean Hewitt, October 2006

1. Creosote log 72" x 9" dia.
2. Creosote timber 36" x 4" x 4"
3. Creosote log 72" x 10" dia.
4. Creosote log 48" x 14" dia.
5. Creosote log 48" x 7" dia.
6. Creosote timber 60" x 12" x 12"
7. Creosote log 144" x 12" dia.
8. Creosote log 60" x 18" dia.
9. Creosote log 72" x 10" dia.
10. Creosote log 108" x 14" dia.
11. Creosote log 40" x 14" dia.
12. Creosote log 48" x 10" dia.
13. Creosote log 60" x 10" dia.
14. Creosote log 120" x 14" dia.
15. Creosote timber 48" x 9" x 9"
16. Creosote timber 36" x 10" x 3"
17. Creosote timber 144" x 10" x 3"
18. Creosote timber 36" x 10" x 6"
19. Creosote log 12" x 10" dia.
20. Treated timber 72" x 8" x 8"
21. Creosote timber 18" x 12" x 4"
22. Treated timber 24" x 6" x 4"

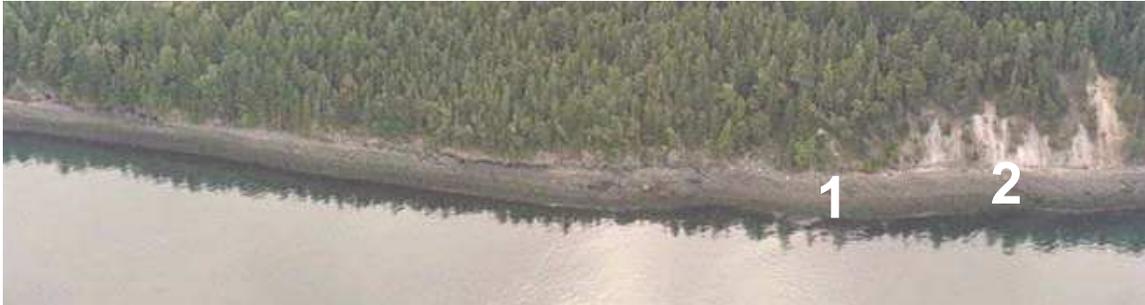
South of Strawberry Bay, Cypress Island  
Shoreline Aerial Photo #SKA0145  
Surveyed by Sean Hewitt, October 2006

1. Creosote timber 48" x 4" x 4"
2. Creosote log 18" x 12" dia.

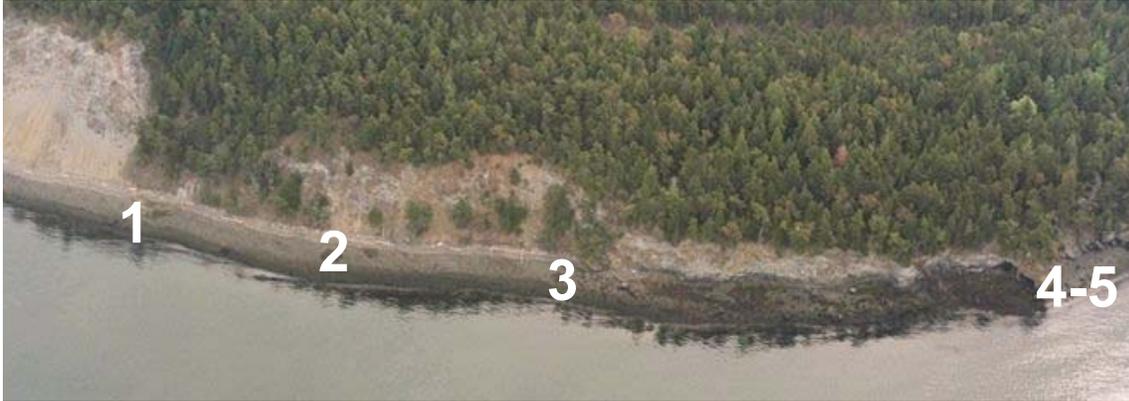
Southwest side, Cypress Island  
Shoreline Aerial Photo #SKA0148  
Surveyed by Sean Hewitt, October 2006

1. Creosote railroad tie 30" x 9" x 9"
2. Treated timber 144" 10" x 2"
3. Creosote log 84" x 9" dia.
4. Creosote timber 72" x 14" x 14"
5. Creosote timber 30" x 6" x 2"

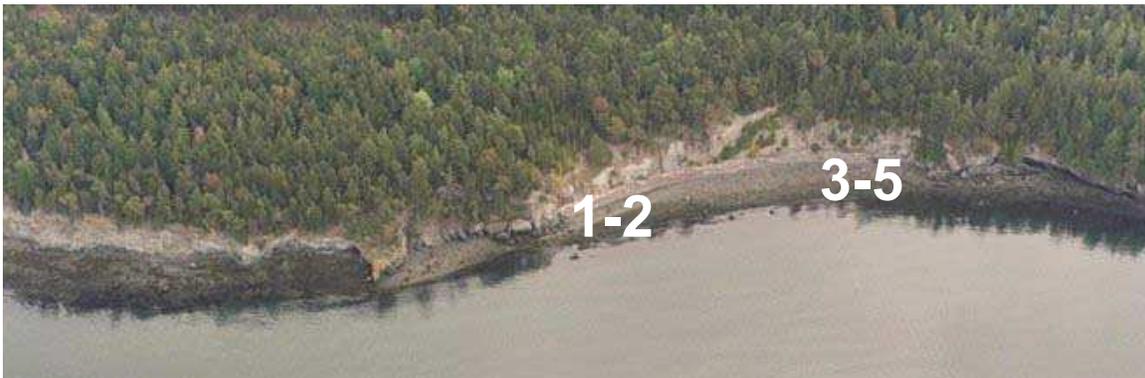
Southwest side, just north of Reef Point, Cypress Island  
Shoreline Aerial Photo #SKA0149  
Surveyed by Sean Hewitt, October 2006

1. Treated timber 180" x 8" x 6"
2. Treated timber 48" x 6" x 1"
3. Creosote timber 24" x 8" x 4"
4. Creosote log 20" x 14" dia.

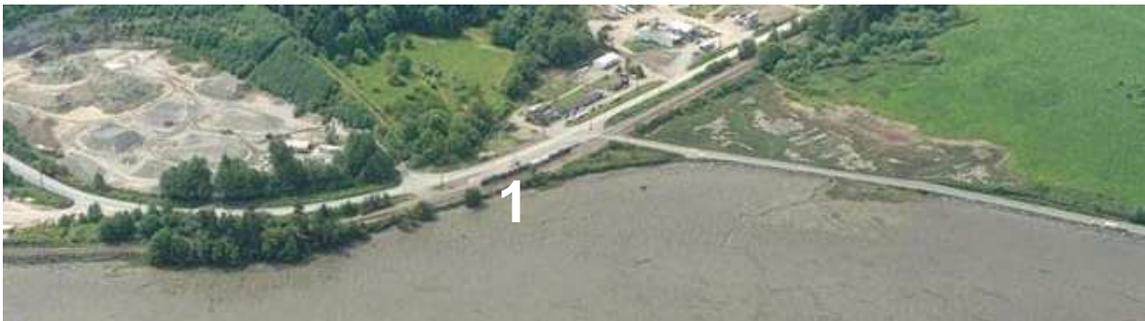
Along Railroad Tracks north of Swinomish Casino  
Shoreline Aerial Photo #SKA0351  
Surveyed by Paul Dinnel by kayak, September 2006

1. Creosote fixed post 48" x 2" dia.
2. Creosote railroad tie piece 36" x 2" x 4"
3. Creosote railroad tie piece 36" x 2" x 6"
4. Creosote fixed post 48" x 12" dia.
5. Creosote railroad tie piece 48" x 8" x 10"
6. Creosote fixed post 48" x 12" dia.
7. Creosote railroad tie piece 36" x 8" x 10"
8. Creosote railroad tie piece 24" x 8" x 10"
9. Creosote railroad tie piece 48" x 8" x 10"
10. Creosote railroad tie piece 36" x 4" x 6"
11. Creosote railroad tie piece 36" x 4" x 6"
12. Creosote fixed post 60" x 12" dia.
13. Creosote fixed post 48" x 12" dia.
14. Creosote log 48" x 12" dia.
15. Creosote fixed post 36" x 12" dia.
16. Creosote log 12" x 12" dia.
17. About 40 pieces of cast off railroad tie pieces along track (average ~ 36" x 4" x 8")

Noted also ~ 25 additional pieces of cast off railroad tie pieces in area 1-15, each averaging ~ 36" x 4" x 6" in size.

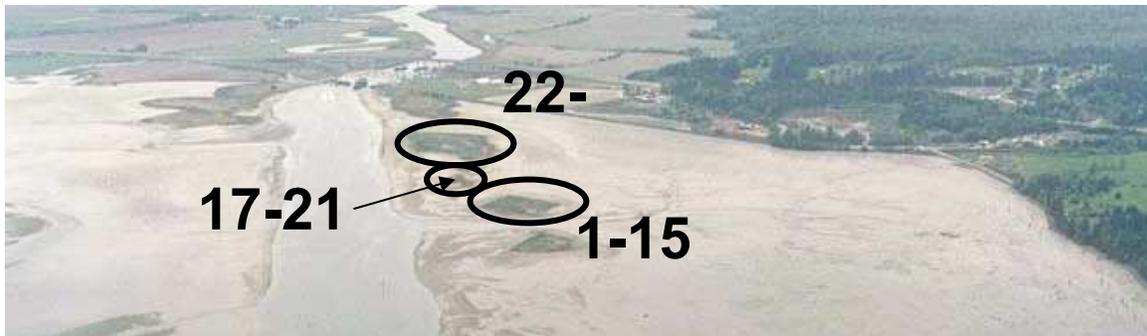
1. Creosote log 72" x 12" dia.
2. Creosote log 48" x 12" dia.
3. Creosote log 48" x 12" dia.
4. Creosote log 72" x 12" dia.
5. Creosote log 24" x 14" dia.
6. Creosote log 24" x 14" dia.
7. Creosote log 12" x 12" dia.
8. Creosote log 48" x 12" dia.
9. Creosote log 24" x 12" dia.
10. Treated timber 48" x 6" x 2"
11. Creosote log 12" x 12" dia.
12. Creosote timber 48" x 12" x 16"
13. Creosote log 72" x 10" dia.

14. Creosote timber 72" x 12" x 12"
15. Creosote timber 60" x 8" x 12"
16. (No number 16)
17. Creosote timber 36" x 12" x 12"
18. Creosote log 24" x 12" dia.

19. Treated timber 4" x 4" x 4"
20. Creosote log 84" x 14" dia.
21. Creosote log 360" x 12" dia.
22. Treated timber 6" x 4" x 8"
23. Creosote timber 24" x 6" x 8"

24. Creosote log 60" x 12" dia.
25. Creosote log 36" x 16" dia.
26. Creosote timber 240" x 4" x 8"
27. Creosote timber 12" x 2" x 8"
28. Creosote log 36" x 14" dia.

29. Creosote log 120" x 8" dia.
30. Treated timber 12" x 4" x 8"
31. Creosote log 48" x 10" dia.
32. Creosote log 48" x 6" dia.
33. Creosote log 36" x 12" dia.

34. Creosote fixed derelict piling 48" x 10" dia.
35. Creosote fixed derelict piling 48" x 10" dia.
36. Creosote log 72" x 18" dia.
37. Creosote log 288" x 16" dia.

38. Creosote log 36" x 26" dia.
39. Creosote log 96" x 12" dia.
40. Treated timber 8" x 2" x 12"
41. Creosote timber 24" x 4" x 12"
42. Creosote timber 12" x 8" x 12"

43. Creosote timber 18" x \*' x 12"
44. Creosote log 12" x 10" dia.
45. Creosote log 48" x 16" dia.
46. Creosote log 12" x 14" dia.
47. Creosote log 36" x 14" dia.

48. Creosote log 60" x 12" dia.
49. Creosote timber 36" x 4" x 12"
50. Creosote log 72" x 14" dia.
51. Creosote log 12" x 12" dia.
52. Creosote timber 72" x 4" x 12"

53. Creosote timber 86" x 4" x 12"
54. Creosote log 72" x 12" dia.
55. Creosote log 6" x 14" dia.
56. Creosote timber 48" x 6" x 16"
57. Creosote log 12" x 12" dia.

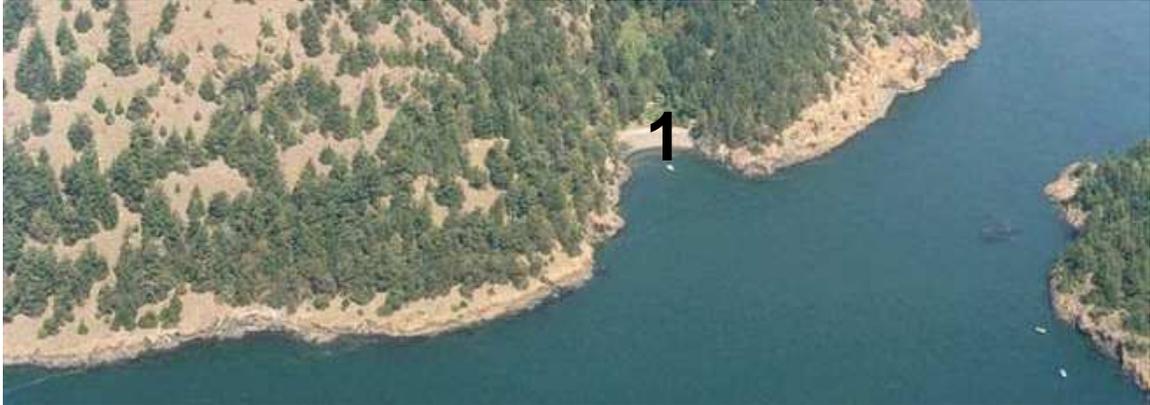
Shoreline Aerial Photo #SKA0684

1. Treated timber 60" x 4" x 8"

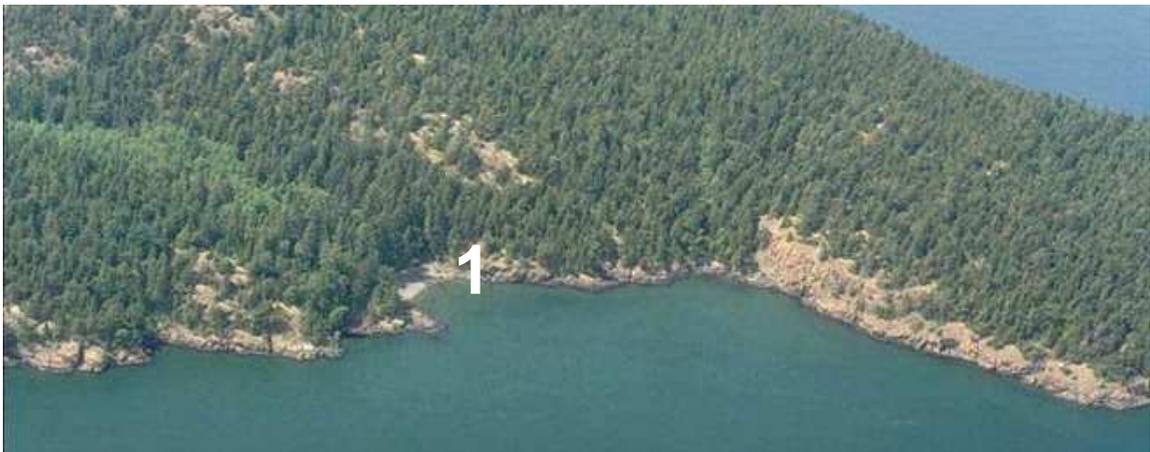
Shoreline Aerial Photo #SKA0682

No treated wood

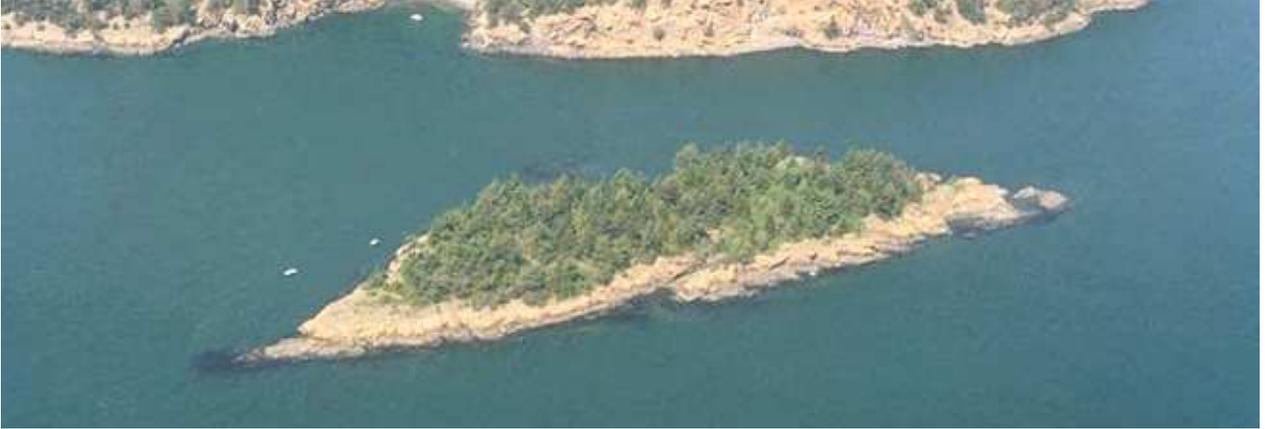
Shoreline Aerial Photo #SKA0693

1. Creosote timber 180'' x 10'' x 10''

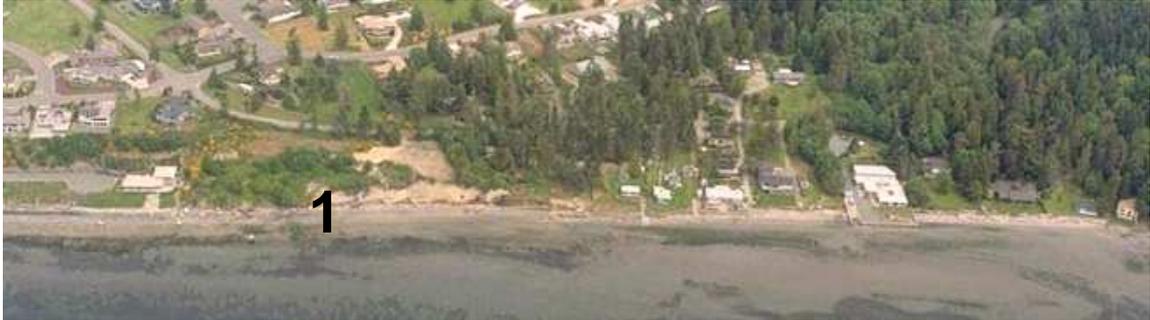
Northeast corner of Burrows Bay  
Shoreline Aerial Photo #SKA0441  
Surveyed by Paul Dinnel, October 2006

1. Creosote timber 180" x 8" x 10"
2. Creosote timber 72" x 6" x 8"

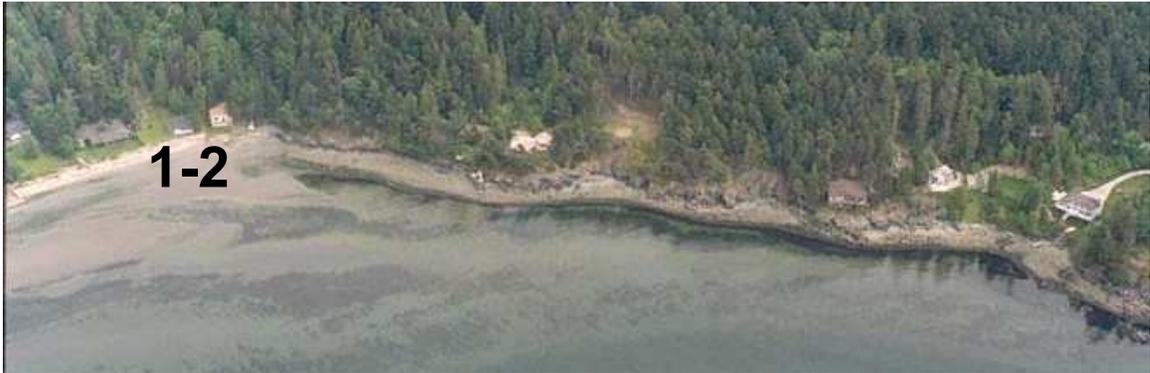
Alexander Beach, east side of Burrows Bay  
Shoreline Aerial Photo #SKA0444  
Surveyed by Paul Dinnel, October 2006

1. Creosote timber 72" x 10" x 10"
2. Creosote fixed piling on beach, in use, 48" x 10" dia.
3. Creosote fixed piling on beach, in use, 48" x 12" dia.
4. Creosote timber 96" x 10" x 10"

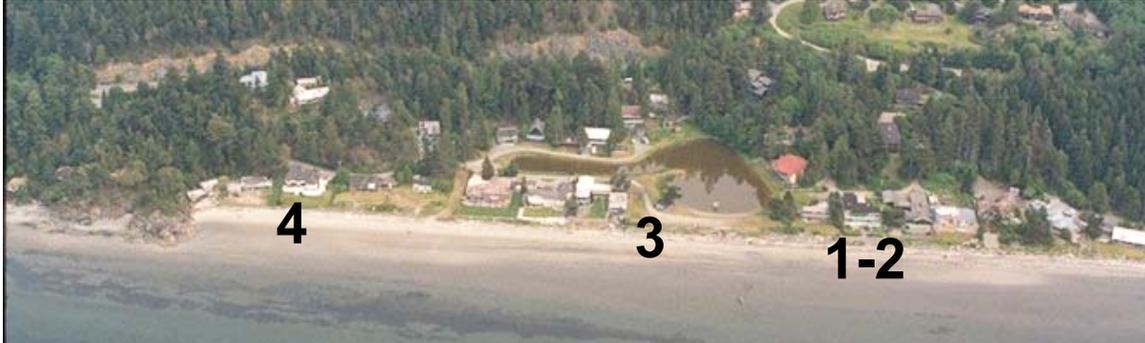
Alexander Beach, east side of Burrows Bay  
Shoreline Aerial Photo #SKA0445  
Surveyed by Paul Dinnel, October 2006

1. Creosote log 10" x 12" dia.
2. Creosote timber 36" x 4" x 6"
3. Creosote log 18" x 16" dia.
4. Creosote log 300" x 14" dia.
5. Creosote timber 36" x 12" x 12"
6. Creosote log 180" x 12" dia.

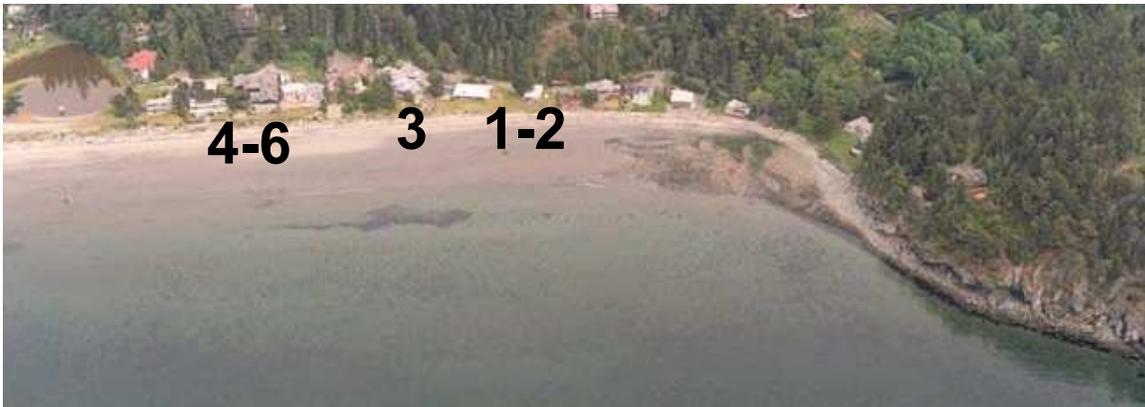
East side of Burrows Bay  
Shoreline Aerial Photo #SKA0449  
Surveyed by Paul Dinnel, October 2006

1. Treated timber 24" x 4" x 10"
2. Creosote timber 24" x 4" x 6"
3. Treated timber 12" x 4" x 8"
4. Creosote log 216" x 16" dia.
5. Creosote log 336" x 16" dia. (nasty!)

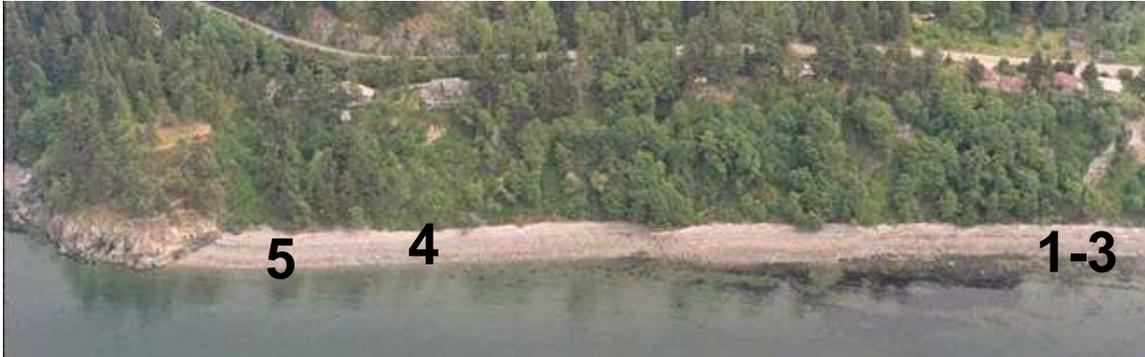
East side of Burrows Bay  
Shoreline Aerial Photo #SKA0450  
Surveyed by Paul Dinnel, October 2006

1. Creosote timber 96" x 10" x 10"

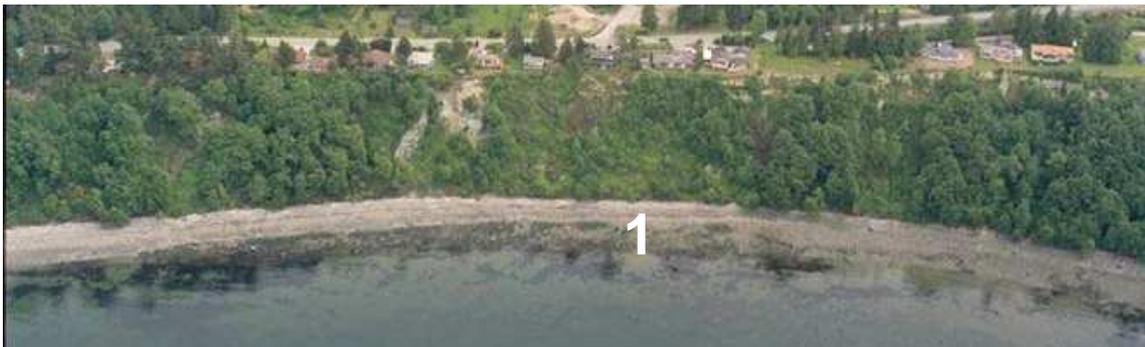
Langley Bay, southeast side of Burrows Bay  
Shoreline Aerial Photo #SKA0454  
Surveyed by Paul Dinnel, October 2006

1. Treated timber 12" x 6" x 6"

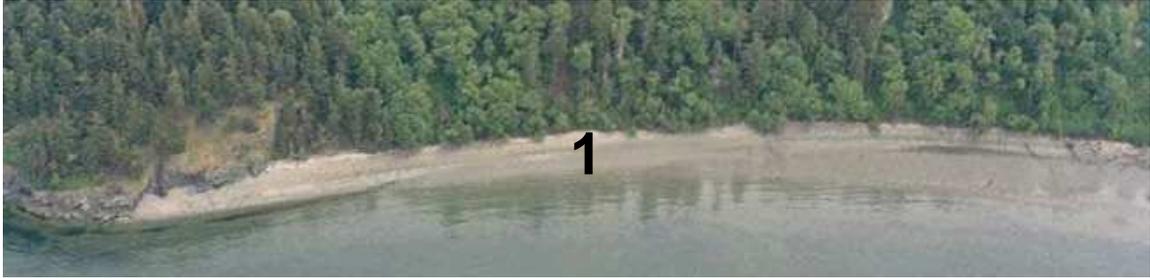
Langley Bay, southeast side of Burrows Bay  
Shoreline Aerial Photo #SKA0455  
Surveyed by Paul Dinnel, October 2006

1. Creosote timber 120" x 6" x 10"

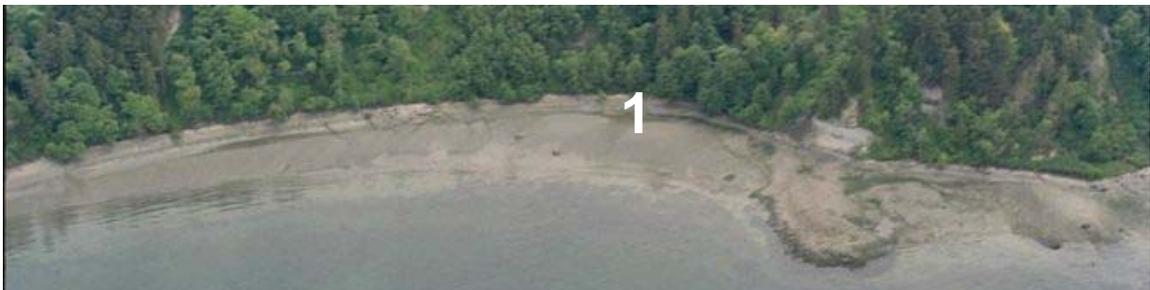
Langley Bay, southeast side of Burrows Bay  
Shoreline Aerial Photo #SKA0456  
Surveyed by Paul Dinnel, October 2006

1. Creosote timber 180" x 12" x 12"

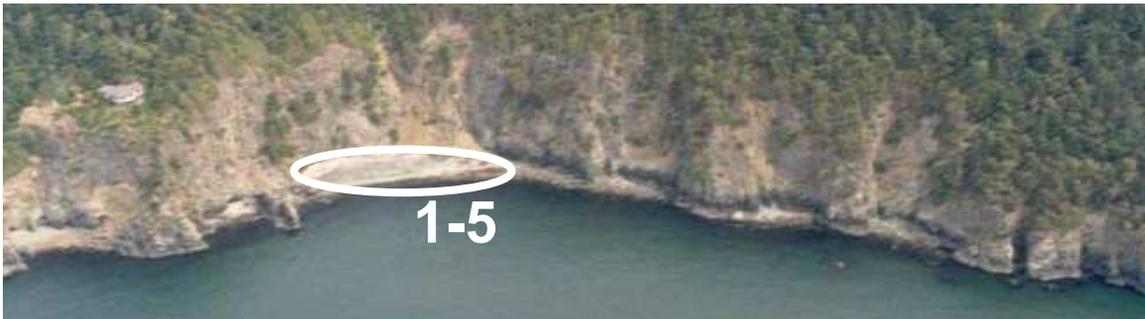
Rosario Bay & Head  
Shoreline Aerial Photo #SKA0468  
Surveyed by Marilyn Wood and Ken Taylor, August 2006

1. Creosote timber pieces, total of 18" x 3" x 1"
2. Treated timber 20" x 3" x 3"
3. Creosote timber 36" x 8" x 6"
4. Creosote timber 60" 12" x 12"
5. Creosote timber 60" 12" x 12"

6. Creosote timber 52" x 8" x 8"
7. Creosote log 60" x 6" dia.
8. Creosote timber 120" x 8" x 8"
9. Creosote timber 180" x 10" x 10"
10. Creosote timber 96" x 8" x 8"

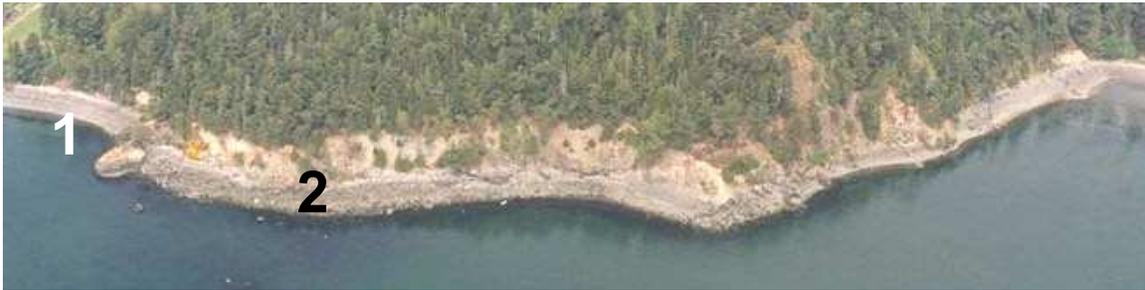
Shoreline Aerial Photo #SKA0471

1. Creosote log 400" x 12" dia.
2. Creosote timber 14" x 1" x 2"

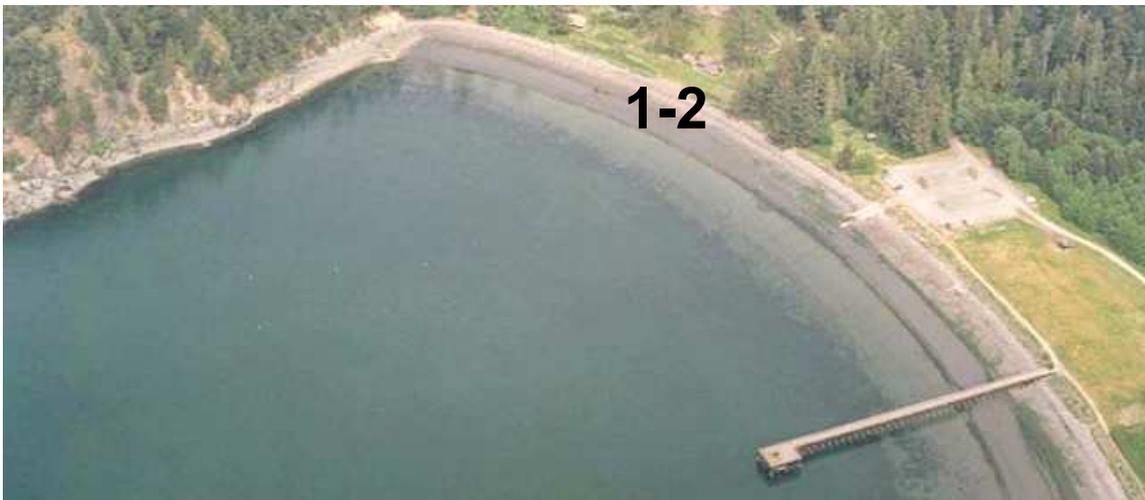
Shoreline Aerial Photo #SKA0472

1. Dock with ~120 fixed pilings (in use), each ~ 240" x 12" dia.
2. Creosote log 44" x 14" dia.
3. Creosote log 95" x 10" dia.
4. Treated timber 108" x 6" x 4"
5. Creosote timber 234" x 8" x 4"
6. Creosote timber 228" x 8" x 4"
7. Creosote log 108" x 12" dia.
8. Creosote log 48" x 18" dia.
9. Creosote log piece 18" x 2" dia.
10. Creosote timber piece 12" x 1" x 1"
11. Creosote timber piece 14" x 1" x 1"

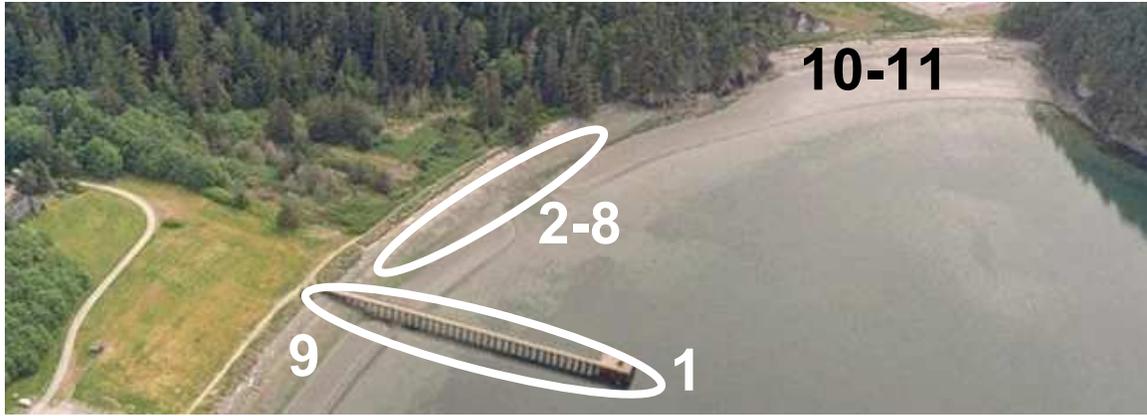
Shoreline Aerial Photo #SKA0474

1. Treated timber 240" x 2" x 6"
