# *Skagit County Creosote Inventory and Removal Project: Phase II*

**Skagit County Marine Resources Committee**

**Final Report -- June 2007**

PROJECT TITLE: Treated Wood Inventory and Removal

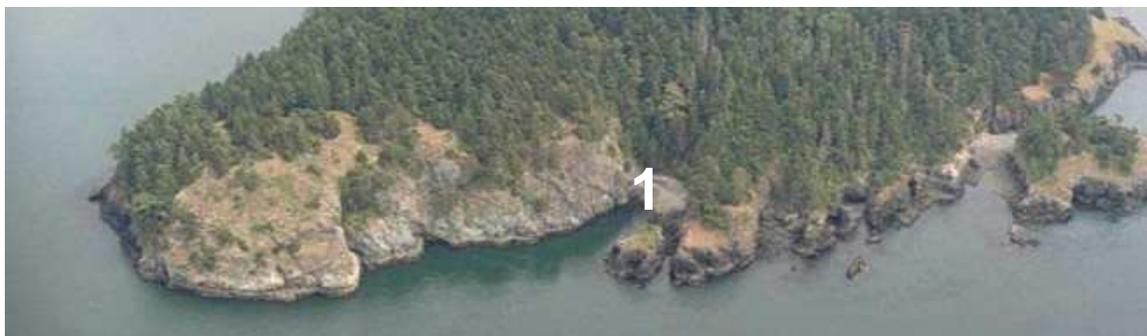
Headland south of Bowman Bay  
Shoreline Aerial Photo #SKA0475  
Surveyed by Kathleen Murphy and Keeley O'Connell, June 2006

1. Creosote timber piece 5" x 3" x 3"

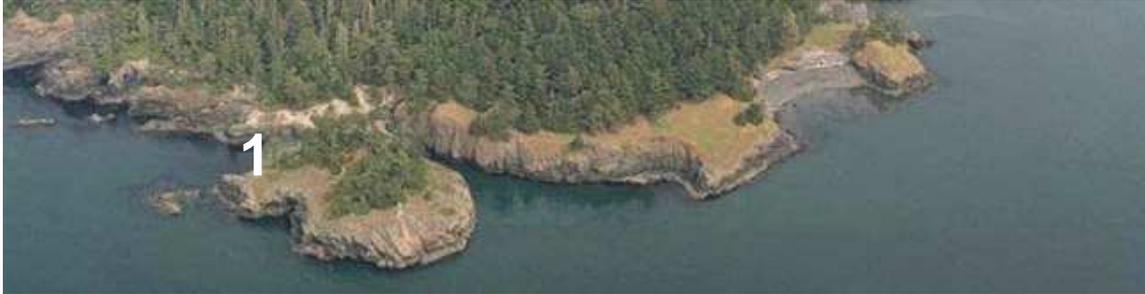
Yokeko Point, inside Deception Pass  
Shoreline Aerial Photo #SKA0483  
Surveyed by boat by Paul Dinnel and Nate Schwarck, May 2007

1. 2 creosote fixed piles in use, each about 300" x 10" dia. Also, wooden floats with treated timbers, size ~ 30" x 4"
2. 4 creosote fixed piles in use, each about 300" x 12" dia. Also, wooden floats with treated timbers, size ~ 40" x 4"
3. 2 creosote fixed piles in use (holding up a deck), 144" x 12" dia.
4. 2 creosote fixed piles holding up deck, each 36" x 12" dia. Also, 1 other pile 48" x 14" dia.
5. 3 creosote timbers, each 300" x 12" x 12"
6. 4 creosote derelict piles, 300" x 12" dia.
7. 8 creosote piles, in use, averaging 360" x 12" dia.

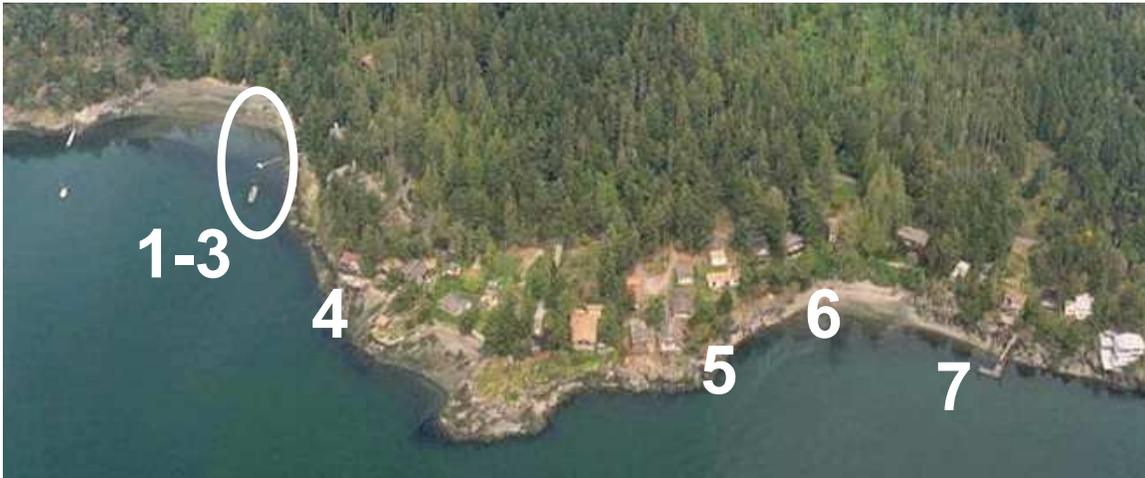
Yokeko Point, inside Deception Pass  
Shoreline Aerial Photo #SKA0486  
Surveyed by Catherine Davis, July 2006

1. 3 Creosote fixed pilings, derelict, size not given; est. 120" x 12" dia. each
2. Creosote timber 94" x 12" x 4"

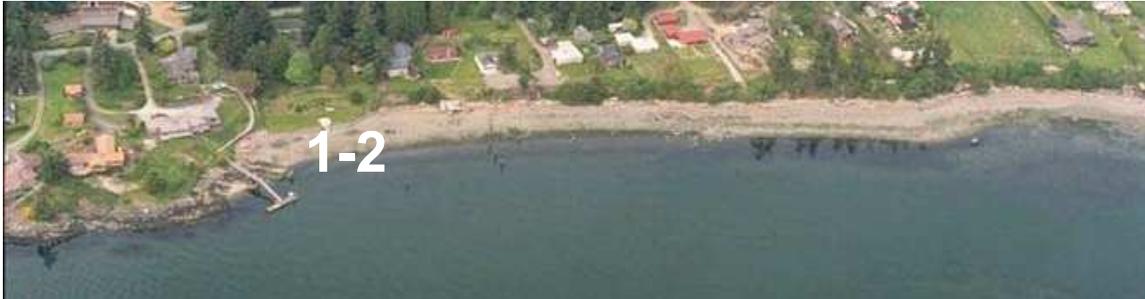
Dewey Beach, north Skagit Bay  
Shoreline Aerial Photo #SKA0487  
Surveyed by Catherine Davis, July 2006

1. 8 creosote fixed derelict pilings, no size given; est. 120" x 12" dia. each
2. 3 creosote fixed derelict pilings, no size given; est. 120" x 12" dia. each

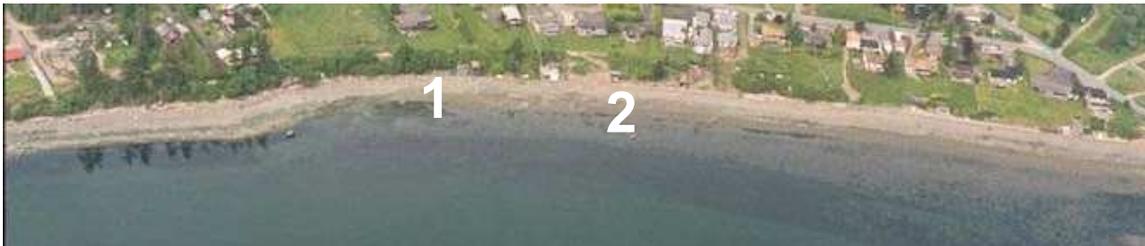
Dewey Beach, north Skagit Bay  
Shoreline Aerial Photo #SKA0488  
Surveyed by Catherine Davis, July 2006

1. Treated timber 42" x 4" x 15"
2. Treated timber 14" x 6" x 4"
3. Treated timber 47" x 6" x 6"
4. Creosote timber 12" x 12" x 8"

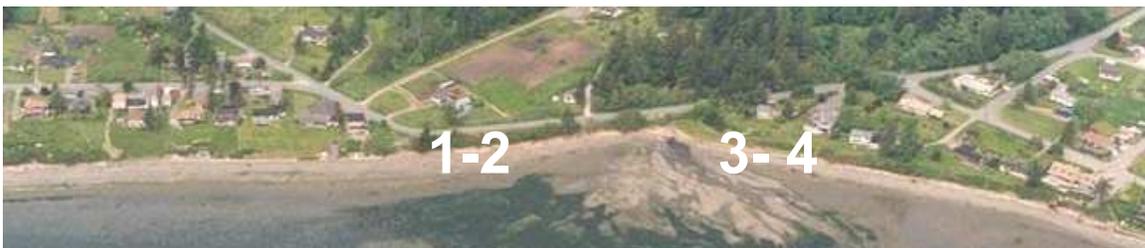
Dewey Beach, north Skagit Bay  
Shoreline Aerial Photo #SKA0489  
Surveyed by Catherine Davis, July 2006

1. Creosote timber 35" x 15" x 4"
2. Creosote log 80" x 6" dia.
3. Creosote derelict fixed piling 26" x 12" dia.
4. Creosote log 13" x 7" dia.
5. Creosote log 60" x 15" dia.
6. Treated timber 240" x 6" x 2"
7. 2 creosote logs, 50" x 8" dia. and 18" x 8" dia.
8. Treated timber 48" x 7" x 2"
9. Creosote log 91" x 9" dia.
10. Treated timber 94" x 7" x 4"
11. Treated timber 24" x 12" x 2"
12. Creosote timber 96" x 8" x 7"
13. Creosote derelict fixed piling 9" x 8" dia.

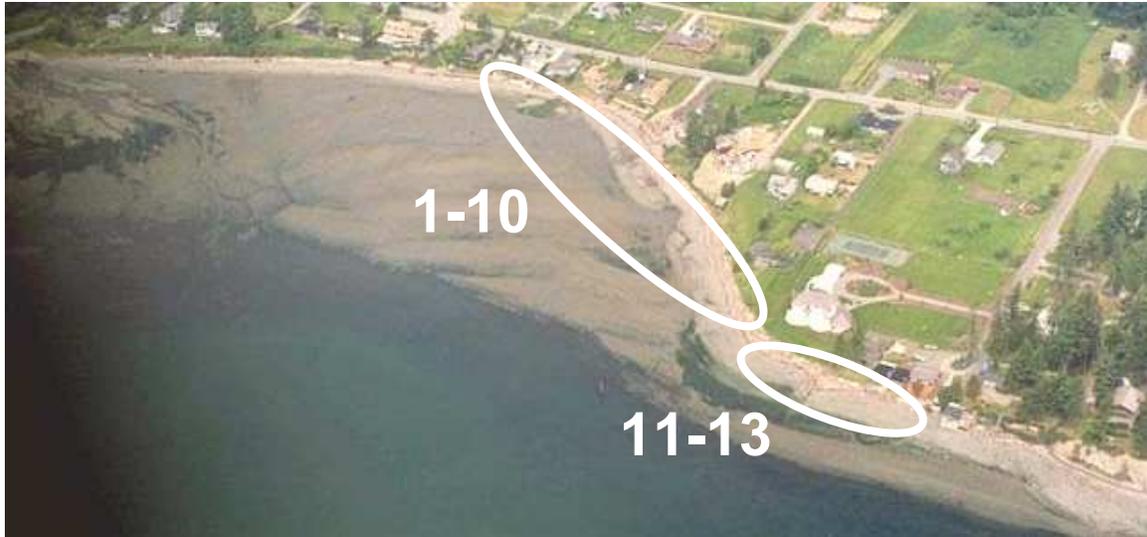
Dewey Beach, north Skagit Bay  
Shoreline Aerial Photo #SKA0490  
Surveyed by Catherine Davis, July 2006

1. Creosote timber 28" x 5" x 3"
2. Creosote timber 120" x 8" x 8"
3. ~36 creosote derelict fixed pilings, average 60" tall x 12" dia.
4. Treated timber 96" x 5" x 4"
5. Creosote log 38" x 14" dia.
6. Treated timber 68" x 6" x 2"
7. Treated timber bulkhead, no size given

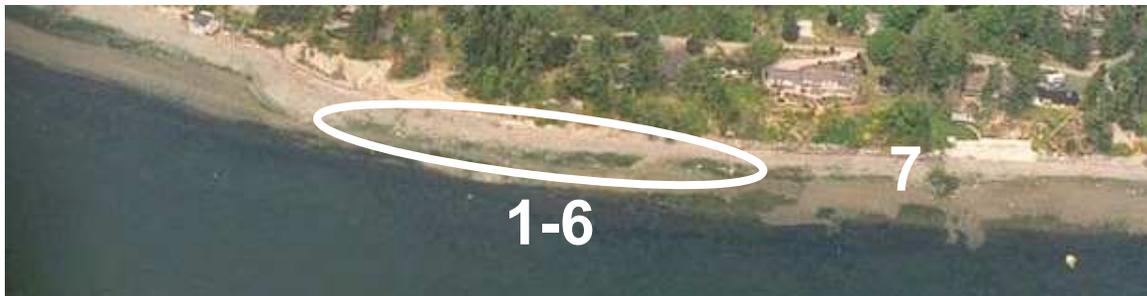
Gibraltar Beach, north Skagit Bay  
 Shoreline Aerial Photo #SKA0493  
 Surveyed by Catherine Davis, July 2006

1. Treated timber pieces, very small
2. Treated timber 48" x 4" x 4"
3. Treated timber 58" x 6" x 4"
4. Treated timber 48" x 4" x 1"
5. Creosote log 48" x 4" dia.
6. Creosote timber, very small
7. Creosote timber 48" x 3" x 2"
8. Treated timber 30" x 4" x 2"
9. Creosote timber 27" x 9" x 3"
10. Creosote timber 32" x 8" x 7"

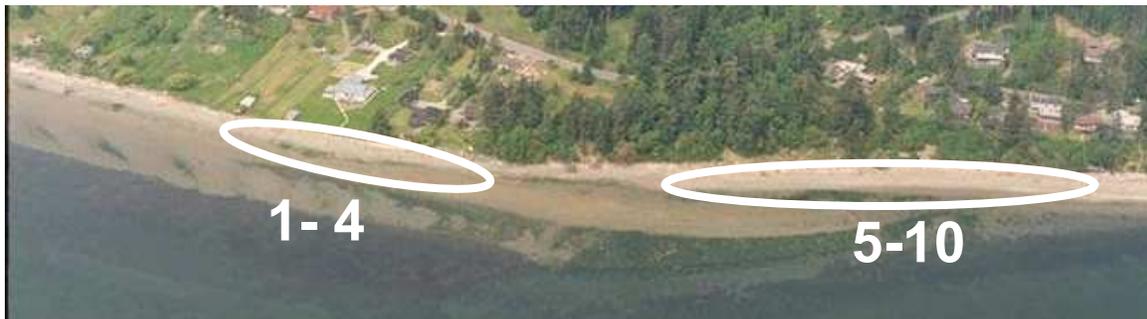
Gibraltar Beach, north Skagit Bay  
 Shoreline Aerial Photo #SKA0494  
 Surveyed by Catherine Davis, July 2006

1. Creosote timber 33" x 4" x 3"
2. Treated timber 94" x 4" x 4"
3. Creosote timber 57" x 9" x 6"
4. Treated timber 27" x 4" x 3"
5. Creosote timber 38" x 3" x 3"
6. Creosote timber 65" x 3" x 2"
7. Creosote timber 108" x 8" x 3"
8. Creosote timber 104" x 2" x 2"
9. Treated timber piece, very small
10. Creosote timber 49" x 9" x 6"
11. Creosote log 84" x 12" dia.

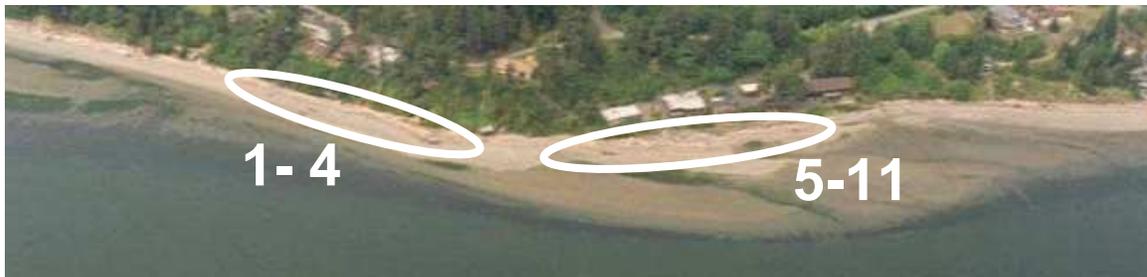
Gibraltar Beach, north Skagit Bay  
 Shoreline Aerial Photo #SKA0495  
 Surveyed by Catherine Davis, July 2006

1. Creosote log 104" x 12" dia.
2. Treated timbers, 5 pieces, all very small
3. Creosote timber 72" x 3" x 2"
4. Treated timber 24" x 2" x 6"
5. Creosote log 50" x 12" dia.
6. Creosote log 36" x 12" dia.

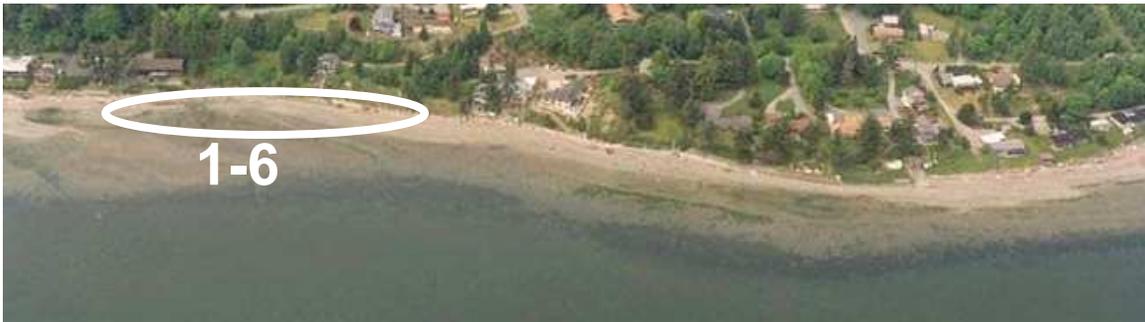
Gibraltar Beach, north Skagit Bay  
 Shoreline Aerial Photo #SKA0496  
 Surveyed by Catherine Davis, July 2006

1. Treated timber pieces, all very small
2. Creosote timber 102" x 7" x 3"
3. Creosote timber 14" x 10" x 5"

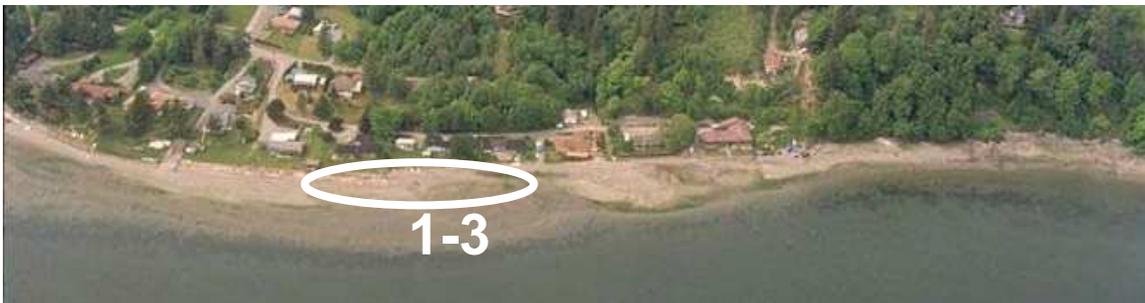
South of Gibraltar Beach, north Skagit Bay  
 Shoreline Aerial Photo #SKA0497  
 Surveyed by Catherine Davis, July 2006

1. Creosote timber 142" x 12" x 4"
2. Creosote timbers pieces, not measured
3. 3 creosote derelict fixed pilings, two 240" x 12" dia., one 96" x 12" dia.
4. Creosote timber 60" x 12" x 11"
5. Creosote timber 224" x 12" x 10"
6. Treated timber 55" x 4" x 3"
7. Treated timber 64" x 4" x 3"
8. Treated timber 115" x 11" x 1"

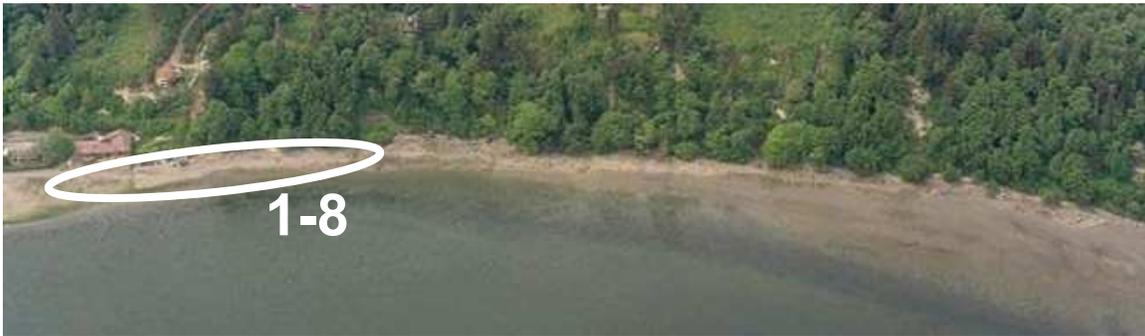
North of Similk Beach, north Skagit Bay  
 Shoreline Aerial Photo #SKA0498  
 Surveyed by Catherine Davis, July 2006

1. 2 treated timbers, each 120" x 12" x 4"
2. Creosote log 69" x 12" dia.
3. Creosote timber 96" x 8" x 7"
4. Creosote log 30" x 12" dia.

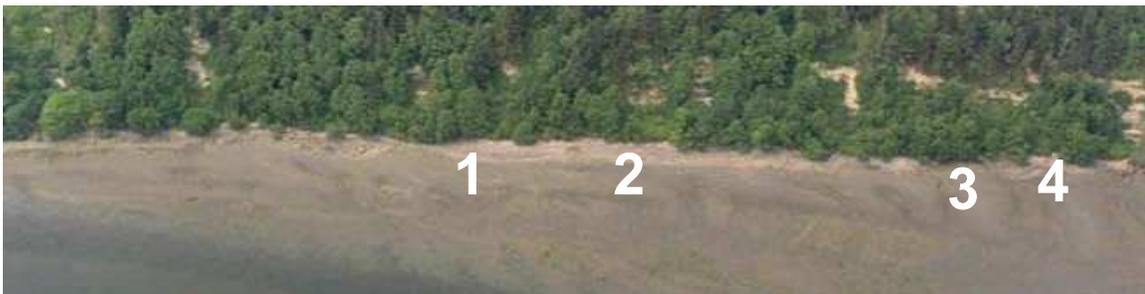
Similk Beach, north Skagit Bay  
 Shoreline Aerial Photo #SKA0501  
 Surveyed by Catherine Davis, July 2006

1. Creosote timber 28" x 8" x 8"
2. Creosote log 8" x 13" dia.
3. Treated timbers, total size = 540" x 6" x 4"
4. Treated timbers 60" x 9" x 2"
5. Creosote timber 34" x 13" x 13"
6. Creosote timber 41" x 13" x 13"
7. Creosote log 24" x 7" dia.
8. Treated timber 72" x 8" x 4"
9. Creosote timber 62" x 9" x 7"

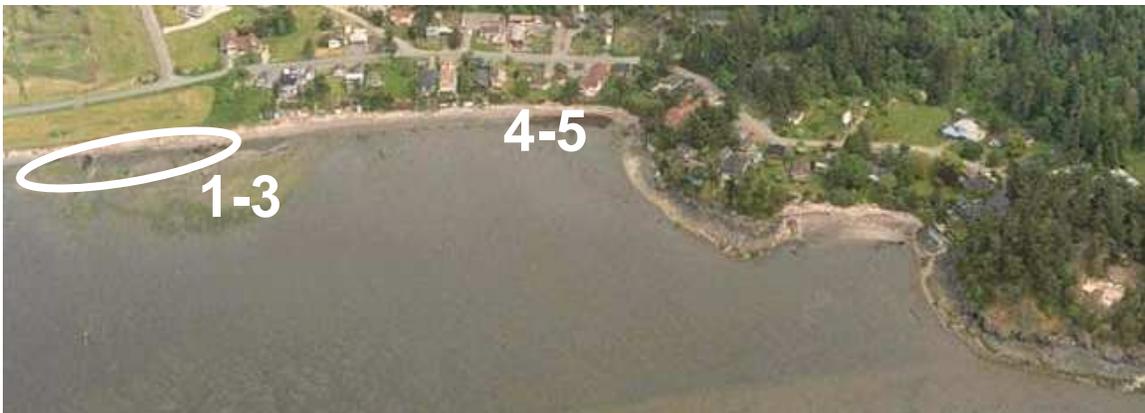
Similk Beach, north Skagit Bay  
 Shoreline Aerial Photo #SKA0502  
 Surveyed by Buddy & Phil Char, August 2006

1. Treated timbers (part of old dock), total size = 474" x 6" x 3"
2. 2 treated timbers, one 72" x 12" x 14", the other 36" x 14" x 14"
3. Treated timber 36" x 14" x 14"
4. 2 treated timbers, each 144" x 6" x 6"
5. Creosote railroad tie 60" x 8" x 8"

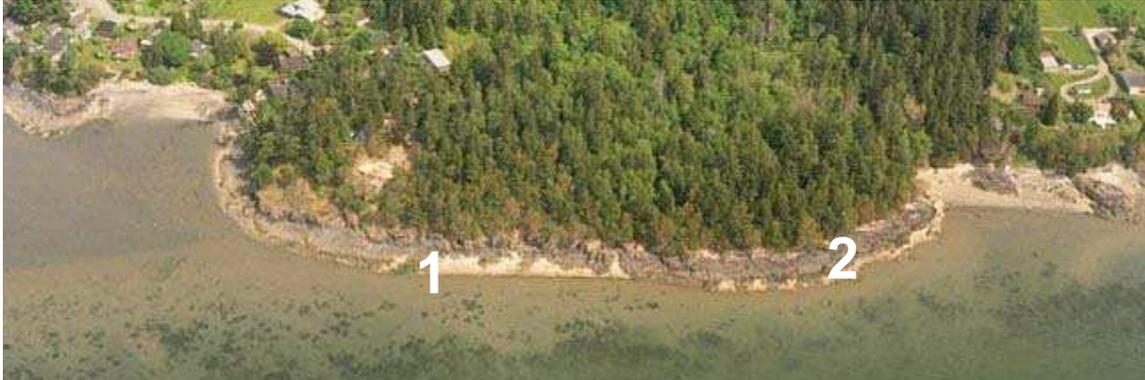
Similk Beach, north Skagit Bay  
Shoreline Aerial Photo #SKA0503  
Surveyed by Buddy & Phil Char, August 2006

1. 3 creosote logs, each 22" x 13" dia.
2. Creosote log 300" x 12" dia.

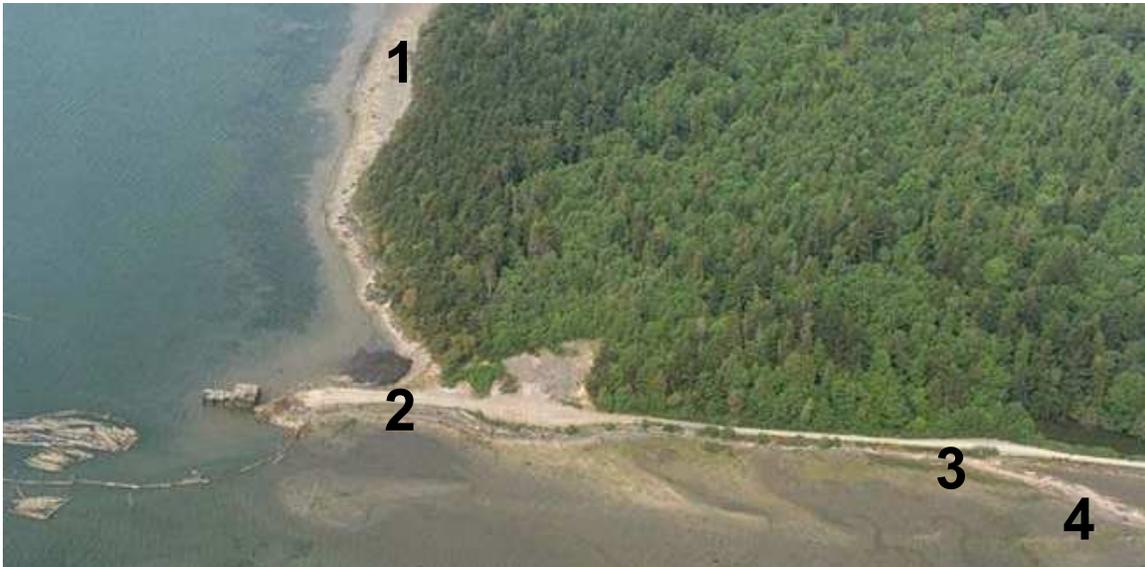
Turner's Bay, north Skagit Bay  
Shoreline Aerial Photo #SKA0506  
Surveyed by Buddy & Phil Char, August 2006

1. Creosote log 70" x 10" dia.
2. 100+ fixed pilings (dock - in use?), no sizes given (assume 120" x 12" dia. each)
3. Creosote log 48" x 12" dia.
4. Old dock structure with several 100 derelict fixed pilings (creosote?) no sizes given

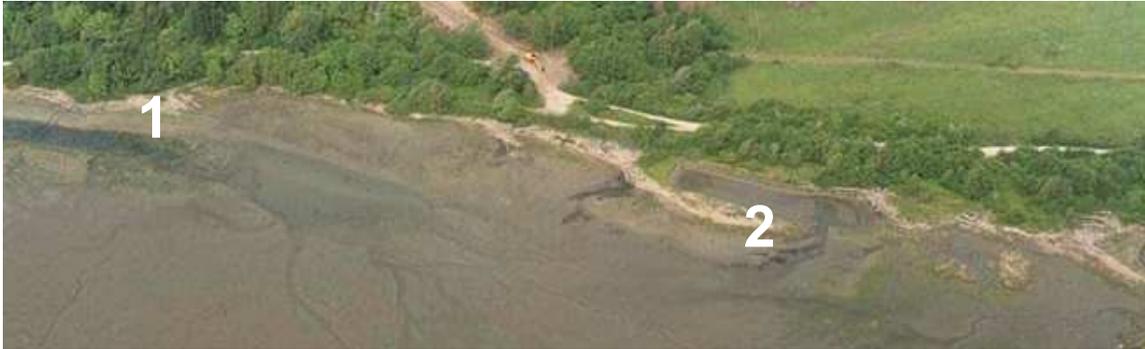
Turner's Bay, north Skagit Bay  
Shoreline Aerial Photo #SKA0508  
Surveyed by Buddy & Phil Char, August 2006

1. 15 treated railroad ties (old launch), each 144'' x 8'' x 6''
2. Treated railroad tie 60'' x 8'' x 6''

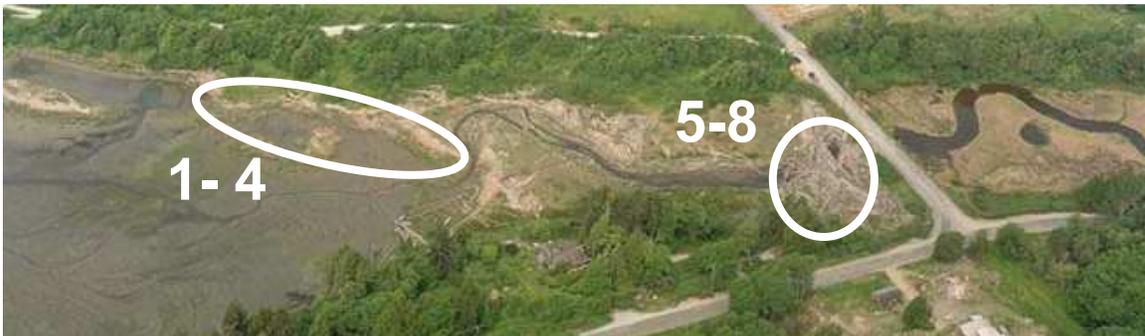
Turner's Bay, north Skagit Bay  
Shoreline Aerial Photo #SKA0509  
Surveyed by Buddy & Phil Char, August 2006

1. Derelict float with several treated timbers, each 120'' x 48'' x 4''
2. Old dock with ~20 treated timbers, each 240'' x 8'' x 10''
3. Treated timber 120'' x 12'' x 4''
4. 5 treated timbers, each averaging 200'' x 12'' x 12''
5. 2 creosote logs, 300'' x 14'' dia. and 132'' x 16'' dia.
6. Creosote log 96'' x 13'' dia.
7. 3 creosote logs, 2 at 360' x 12'' dia. and one at 120'' x 12'' dia.
8. Creosote log 12'' x 14'' dia.

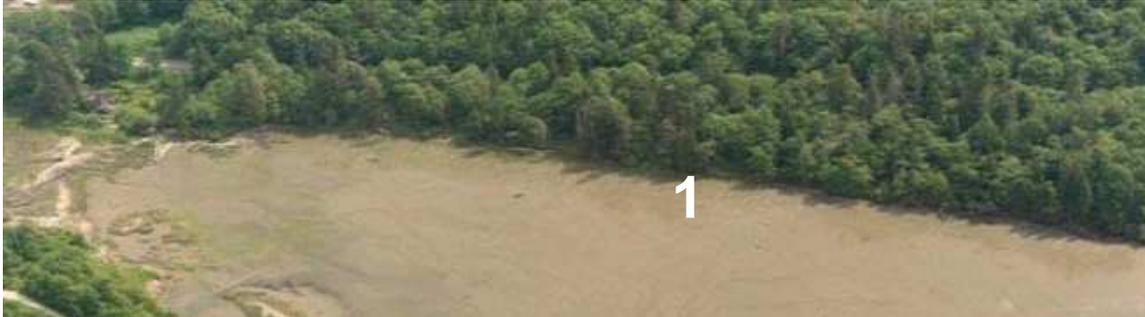
Turner's Bay, north Skagit Bay  
Shoreline Aerial Photo #SKA0511  
Surveyed by Buddy & Phil Char, August 2006

1. Treated timber 156'' x 12'' x 4''

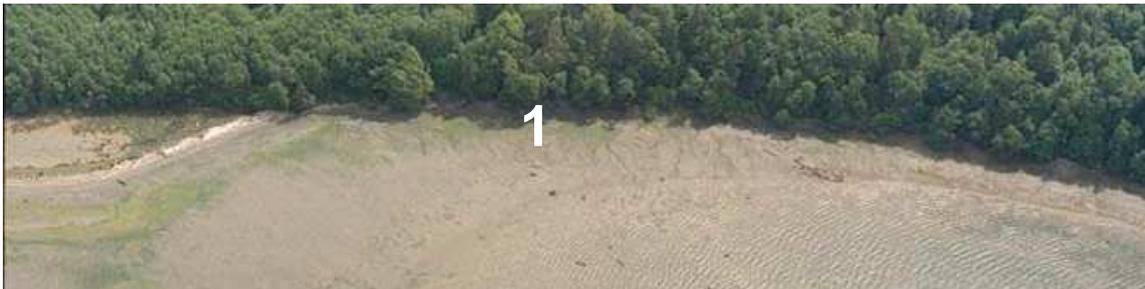
Turner's Bay, north Skagit Bay  
Shoreline Aerial Photo #SKA0513  
Surveyed by Buddy & Phil Char, August 2006

1. Derelict fixed piling 240'' x 14'' dia.

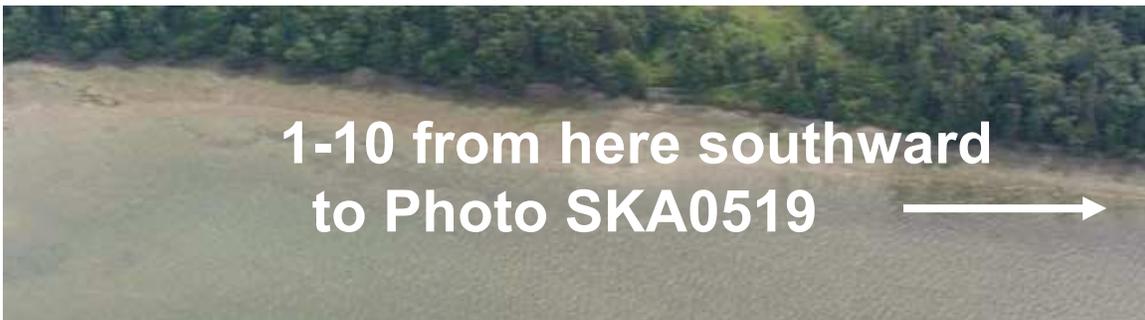
Turner's Bay, north Skagit Bay  
Shoreline Aerial Photo #SKA0514-519  
Surveyed by Lyn Bishop and Eric Shen, September 2006

1. Treated timber 55'' x 2'' x 4''

2. Creosote log 166" x 12" dia.
3. Creosote log 51" x 10" dia.
4. Treated timber 53" x 8" x 2"
5. Creosote log 30" x 12" dia.
6. Treated timber 82" x 4" x 2"
7. 20 creosote fixed pilings, 9" dia., but lengths not given
8. Creosote timber 175" x 10" x 4"
9. Creosote log 165" x 12" dia.
10. Creosote timber 137" x 12" x 4"

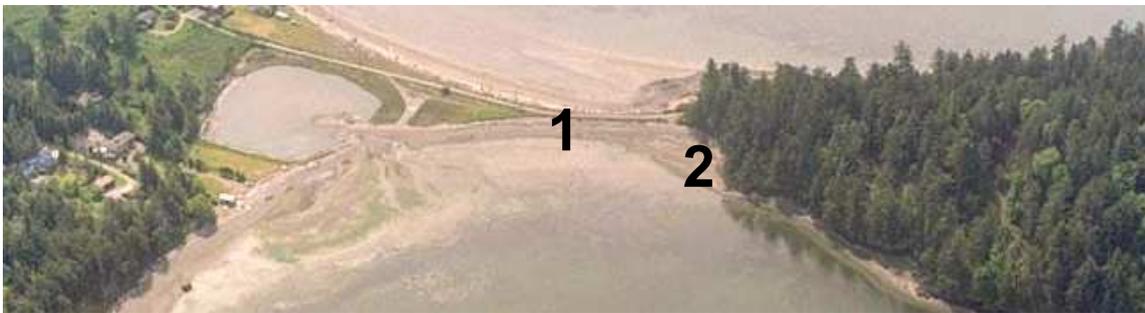
Shoreline Aerial Photo #SKA0521

1. Creosote timber 180" x 8" x 10"
2. Creosote log 12" x 12" dia.

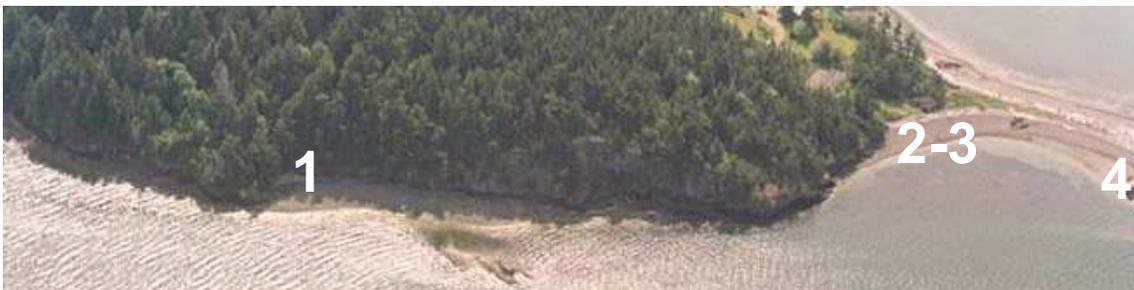
Shoreline Aerial Photo #SKA0523

1. Creosote railroad tie piece 48" x 8" x 10"
2. Creosote railroad tie 96" x 8" x 10"
3. Creosote railroad tie 96" x 8" x 10"
4. Creosote log 12" x 12" dia.

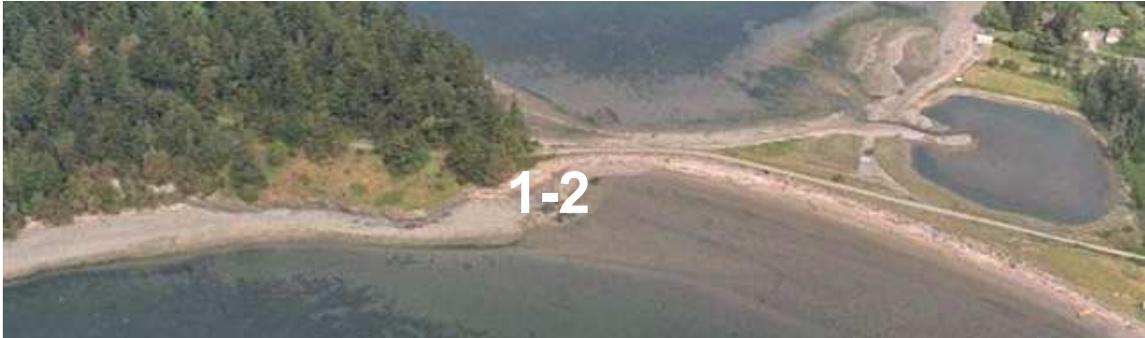
Shoreline Aerial Photo #SKA0531

1. Creosote log 96" x 12" dia.
2. Creosote timber 300" x 6" x 10"

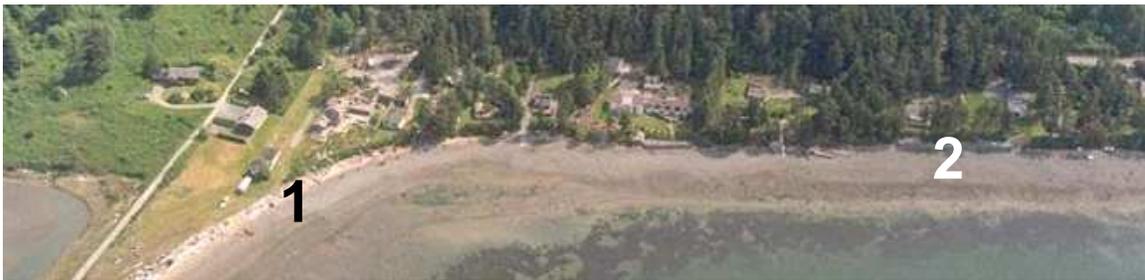
Shoreline Aerial Photo #SKA0533

1. Creosote log 240" x 12" dia.
2. Treated timber bulkhead, ~60 feet long x 4 feet high with 4" x 12" timbers

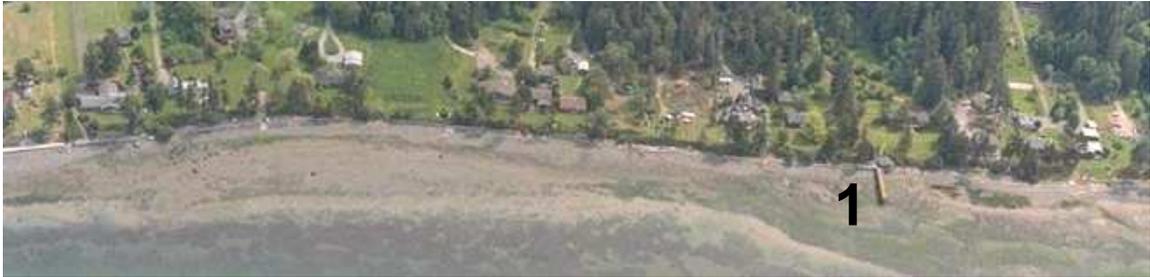
South of Kiket Island, Skagit Bay  
Shoreline Aerial Photo #SKA0535  
Surveyed by Paul Dinnel and Nate McNeil, September 2006

1. Dock with 7 creosote fixed piles (in use) averaging 72" x 12" dia. Dock made out of treated timbers of varying sizes.

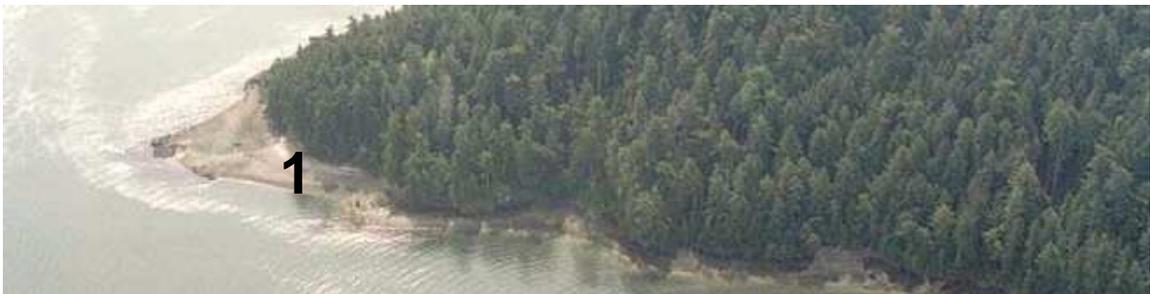
Hope Island, east end, Skagit Bay  
Shoreline Aerial Photo #SKA0538  
Surveyed by Paul Dinnel, September 2006

1. Creosote log 24" x 12" dia.

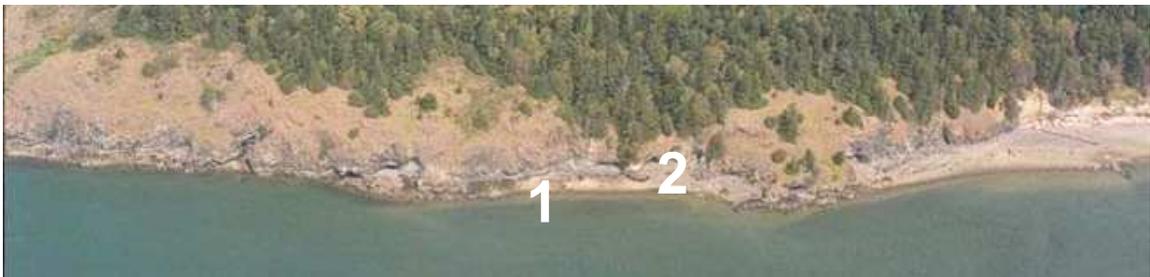
Hope Island, south side, Skagit Bay  
Shoreline Aerial Photo #SKA0544  
Surveyed by Paul Dinnel, September 2006

1. Creosote log 180" x 12" dia.
2. Creosote log 132" x 14" dia.

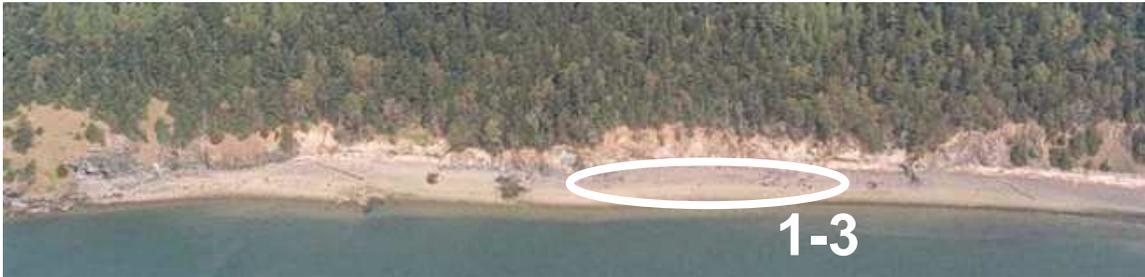
Hope Island, south side, Skagit Bay  
Shoreline Aerial Photo #SKA0545  
Surveyed by Paul Dinnel, September 2006

1. Creosote log 60" x 12" dia.
2. Creosote log 12" x 20" dia.
3. Creosote log 36" x 12" dia.

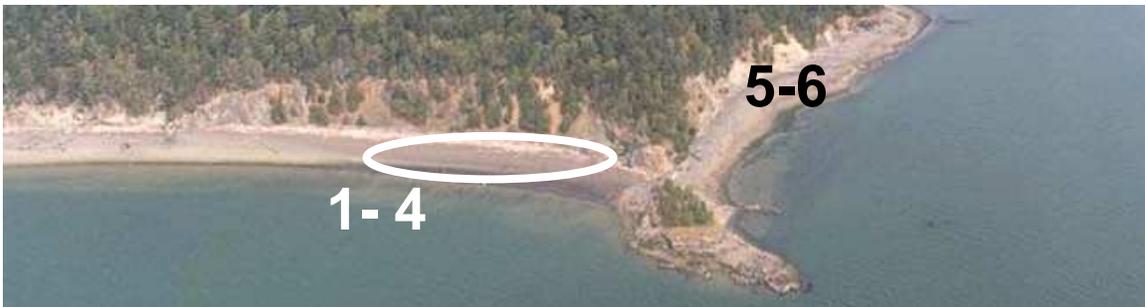
Hope Island, southeast side, Skagit Bay  
Shoreline Aerial Photo #SKA0546  
Surveyed by Paul Dinnel, September 2006

1. Creosote timber 12" x 2" x 6"
2. Creosote log 36" x 12" dia.
3. Creosote log 60" x 12" dia.
4. Creosote log 192" x 10" dia.
5. Treated timber 48" x 4" x 4"
6. Treated timber 192" x 2" x 6"

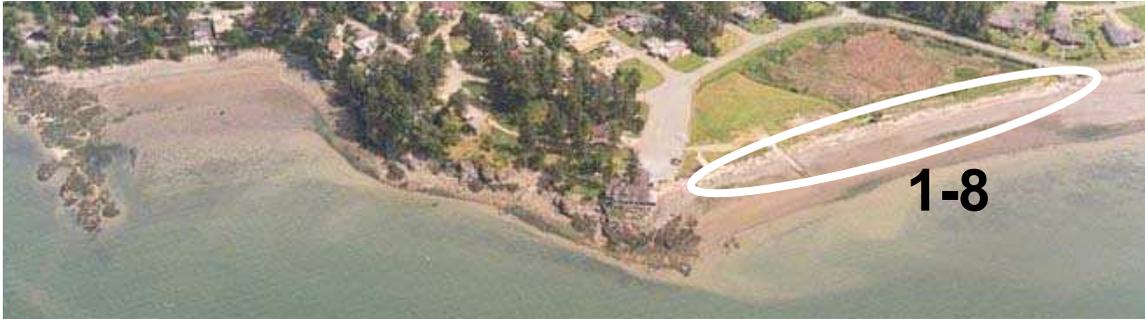
Snee-Oosh Point, Skagit Bay  
 Shoreline Aerial Photo #SKA0550  
 Surveyed by Paul Dinnel and Michael Meldahl, October 2006

1. Creosote log 24" x 12" dia.
2. Treated timber 36" x 6" x 6"
3. Creosote timber 36" x 8" x 10"
4. Creosote timber 36" x 2" x 4"
5. Creosote log 72" x 12" dia.
6. Creosote timber 120" x 8" x 8"
7. Creosote timber 24" x 8" x 10"
8. Creosote log 24" x 12" dia.

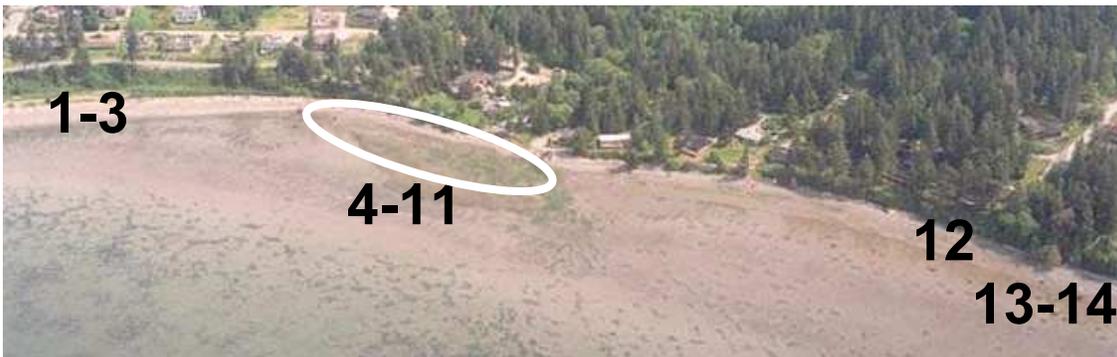
South of Snee-Oosh Point, Skagit Bay  
 Shoreline Aerial Photo #SKA0552  
 Surveyed by Paul Dinnel, October 2006

1. Creosote log 156" x 12" dia.
2. Creosote log 72" x 14" dia.
3. Creosote timber 48" x 8" x 8"
4. Treated timber 36" x 2" x 6"
5. 5 creosote timbers, each 72" x 6" x 6"
6. Creosote timber 24" x 8" x 10"
7. Creosote timber 48" x 4" x 8"
8. Treated timber 12" x 2" x 6"
9. Creosote timber 24" x 12" x 12"

## 10. *Spartina* clump

11. Creosote timber 8" x 8" x 8"
12. 2 creosote timbers, total 144" x 6" x 8"
13. Creosote timber 96" x 6" x 6"
14. Treated timber 96" x 2" x 4"
15. Creosote timber 120" x 12" x 12"

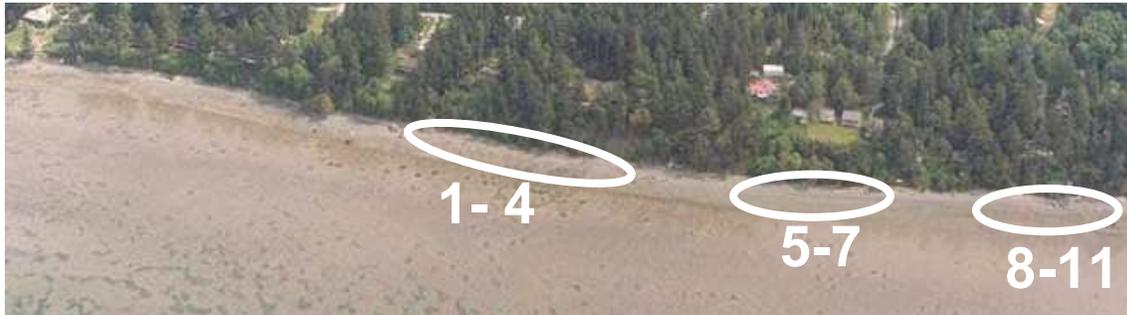
South of Snee-Oosh Point, Skagit Bay  
Shoreline Aerial Photo #SKA0553  
Surveyed by Paul Dinnel, October 2006

1. Stairway with treated timbers, total of ~150 lineal feet of 2" x 8" timbers
2. Stairway with treated timbers, total of ~ 300 board feet of timbers
3. Treated timber 48" x 4" x 4"
4. **Two *Spartina* clumps**
5. 8 pieces of creosote/treated timber pieces, ~ 10 board feet total
6. Stairway with treated timbers & bulkhead, ~ 250 board feet total
7. Creosote timber 24" x 4" x 8"
8. Creosote log 48" x 12" dia.
9. Treated wood stairway, ~ 60 board feet total
10. Treated timber 96" x 2" x 10"
11. Treated timbers (derelict stairway), ~ 40 board feet total

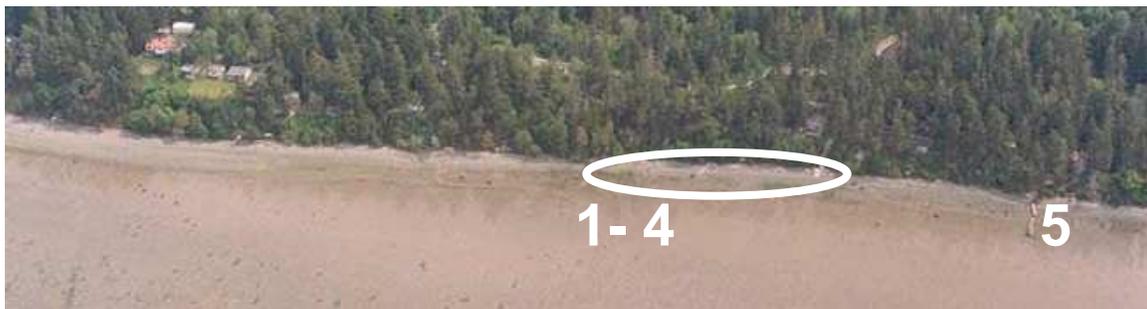
South of Snee-Oosh Point, Skagit Bay  
Shoreline Aerial Photo #SKA0554  
Surveyed by Paul Dinnel, October 2006

1. Creosote log 48" x 12" dia.

2. Treated timber 72" x 2" x 8"
3. Treated timber 60" x 2" x 10"
4. Treated fixed post 36" x 4" x 4"
5. Dock with treated timbers, estimate ~ 2,000 board feet

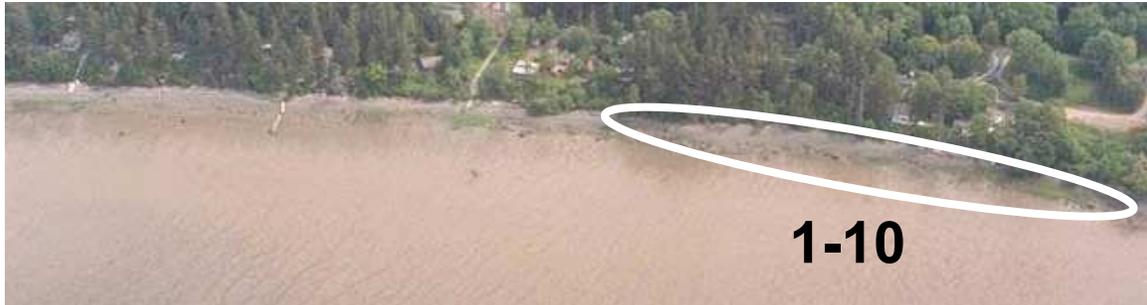
South of Snee-Oosh Point, Skagit Bay  
 Shoreline Aerial Photo #SKA0555  
 Surveyed by Paul Dinnel, October 2006

1. Creosote log 12" x 14" dia.
2. Creosote timber 24" x 10" x 10"
3. Treated timber stairway, ~40 board feet
4. Creosote timber 48" x 8" x 8"
5. Treated wood stairway, ~30 board feet
6. Treated wood stairway, ~50 board feet
7. Treated wood stairway, ~100 board feet
8. Creosote log 24" x 12" dia.
9. Creosote timber 24" x 14" x 14"
10. Treated timber 72" x 2" x 4"

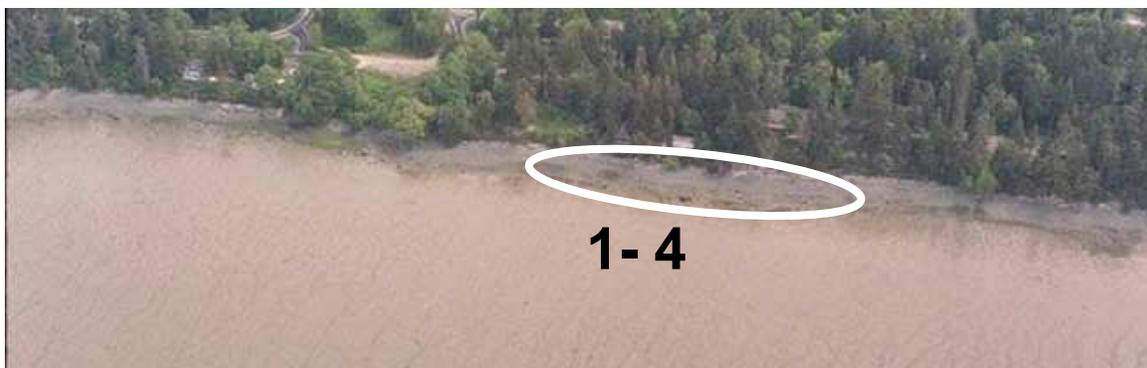
Indian Road Beach, Skagit Bay  
 Shoreline Aerial Photo #SKA0556  
 Surveyed by Paul Dinnel, October 2006

1. Treated timber 24" x 2" x 6"
2. About 12 treated timbers = ~ 20 board feet

3. Creosote log 72" x 12" dia.
4. Treated timber 48" x 4" x 4"

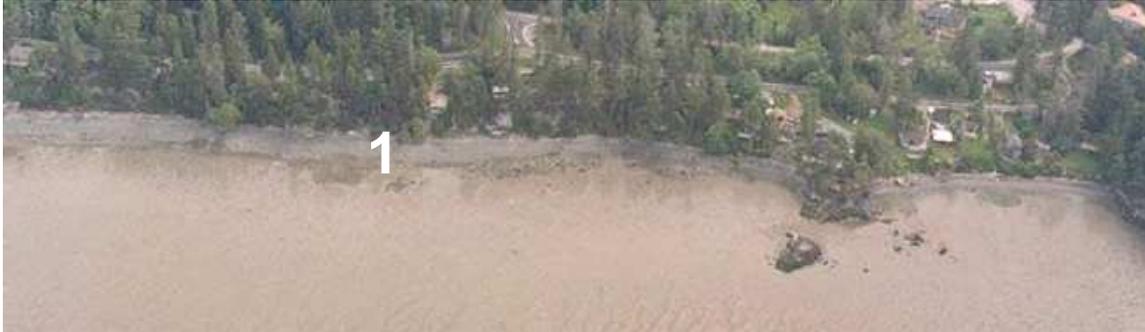
Indian Road Beach, Skagit Bay  
Shoreline Aerial Photo #SKA0557  
Surveyed by Paul Dinnel, October 2006

1. 2 creosote fixed posts, each 48" x 8" x 8"

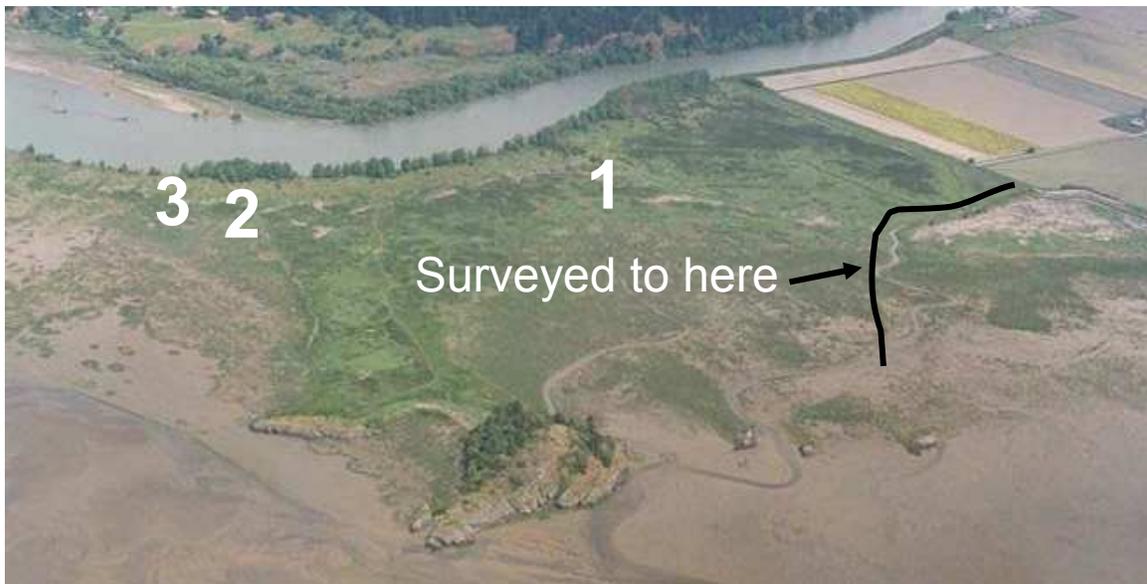
Shoreline Aerial Photo #SKA0651

1. Creosote timber 144" x 2" x 12"
2. Creosote log 16" x 14" dia.

3. Treated timber 24" x 6" x 6"

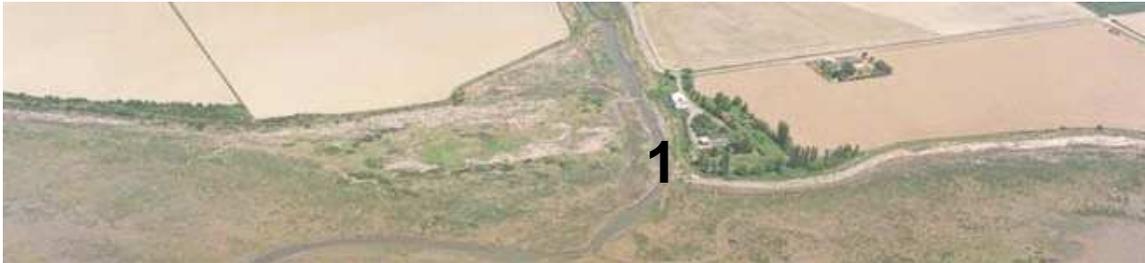
Fir Island, Hall Slough, South Skagit Bay  
 Shoreline Aerial Photo #SKA0654  
 Surveyed by Paul Dinnel, October 2006

**1. Lots of Spartina!**

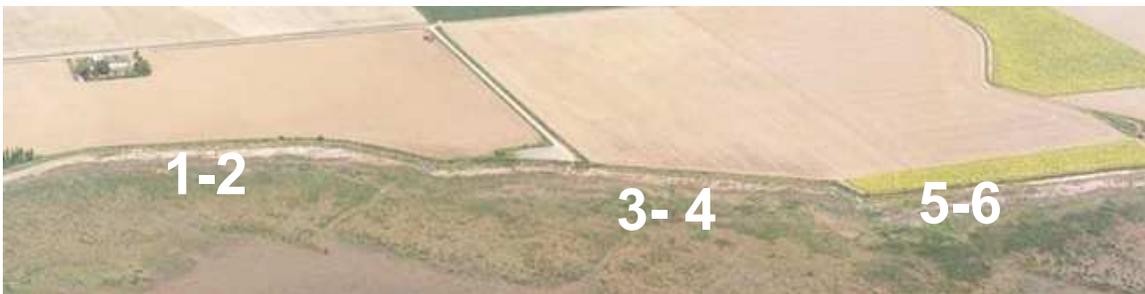
Fir Island, south of Hall Slough, South Skagit Bay  
 Shoreline Aerial Photo #SKA0655  
 Surveyed by Paul Dinnel, October 2006

1. Creosote timber 144" x 4" x 4"
2. Treated timber 36" x 2" x 12"
3. Treated timber 60" x 3" x 10"
4. Creosote log 24" x 12" dia.
5. Creosote timber 36" x 4" x 10"
6. Creosote timber 48" x 10" x 10"
7. **A few patches of Spartina throughout area**

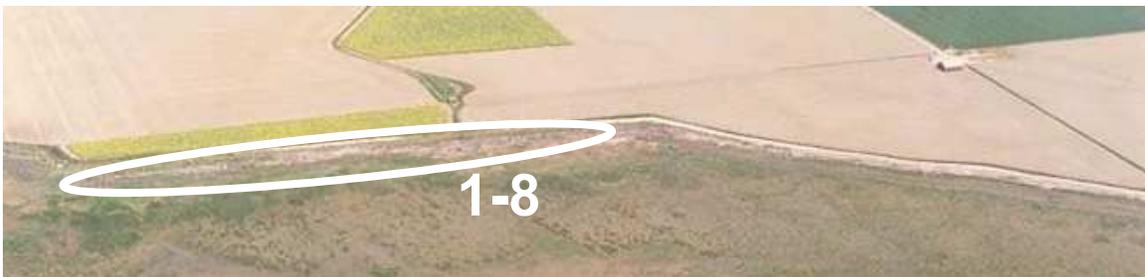
Fir Island, south of Hall Slough, South Skagit Bay  
 Shoreline Aerial Photo #SKA0656  
 Surveyed by Paul Dinnel, October 2006

1. Creosote log 48" x 12" dia.
2. Creosote timber 72" x 10" x 10"
3. Treated timber 48" x 2" x 6"
4. Creosote log 36" x 10" dia.
5. Creosote log 72" x 16" dia.
6. Treated timber 12" x 6" x 10"
7. Treated timber 48" x 4" x 4"
8. Creosote log 300" x 12" dia.
9. **A few patches of Spartina throughout this area**

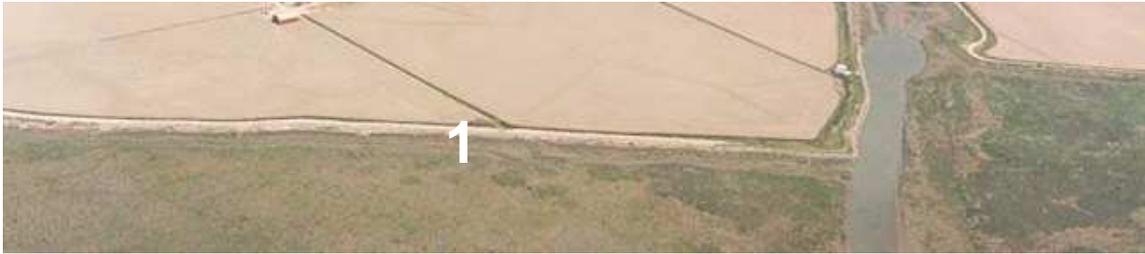
Fir Island, Brown Slough, South Skagit Bay  
 Shoreline Aerial Photo #SKA0657  
 Surveyed by Paul Dinnel, October 2006

1. Treated timber 36" x 4" x 6"

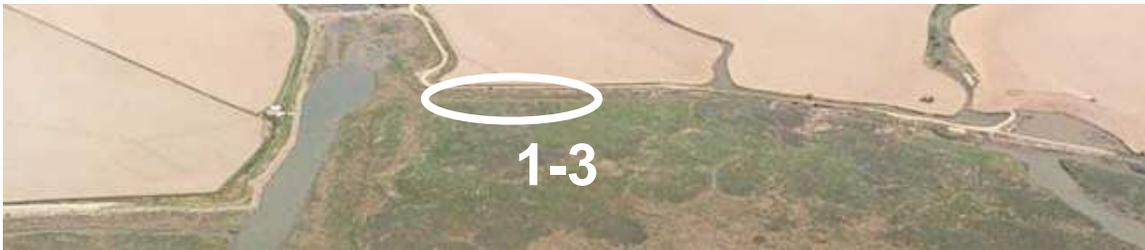
Fir Island, Brown Slough, South Skagit Bay  
 Shoreline Aerial Photo #SKA0658  
 Surveyed by Paul Dinnel, October 2006

1. Treated timber 18" x 6" x 8"
2. Treated timbers (dock structure?), ~50 board feet
3. Creosote log 48" x 12" dia.

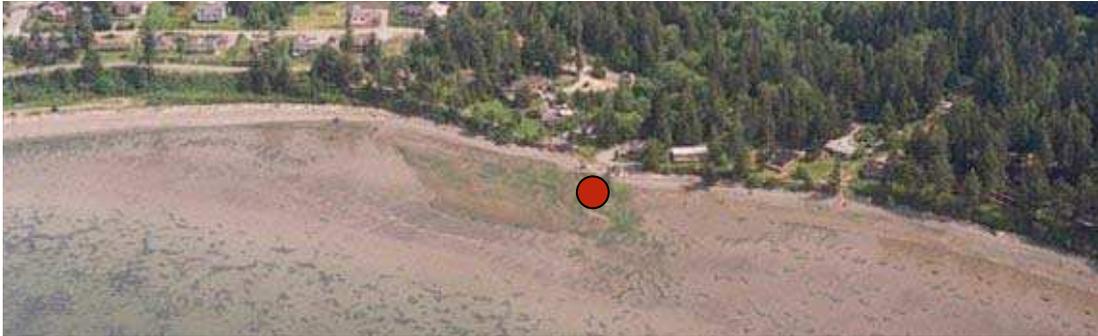
1. Skagit Bay, Ecology Photo #SKA05552  
Small patch in outflow of stream south of Snee-oosh Beach  
Latitude: 48.23.728N, Longitude: 122.32.321W

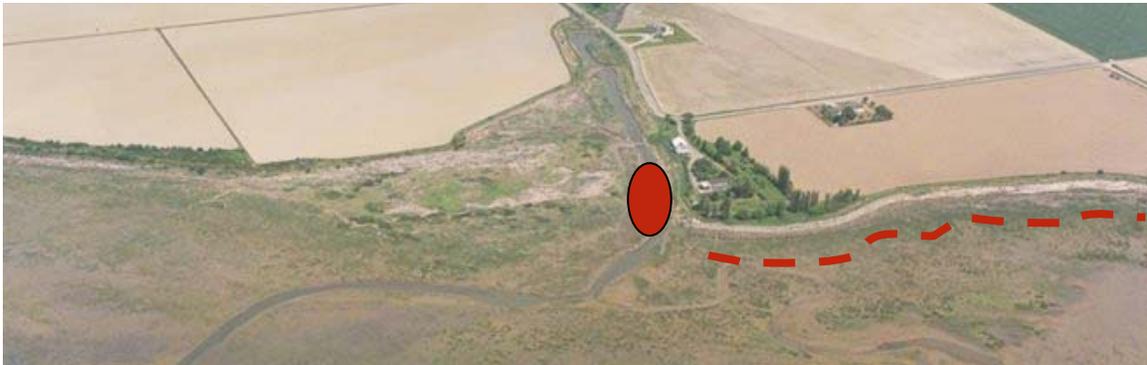
2. Skagit Bay Ecology Photo #SKA0654  
Lots of Spartina patches in Hall Slough, Fir Island and scattered patches extending  
to the south (dotted line)  
Latitude: 48.20.435N, Longitude: 122.26.419W

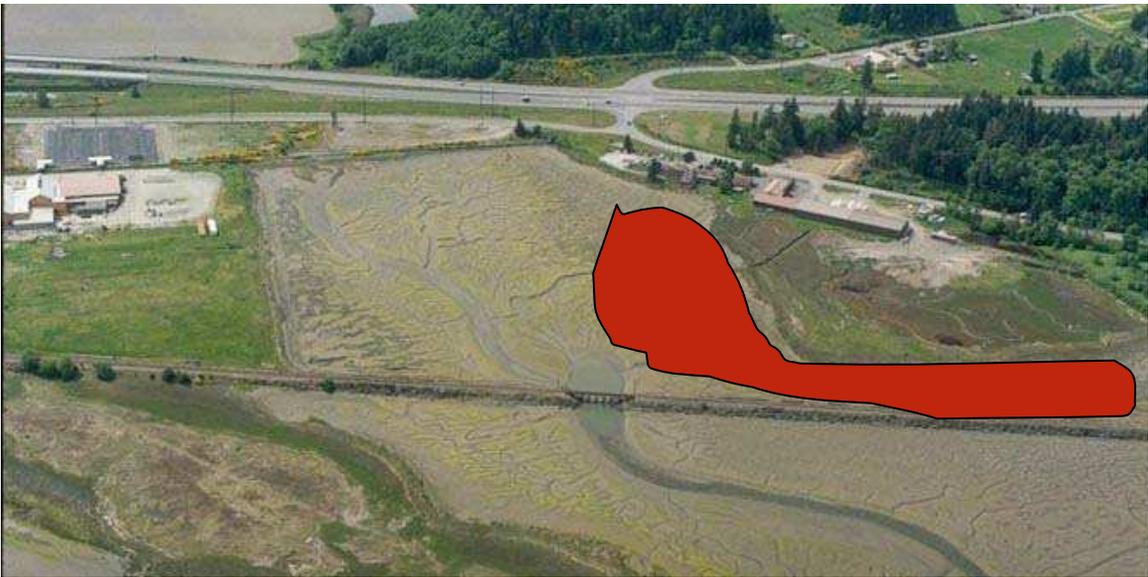
5. Southwest corner of Padilla Bay at Whitmarsh Junction (Ecology Photo # SKA0350) in lagoon just north of the Swinomish Tribal Casino off of Highway 20. Lots of Spartina patches, with seed heads. (no latitude/longitude coordinates).

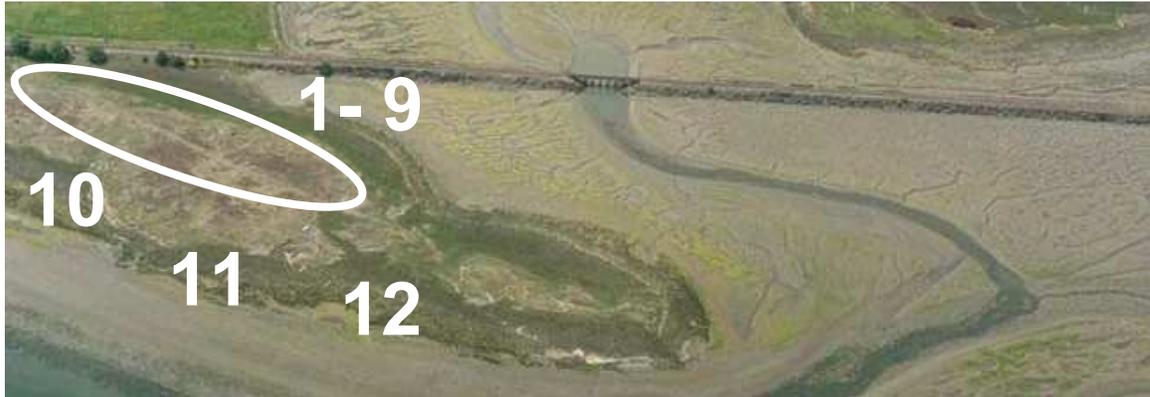
Shoreline Aerial Photo #SKA0350

1. Creosote log, 24" x 14" dia.
2. Treated timber, 48" x 6" x 4"
3. Creosote log, 240" x 10" dia.
4. Creosote log, 60" x 16" dia.
5. Creosote log, 60" x 14" dia.
6. Creosote log, 36" x 14" dia.
7. 2 Creosote timbers, each 36" x 6" x 6"
8. Treated timber, 12" x 12" x 2"
9. Treated timber, 6" x 6" x 4"
10. Treated timber, 36" x 6" x 2"
11. Treated timber, 12" x 6" x 2"
12. Creosote timber, 240" x 8" x 2"
