# *Skagit County Creosote Inventory and Removal Project: Phase II*

**Skagit County Marine Resources Committee**

**Final Report -- June 2007**

PROJECT TITLE: Treated Wood Inventory and Removal

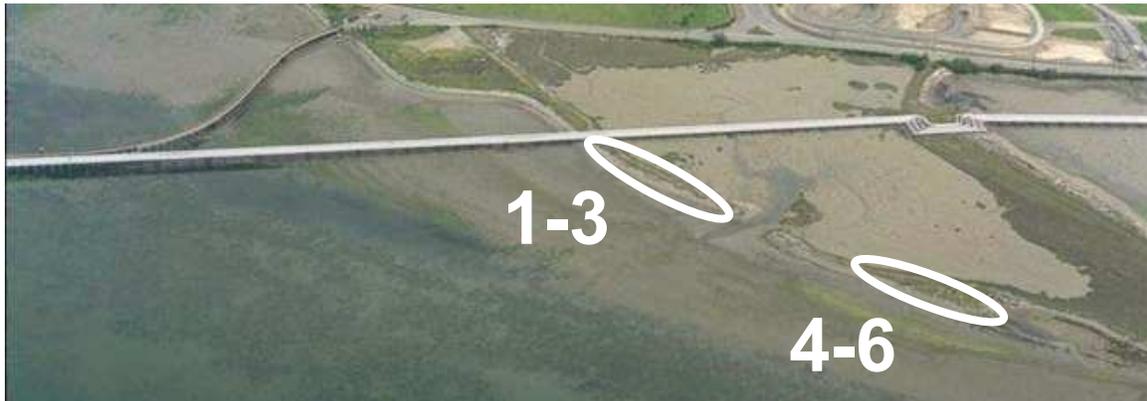
Shoreline Aerial Photo #SKA0370

1. Creosote timber, 240" x 12" x 4"
2. Dock structure – creosote and treated timbers, size 324" x 48" x 18"
3. Creosote timber, 240" 12" x 4"
4. Creosote log piece, 8" x 10" dia.
5. Treated timber, 36" x 4" x 4"
6. 2 treated timbers, both 12" x 12" x 14"

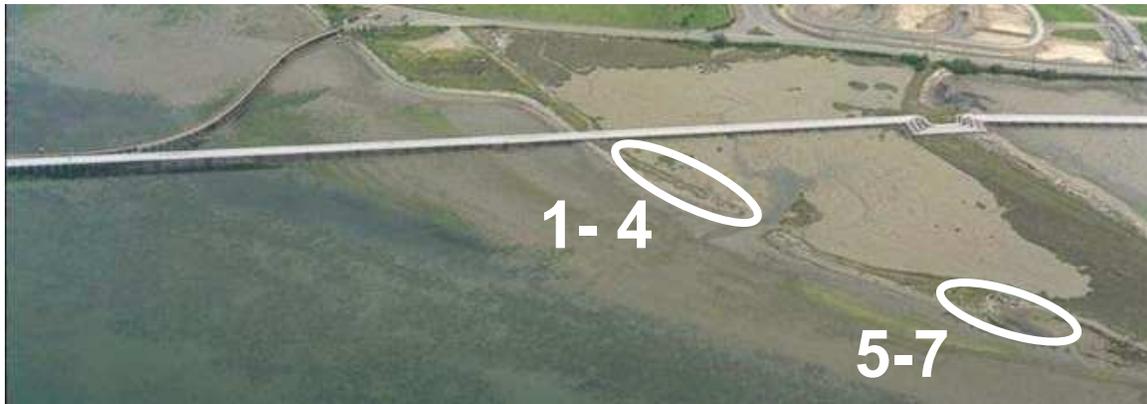
Shoreline Aerial Photo #SKA0370

1. Treated timber, 168" x 4" x 8"
2. Treated timber, 12" x 4" x 6"
3. Treated timber, 18" x 4" x 6"
4. Treated log piece, 2" x 12" dia.
5. Creosote log, 72" x 12" dia.
6. Treated timber, 156" x 10" x 4"
7. Treated timber, 24" x 4" x 4"

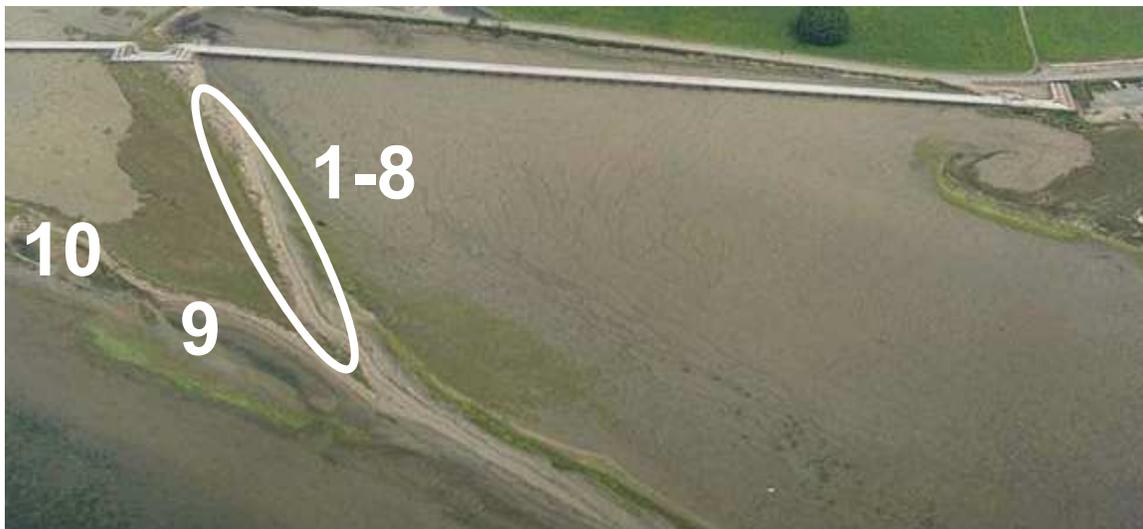
Shoreline Aerial Photo #SKA0371

1. Creosote timber 240" x 12" x 4"
2. Creosote timber, 12" x 6" x 4"
3. 2 Treated timber pieces – 48" x 8" x 2" and 6" x 8" x 2"

4. Treated timber, 36" x 4" x 2"
5. Creosote timber, 36" x 6" x 4"
6. Treated timber, 4" x 6" x 2"
7. Treated timber, 48" x 6" x 2"
8. Treated timber, 12" x 6" x 4"
9. Creosote timber, 24" x 12" x 4"
10. Creosote timber, 12" x 6" x 4"

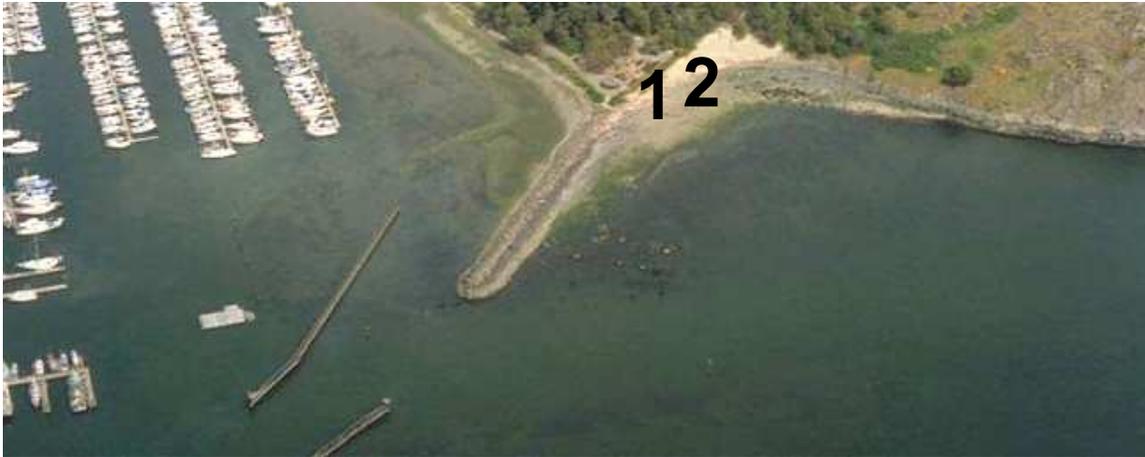
Shoreline Aerial Photo #SKA0402

1. Treated timber, 12" x 8" x 2"
2. Creosote log, 24" x 14" dia.

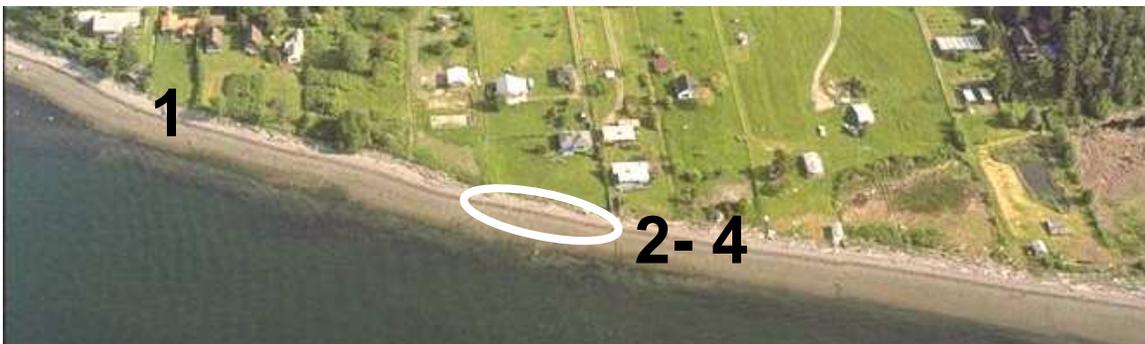
Shoreline Aerial Photo #SKA0047, south shore, west of ferry dock  
Surveyed by Paul Dinnel

1. Treated timber, 12' x 4" x 4"
2. Creosote timber, 12" x 4" x 4"
3. Creosote timber, 6" x 6" x 6"
4. Creosote timber, 240" x 6" x 4"

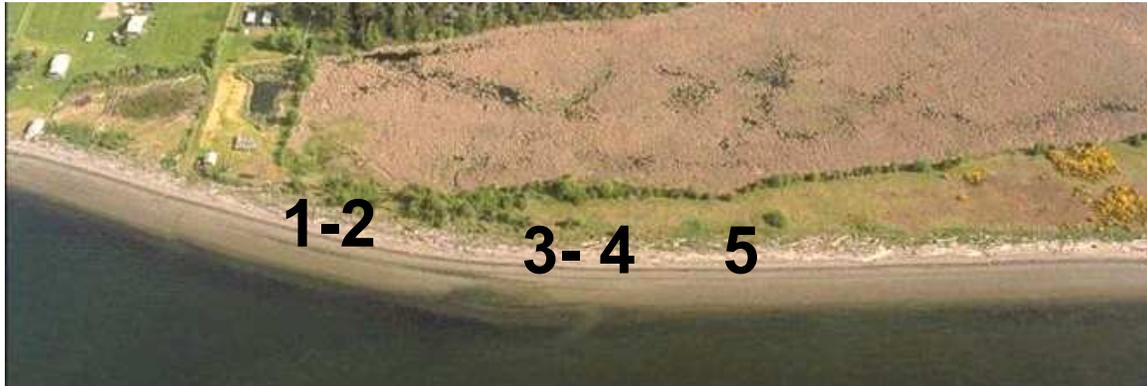
Shoreline Aerial Photo #SKA0048, west of ferry dock

1. Creosote timber, 6" x 10" x 4"
2. Treated timber, 6" x 4" x 2"
3. Treated timber, 24" x 8" x 4"
4. Treated timber, 8" x 4" x 2"
5. Creosote timber, 16" x 8" x 4"

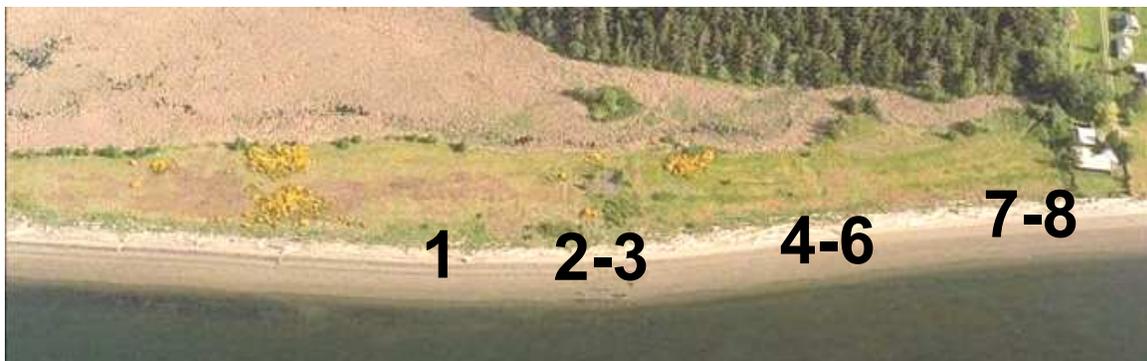
Shoreline Aerial Photo #SKA0049, south shore, west of ferry dock

1. Creosote log, 24" x 16" dia.
2. Treated timber, 60" x 12" x 4"
3. Creosote log, 276" x 12" dia.
4. Creosote timber, 36" x 4" x 1"
5. Creosote timber, 12" x 10" x 4"
6. Creosote timber, 6" x 6" x 3"

7. Treated timber, 8" x 4" x 4"
8. Treated timber, 12" x 10" x 4"

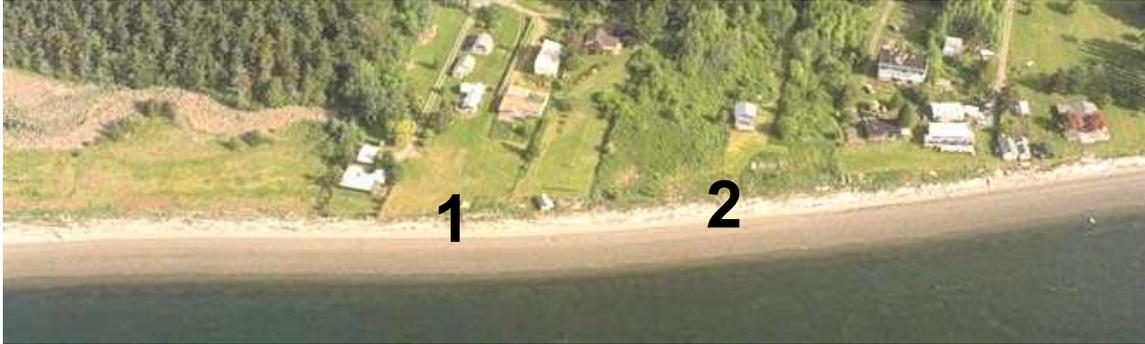
Shoreline Aerial Photo #SKA0050, west of ferry dock

1. Treated timber, 10" x 4" x 2"
2. Creosote timber, 36" x 16" x 8"

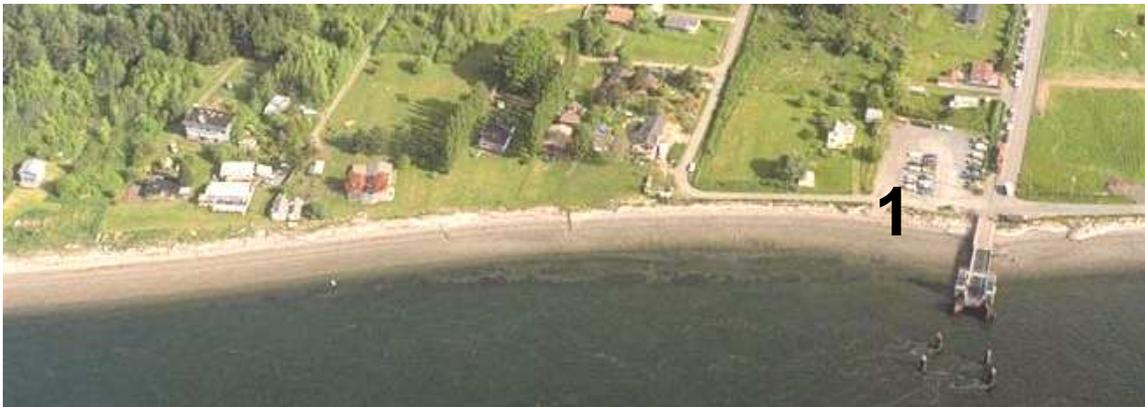
Shoreline Aerial Photo #SKA0051, south shore, west of ferry dock

1. Creosote timber, 36" x 16" x 8"

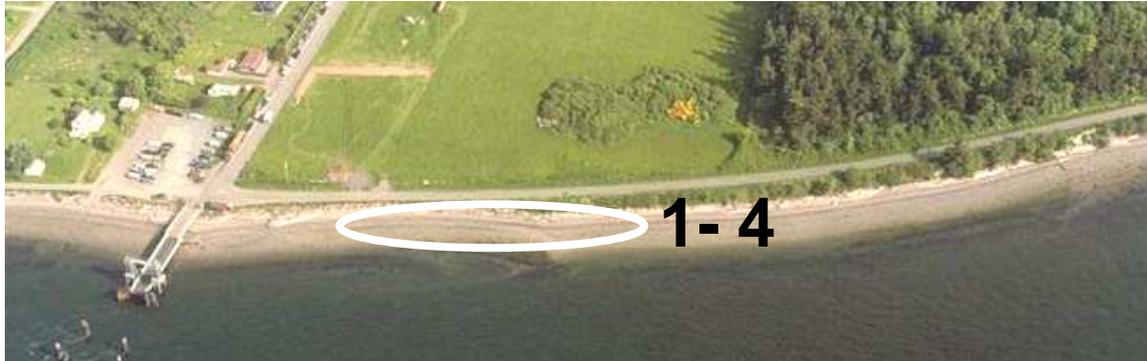
Shoreline Aerial Photo #SKA0052, east of ferry dock

1. Creosote timber, 78" x 12" x 12"
2. Creosote log, 120" x 16" dia.
3. Treated timber, 240" x 8" x 4"
4. Creosote log piece, 8" x 12" dia.

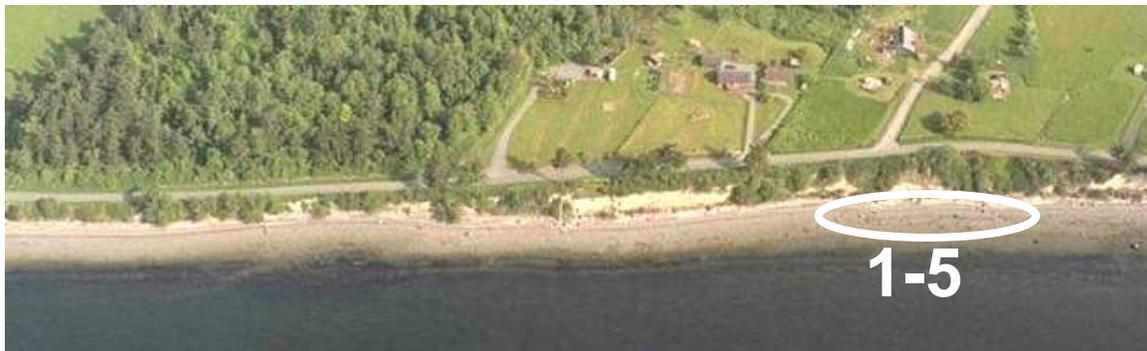
Shoreline Aerial Photo #SKA0053, south shore, east of ferry dock

1. Creosote timber 12" x 10" x 10"
2. Treated timber 10" x 10" x 6"
3. Treated post 60" x 4" dia.
4. Creosote log 72" x 12" dia.
5. Creosote log 28" x 16" dia.

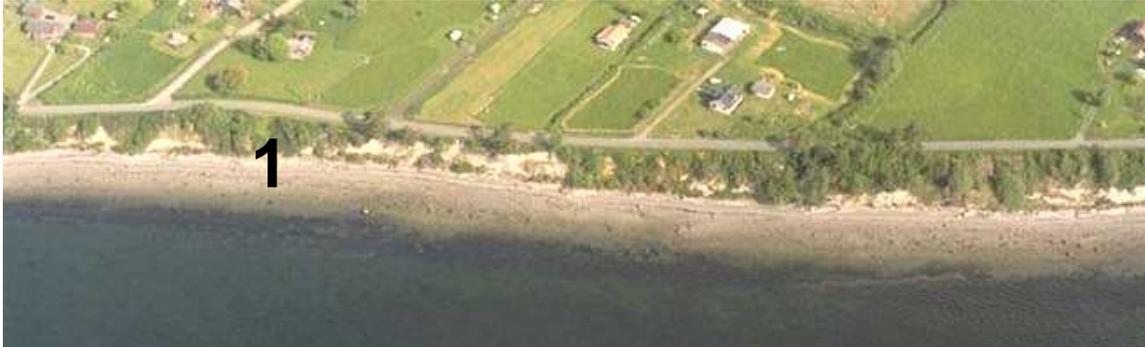
Shoreline Aerial Photo #SKA0054, south shore, east of ferry dock  
Surveyed by Dixon Elder

1. Creosote log 72" x 14" dia.

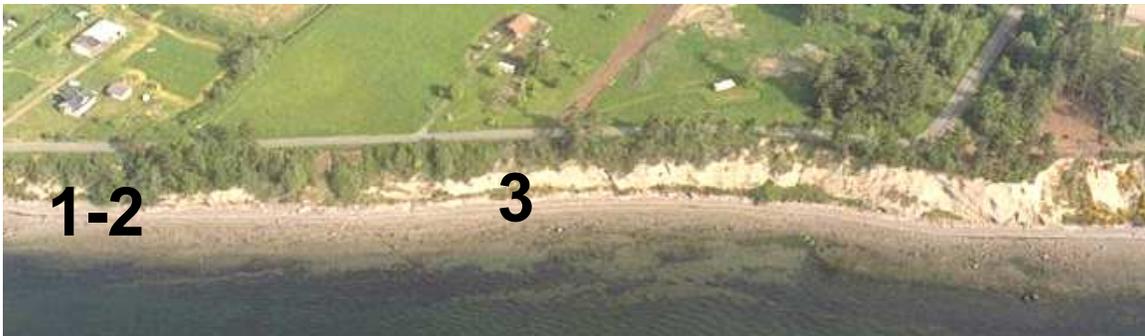
Shoreline Aerial Photo #SKA0055, south shore, east of ferry dock  
Surveyed by Dixon Elder

1. Treated timber 36" x 8" x 4"
2. Creosote timber 16" x 10" x 12"
3. Creosote log 600" x 14" dia.

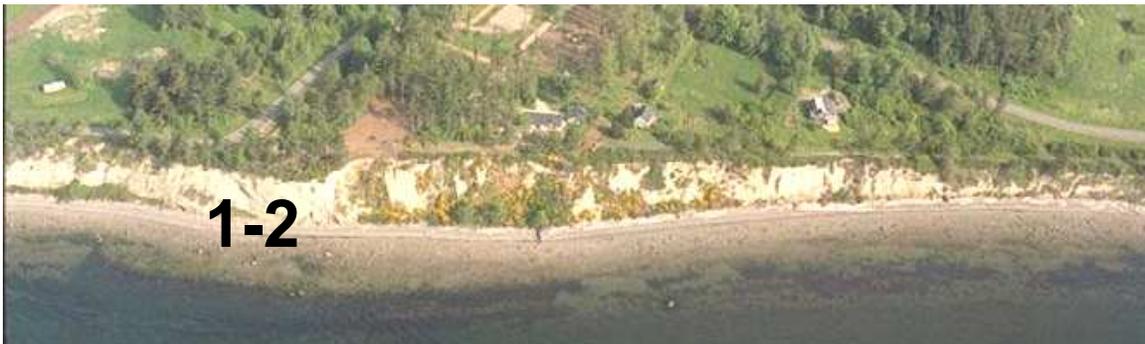
Shoreline Aerial Photo #SKA0056, south shore, east of ferry dock  
Surveyed by Dixon Elder

1. Creosote log end 4" x 16" dia.
2. Creosote log piece 84" x 4" dia.

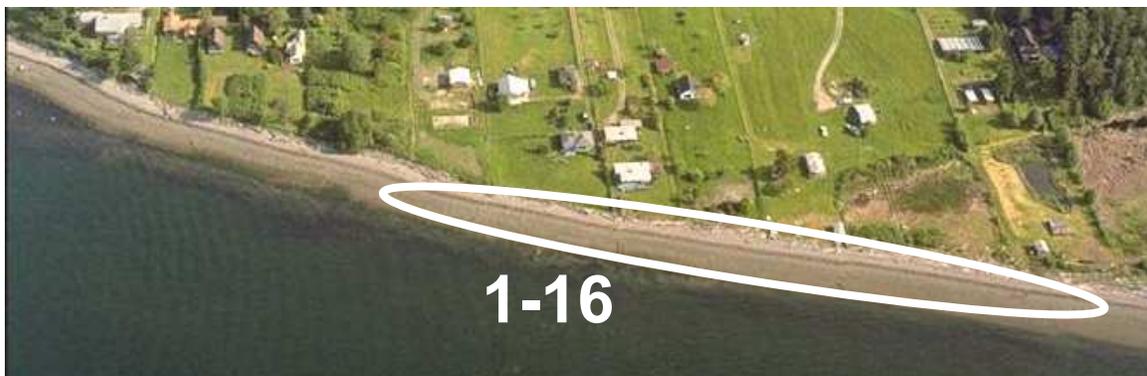
Shoreline Aerial Photo #SKA0047, south shore, west of ferry dock  
 Surveyed by Paul Dinnel and Beach Watcher/MRC volunteers

1. Creosote timber 144" x 8" x 4"
2. Treated timber 6" x 6" x 6"
3. Creosote log 36" x 16" dia.
4. Treated timber 24" x 8" x 8"
5. Creosote log 240" 14" dia.
6. Creosote log 36" x 12" dia.
7. 4 creosote timbers in use, total 720" x 10" x 4"
8. Treated timber 24" x 8" x 6"
9. Treated timber 6" x 4" x 4"
10. Creosote log 24" x 12" dia.
11. Creosote log 72" x 12" dia. (under railroad tracks)
12. Treated timber 24" x 8" x 4"
13. Treated timber 72" x 6" x 6"
14. Treated timber 144" x 12" x 4"
15. Creosote log 12" x 16" dia.
16. Creosote log 12" x 14" dia.

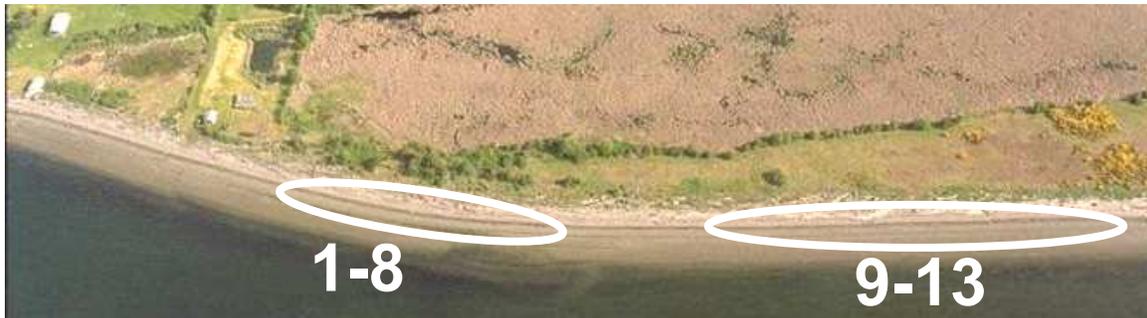
Shoreline Aerial Photo #SKA0048, south shore, west of ferry dock  
Surveyed by Paul Dinnel and Beach Watcher/MRC volunteers

1. Creosote log 72" x 14" dia.
2. Treated timber 12" x 8" x 8"
3. Treated timber 6" x 8" x 6"
4. Treated timber 36" x 10" x 4"
5. Creosote log piece 6" x 8" dia.
6. Creosote log piece 8" x 12" dia.
7. Treated timber 12" x 8" x 4"
8. Creosote log 36" x 14" dia.
9. Creosote log 96" x 16" dia.
10. Creosote log 72" x 14" dia.
11. Creosote log 36" x 10" dia.
12. Creosote log 6" x 8" dia.
13. Creosote log 36" x 12" dia.

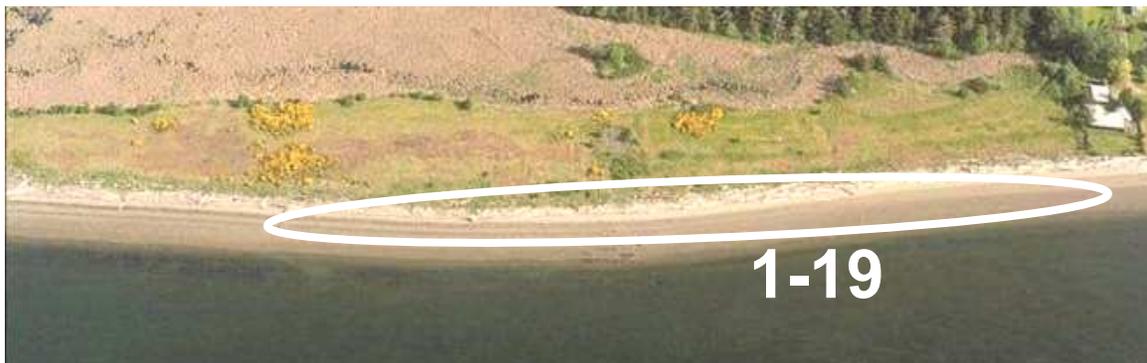
Shoreline Aerial Photo #SKA0049, south shore, west of ferry dock  
Surveyed by Paul Dinnel and Beach Watcher/MRC volunteers

1. Treated timber 8" x 6" x 4"
2. Creosote log 24" x 14" dia.
3. Creosote log 18" x 14" dia.
4. Creosote log 12" x 14" dia.

5. Treated timber 60" x 14" x 14"
6. Treated timber 12" x 6" x 4"
7. Treated timber 60" x 10" x 4"
8. Creosote log 12" x 12" dia.
9. Treated timber 24" x 8" x 4"
10. Creosote timber 180" 8" x 4"
11. Creosote log 26" x 16" dia.
12. Creosote log 48" x 18" dia.
13. Creosote log 36" x 12" dia.
14. Treated timber 24" x 8" x 4"
15. Treated timber 6" x 6" x 4"
16. Treated timber 18" x 6" x 4"
17. Treated timber 12" x 10" x 2"
18. Creosote log 36" x 12" dia.
19. Creosote log 48" x 12" dia.

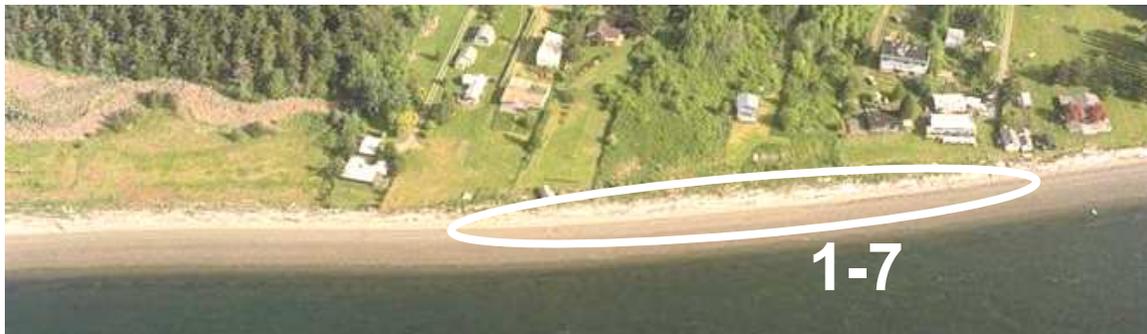
Shoreline Aerial Photo #SKA0050, south shore, west of ferry dock

1. Creosote log 18" x 12" dia.
2. Creosote log 30" x 12" dia.
3. Creosote log 216" x 16" dia.
4. Creosote log 96" x 12" dia.
5. Creosote log 12" x 12" dia.
6. Creosote log 48" x 12" dia.
7. Treated timber 36" x 10" x 4"

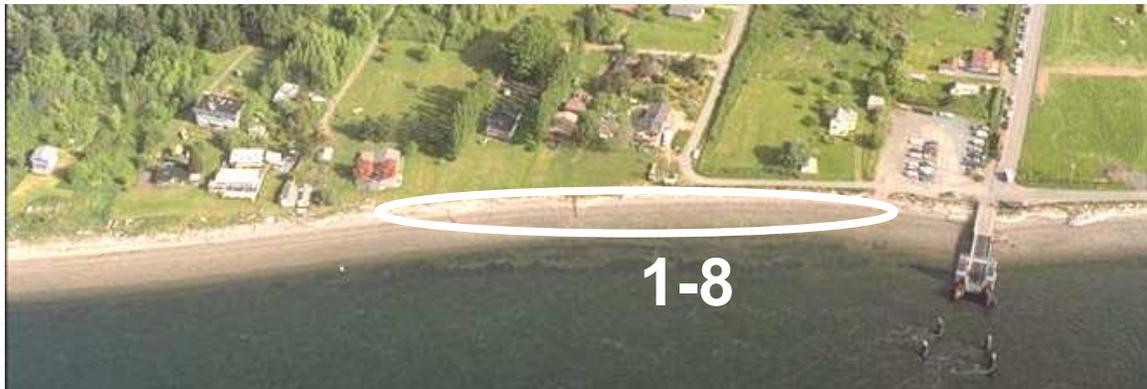
Shoreline Aerial Photo #SKA0051, south shore, west of ferry dock  
Surveyed by Paul Dinnel and Beach Watcher/MRC volunteers

1. Creosote log 72" x 18" dia.
2. Treated timber 12" x 12" x 12"
3. Treated timber 48" x 4" x 2"
4. Treated timber 48" x 12" x 8"
5. Creosote log 24" x 14" dia.
6. Creosote log 216" x 12" dia.
7. Creosote timber 120" x 8" x 6"
8. Creosote timber 12" x 8" x 6"

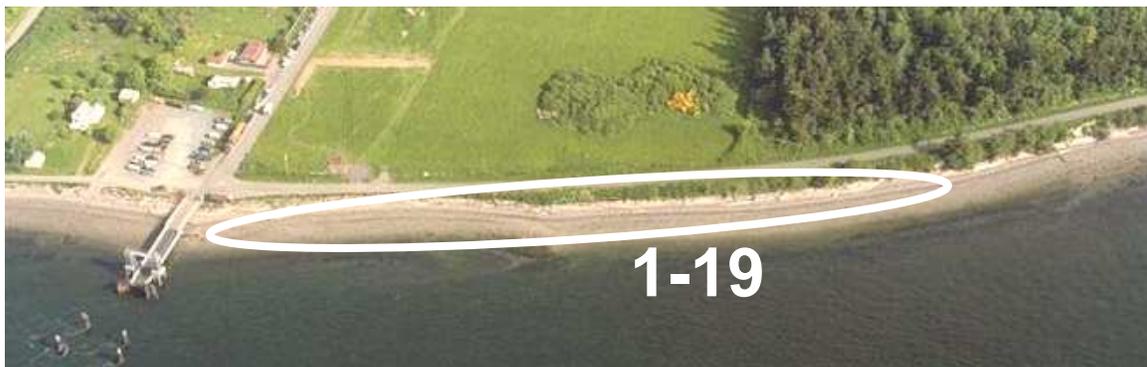
Shoreline Aerial Photo #SKA0052, south shore, east of ferry dock  
Surveyed by Paul Dinnel and Beach Watcher/MRC volunteers

1. Creosote timber 12" x 12" x 12"
2. Treated timber 36" x 6" x 2"
3. Creosote log 24" x 10" dia.
4. Creosote log 240" x 14" dia.
5. Treated timber 12" x 6" x 2"

6. Creosote log 12" x 14" dia.
7. Treated timber 120" x 6" x 4"
8. Creosote log 96" x 12" dia.
9. Creosote timber 84" x 6" x 4"
10. Treated timber 12" x 6" x 2"
11. Creosote timber 12" x 4" x 4"
12. Creosote timber 48" x 4" x 4"
13. Creosote log 96" x 12" dia.
14. Creosote log 12" x 10" dia.
15. Creosote timber 36" x 12" x 12"
16. Creosote log 48" x 14" dia.
17. Creosote log 48" x 16" dia.
18. Creosote log 12" x 14" dia.
19. Creosote log 60" x 12" dia.

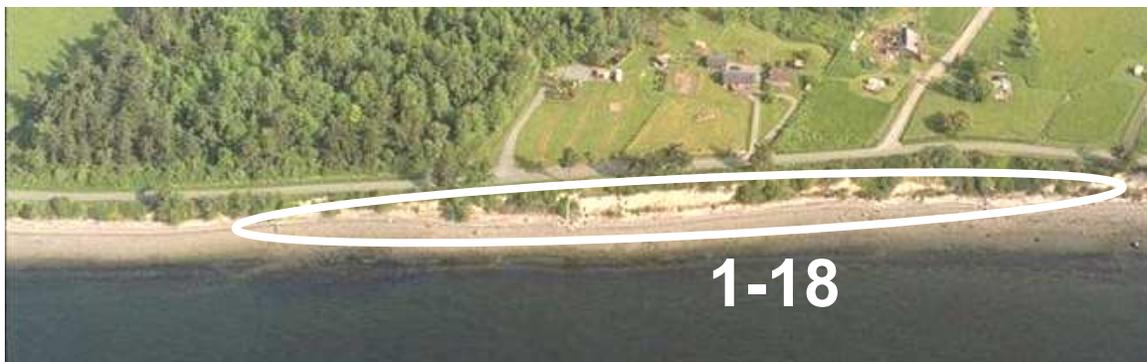
Shoreline Aerial Photo #SKA0053, south shore, east of ferry dock  
 Surveyed by Paul Dinnel and Beach Watcher/MRC volunteers

1. Treated timber 6" x 6" x 4"
2. Treated timber 12" x 4" x 4"
3. Creosote log 24" x 12" dia.
4. Creosote log 36" x 8" dia.
5. Creosote timber 60" x 6" x 4"
6. Creosote log 120" x 12" dia.
7. Treated timber 48" x 12" x 4"
8. Creosote log 360" x 12" dia.
9. Creosote log 18" x 12" dia.
10. Creosote log 336" x 12" dia.
11. Treated timber 72" x 12" x 4"
12. Creosote log 36" x 12" dia.
13. Creosote log 12" x 12" dia.
14. Creosote log 48" x 12" dia.
15. Creosote log 24" x 14" dia.
16. Treated timber 36" x 6" x 2"
17. Treated timber 24" x 10" x 4"

18. Creosote log 36" x 18" dia.

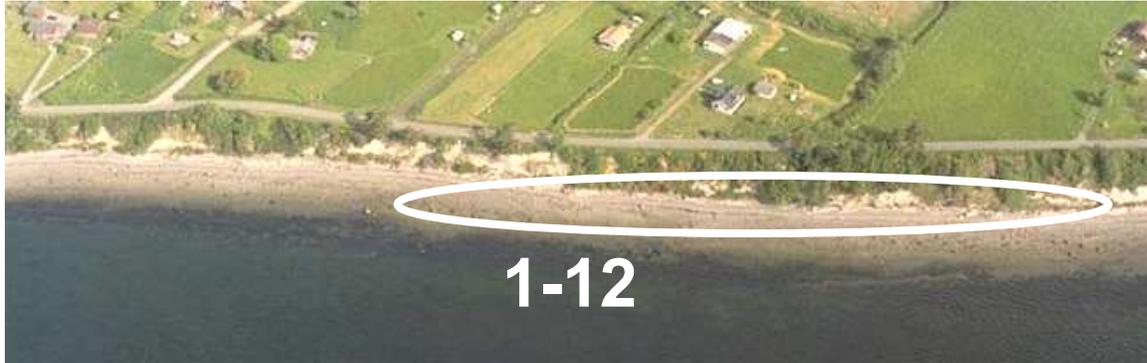
Shoreline Aerial Photo #SKA0054, south shore, east of ferry dock

1. Creosote log 24" x 12" dia.
2. Creosote timber 12" x 10" x 8"
3. Treated timber 12" x 8" x 4"
4. Treated timber 120" x 12" x 2"
5. Treated timber 18" x 12" x 12"
6. Creosote log 36" x 12" dia.
7. Creosote log 48" x 12" dia.
8. Creosote log 288" x 12" dia.
9. Creosote log 84" x 12" dia.
10. Creosote log 72" x 12" dia.
11. Treated timber 48" x 4" x 2"
12. Creosote timber 120" x 10" x 8"

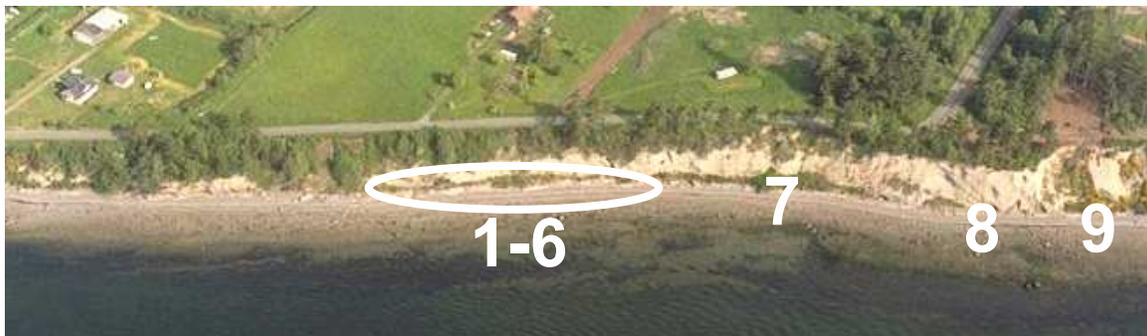
Shoreline Aerial Photo #SKA0055, south shore, east of ferry dock

1. Treated timber 12" x 12" x 4"
2. Treated timber 12" x 4" x 2"

3. Treated timber 12" x 10" x 2"
4. Treated timber 18" x 4" x 2"
5. Creosote log 12" x 12" dia.
6. Creosote log 12" x 8" dia.
7. Creosote timber 120" x 8" x 4"
8. Creosote timber 180" x 10" x 8"
9. Treated wood structure 144" x 18" x 12"

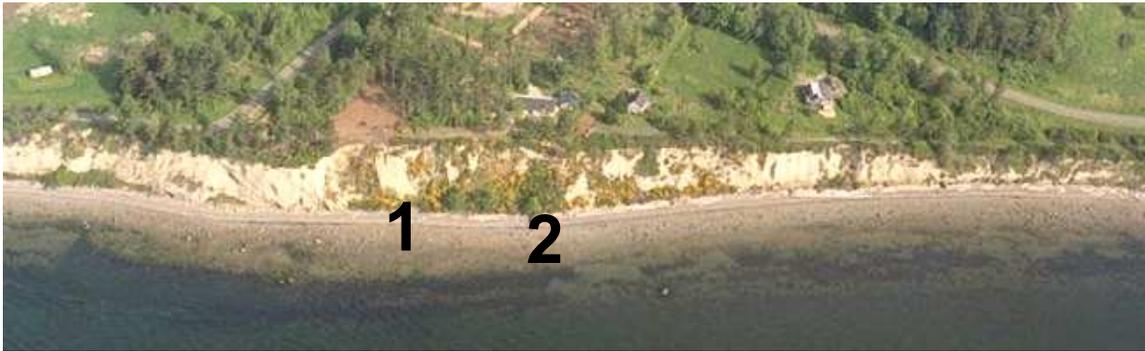
Shoreline Aerial Photo #SKA0056, south shore, east of ferry dock  
 Surveyed by Paul Dinnel and Beach Watcher/MRC volunteers

1. Creosote log 24" x 10" dia
2. Treated timber 24" x 6" x 4"
